## **BUILDING CONDITION SURVEY REPORT**

**Property Address:**           **Any House**  
   **Any Street**  
   **Any Town**  
   **Any County**  
   **Any Postcode**

## BUILDING CONDITION SURVEY REPORT

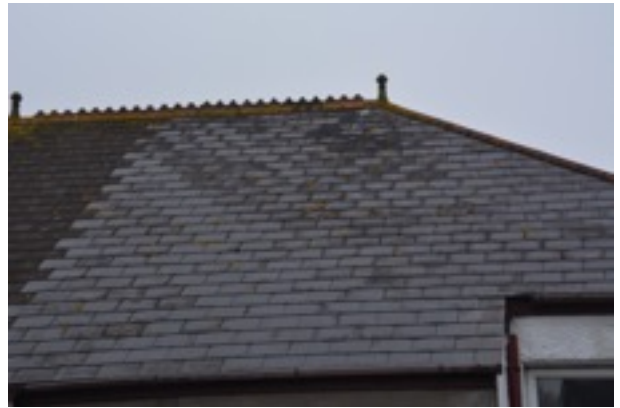
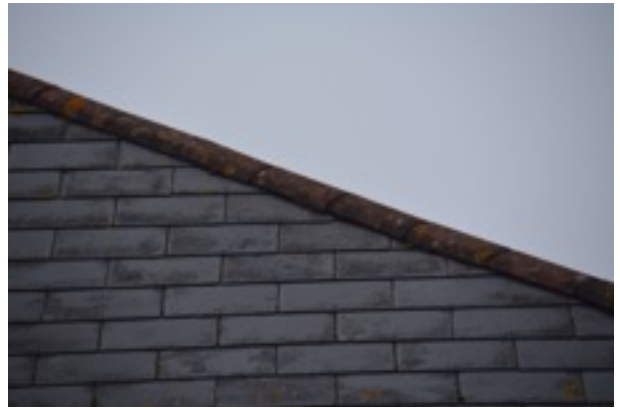
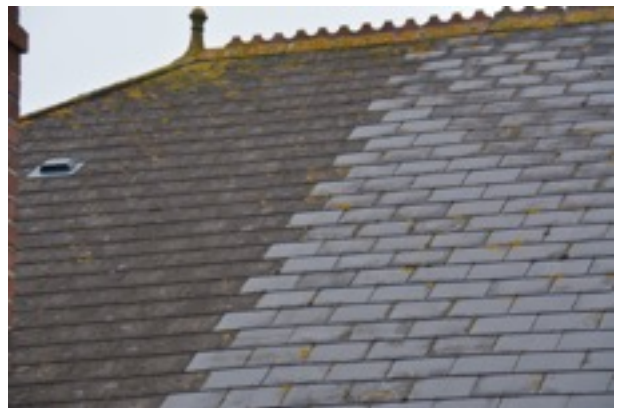
The main roof to the property is of pitched construction clad in manmade fibre tiles on a hollow timber frame. As viewed from the rear of the building the roof slope was seen to be even and free from signs of undulation or significant damage, the tiles being knitted into the tiled roof surface of the adjoining property, which is very obviously older. Ridge tiles to the apex of the roof are slightly ornate, these being level, even and well bedded onto cement with the hip ridge also being straight, there being a hip angle present at the base to provide for additional support. There is a certain amount of lichen growth over the surface of the roof, but we are not overly concerned about this in its present form.

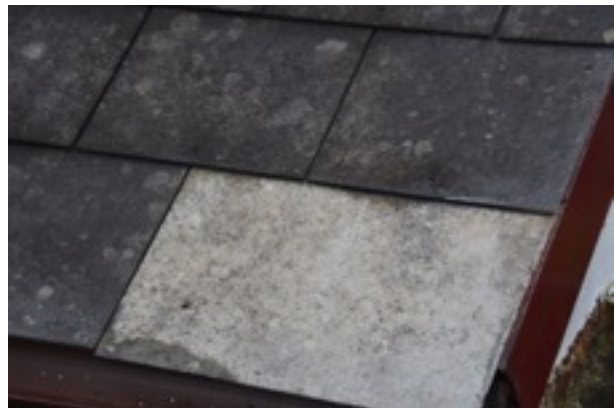
Where the rear extension is located there is a further pitched and hipped roof structure, this effectively extending over the kitchen and the bathroom as well as the small rear store, this also being clad over in manmade fibre tiles, but we believe some of these may contain a degree of asbestos, although we are unable to confirm. The rear roof slope of this extension has a slightly different pitch towards the lower sections, and at the base at the eaves at least one tile was noted to be smashed and broken, and one further asbestos tile has badly discoloured. A small amount of moss growth is present over the surface, but again we are not overly concerned about this in its present form, this roof also extending across the rear addition of the adjoining dwelling. Hip ridges have been formed out of cement and were seen to be in fair condition.

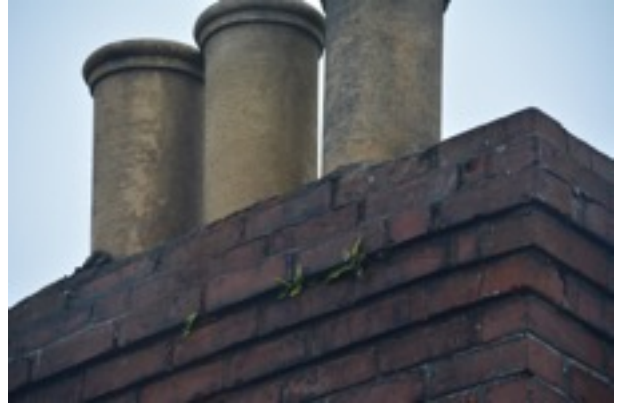
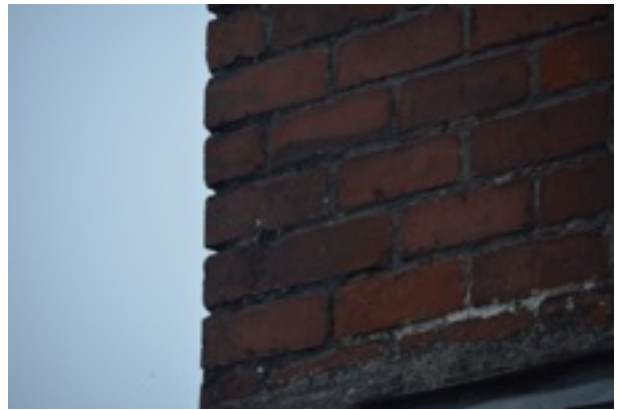
Rising up through the middle of the back addition there is a brick-built chimney stack which we suspect originally had four pots to the crown, although only three are presently visible. The crown and flaunching areas were largely hidden from view. The stack was seen to be generally vertical, but a small amount of plant growth was noted to be present to the brickwork. Some of the brickwork is beginning to spall and deteriorate, and there is also a need for attention to pointing. Flashings are present around the base of the stack. The chimney stack is, we presume, a shared liability and solicitors should please confirm.

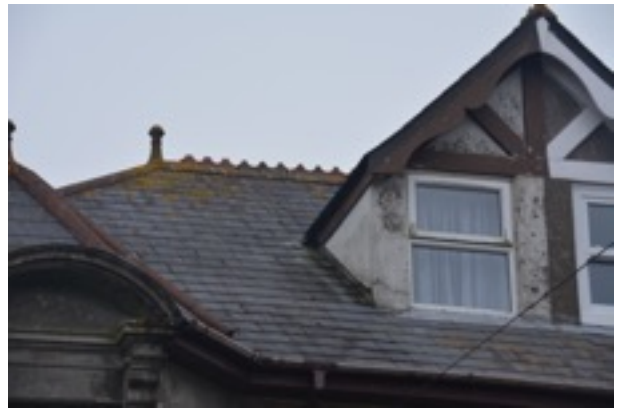
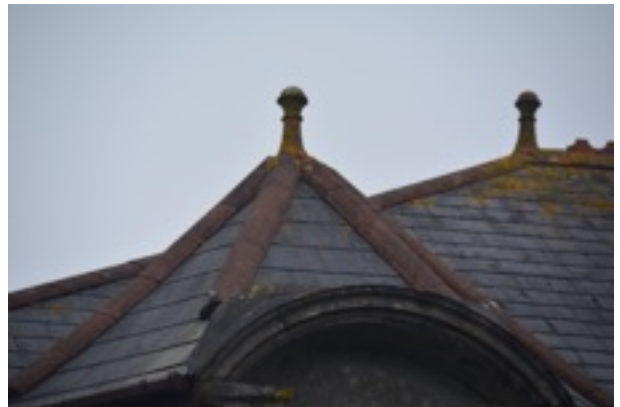
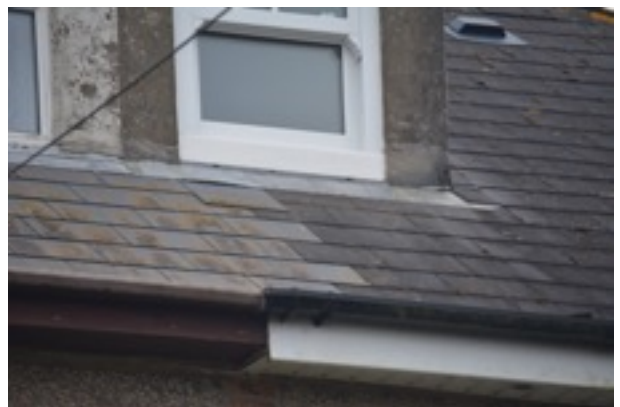
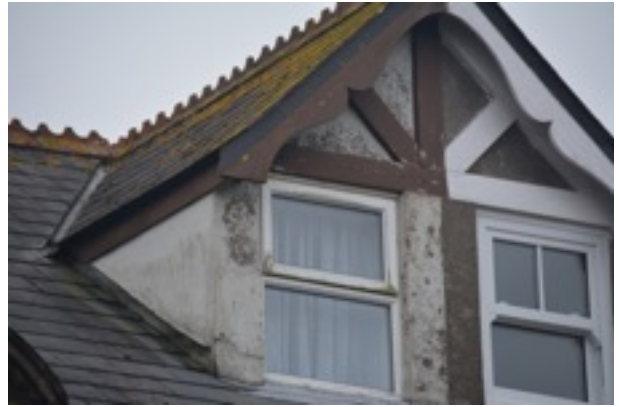
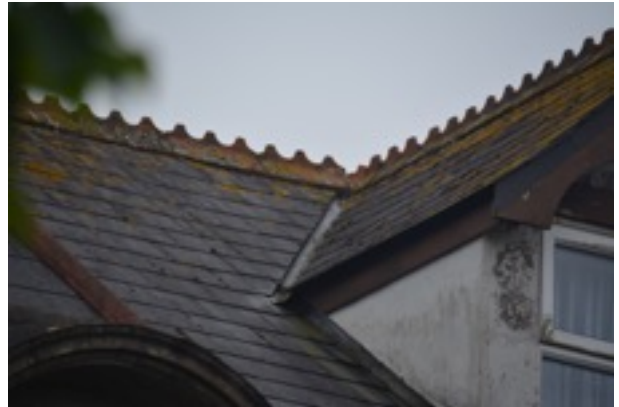
As viewed from the front of the property the roof was seen to be similarly clad over in manmade fibre tiles with a conical hipped roof positioned immediately over the bay. All parts visible were seen to be in fair condition with tiles again being generally well knitted into the roof over the adjoining dwelling. Where the dormer is located a sensible lead flashing is present immediately below the window. Where the conical roof is positioned over the bay this too was seen to be in fair condition with the hip ridges straight, with hip angle irons present at the base. As with other roof areas, a small amount of lichen growth is present over the surface, and should this become excessive it will need to be killed off and removed. Some valleys are present to either side of the conical roof as well as to the rear of the dormer, and we noted no obvious signs of blockage where easily visible at the time of inspection. The cheeks of the dormer have all been rendered and it is apparent that these have not been redecorated for some time. We suspect that these may be of timber framed construction. Those small areas of the roof over the dormer that we were able to see were again in satisfactory condition, but further lichen growth is present. Additional ornate ridge tiles were also seen to be located in this position.

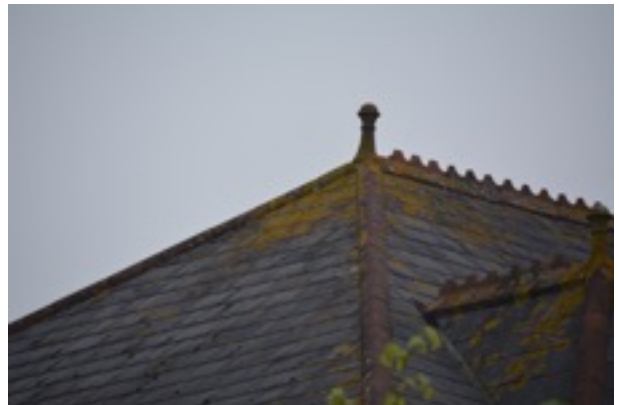
With regard to the hipped roof slope facing towards the adjoining bungalow, only a limited distant inspection was possible of this from the roadway. We can again confirm that the roof was seen to be even and free from signs of undulation, and those parts visible were in similar condition to the other roof areas already inspected. Further lichen growth is present close to the apex of the roof, to which the same comments apply, the hip ridges on either side being straight and free from damage or defect as far as we could ascertain, but obviously a close inspection was simply not practical.

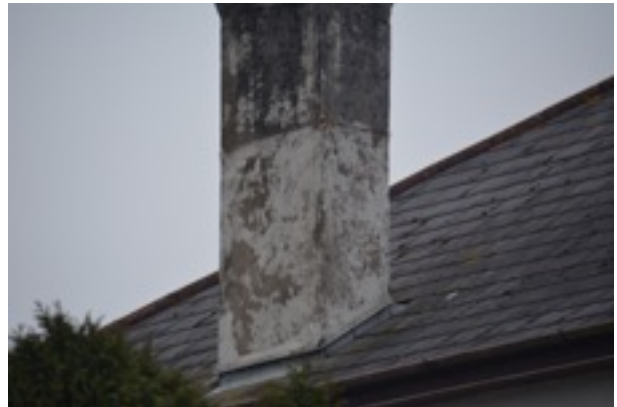
Rising up through this hipped roof slope there is a chimney stack, which we suspect is of brick, this all being externally rendered with two pots to the crown of the stack, but the crown and flaunching areas were largely hidden from view, both of the chimney pots being covered over with mesh cages. The stack has been painted in the past, but has obviously not been decorated for very many years. There is some evidence to suggest lead flashings and soakers around the base of the stack may have more recently been replaced.

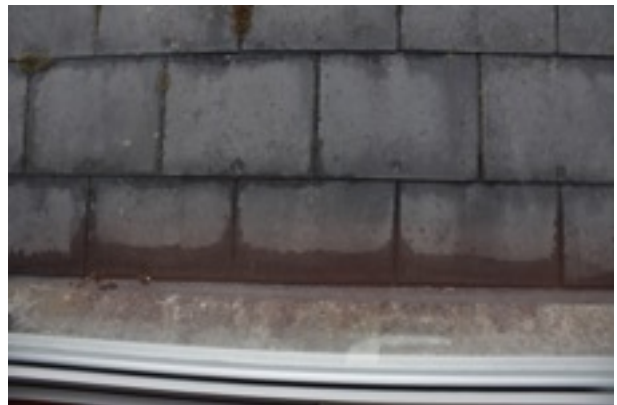
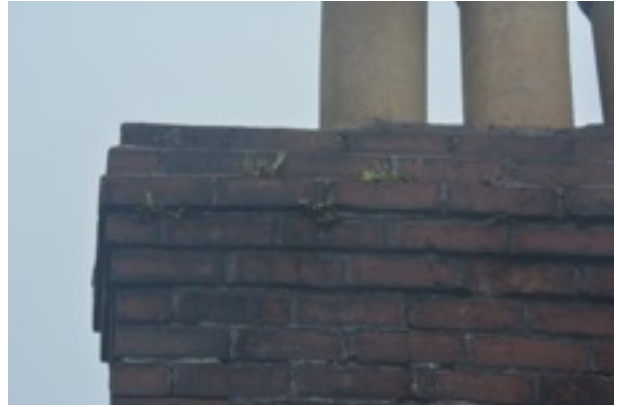
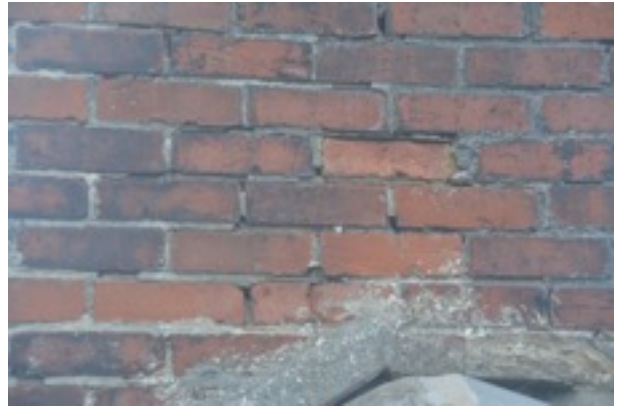
The rear hipped roof slope of the back addition could be inspected from the half-landing window. We can again confirm that the tiled roof surface was seen to be in fair condition and free from damage or defect, but a small amount of moss growth is present, as indeed was visible to other roof slopes. The roof drains down to a lead-lined valley at the base of the wall which ultimately feeds to the side of the property. Those rear sections of the chimney stack visible again showed evidence of plant growth as well as damage and deterioration to pointing and brickwork, thus emphasising the need for works in this location.

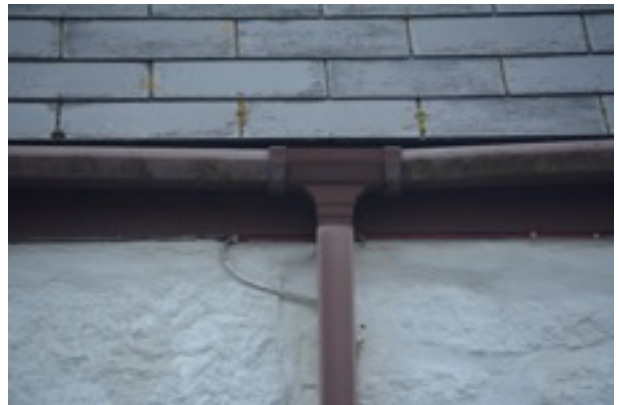
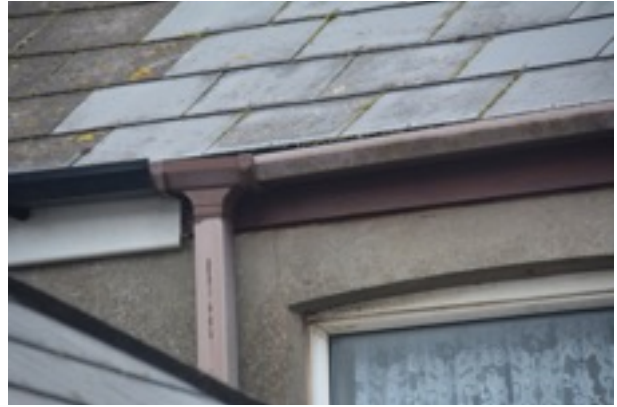
As viewed from the back of the building guttering serving the main roof slope has been run in brown box-shaped plastic sections. Guttering was seen to be in fair condition and free from any obvious leaks on this relatively dry day. To the right hand side of the first floor WC guttering does not extend totally into the corner, and in this location a small amount of lead flashing is present in order to divert water runoff from the roof into the guttering itself. Guttering would all now benefit from being cleaned and flushed through. The downpipe was well secured to the elevation wall, this ultimately jettisoning stormwater down into a sealed gully at the base of the wall.

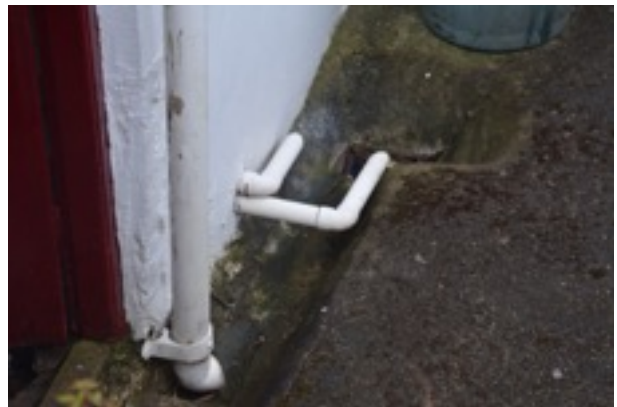
Guttering serving the side of the extension has been run in white half-round plastic sections. This too was seen to be in fair condition, there being a downpipe secured to the elevation wall by the store door, this ultimately jettisoning stormwater into the nearby gully, which also collects waste water from the bathroom. It was noted that the fixing bracket at the base of the downpipe has worked loose.

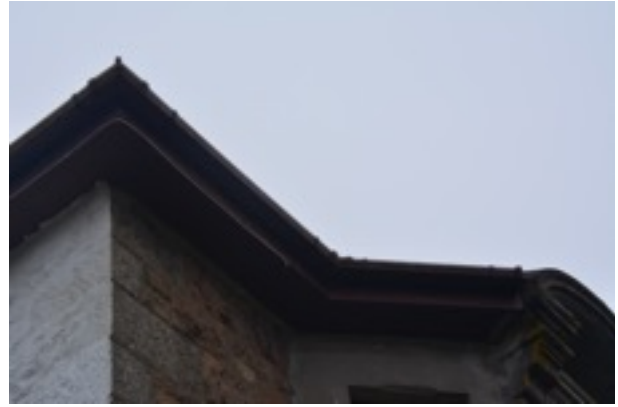
Guttering serving the rear roof slope has been run in a mixture of both brown and white plastic sections. This is shared with the adjoining dwelling and extends across and ultimately jettisons stormwater onto the side of the adjoining dwelling. The guttering extends down the side of the building where it is also run in brown box-shaped sections. Whilst we noted no obvious signs of any leaks, it is quite apparent that the guttering is dirt stained in this location and again requires to be cleaned and flushed through. The guttering wraps around the front of the building to where the bay is located.

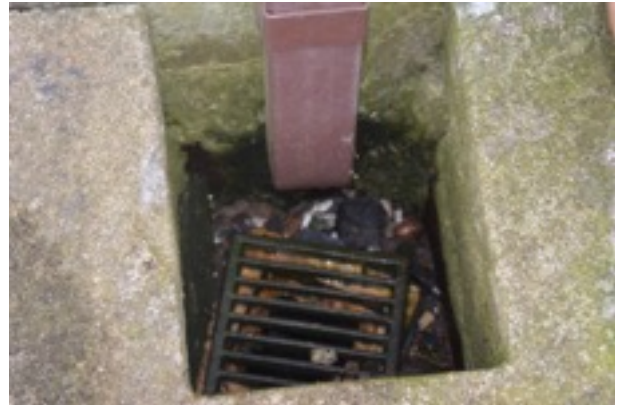
The final section of guttering is positioned to the right hand side of the bay where there is a further downpipe, this ultimately jettisoning stormwater into an open, although protected, gully at the base of the wall. It was noted that some of the cement benching surrounding the gully has now washed and weathered away, and this should be repaired to prevent water soaking down through into the foundation areas, which will ultimately cause damage and settlement problems.

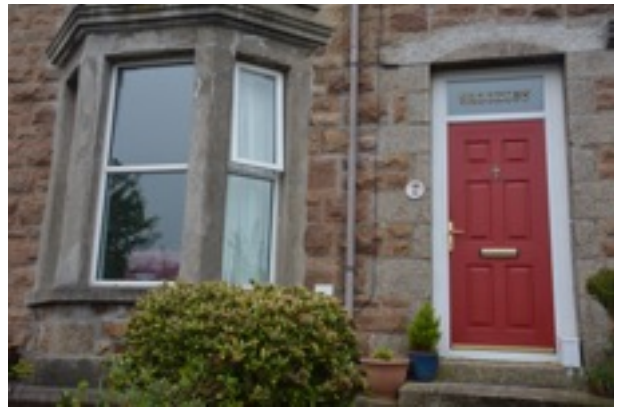
As viewed from the front of the dwelling the elevation wall was seen to be generally vertical, this largely comprising both stone and granite, with granite quoins and lintels around door and window openings. Where the bay is located, the bays have been rendered and the nature of the material below is not known, but we suspect stone or brickwork. This has obviously not been decorated and it would perhaps be greatly enhanced if the whole of the bay area was painted accordingly. Pointing to the stonework was seen to be in fair condition, there being one air brick present at low level below the bay providing for sub-floor ventilation.

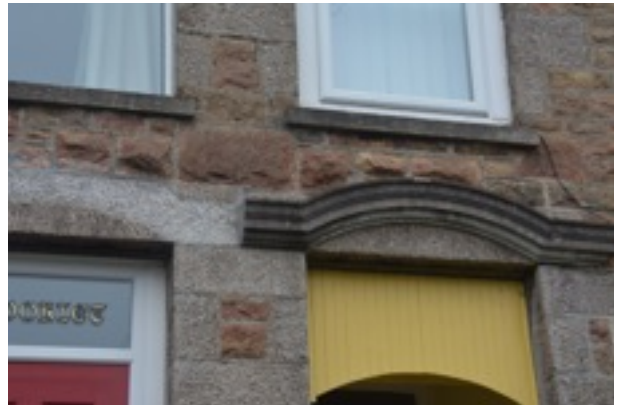
Some patch repairs have been undertaken to the pointing during the history of this dwelling. Where the entrance door is located originally there was some ornate cornicing immediately above the door, similar to that on No. 34, but this has obviously long since cracked and broken away, there now being a light scar on the granite where this was originally positioned.

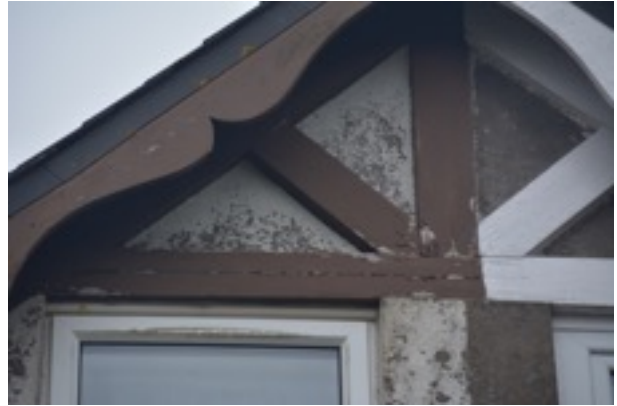
Where the dormer is located at the uppermost level we noted evidence of cracking to the rendered surface and suspect that the render may well be blown in this location. This obviously has not been decorated for very many years, to include for the wooden timberwork present in the uppermost part.

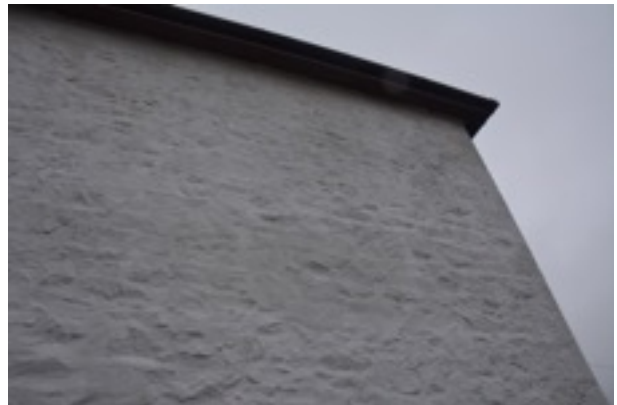
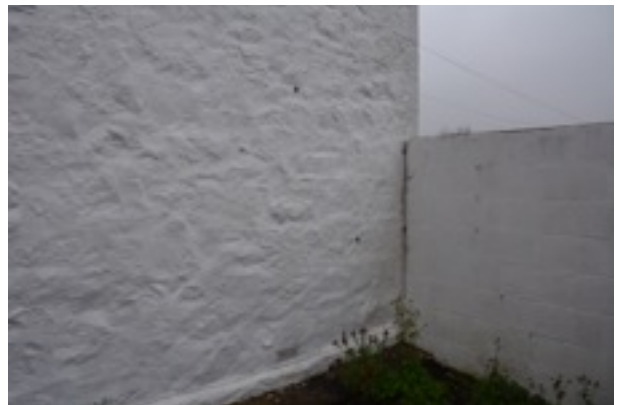
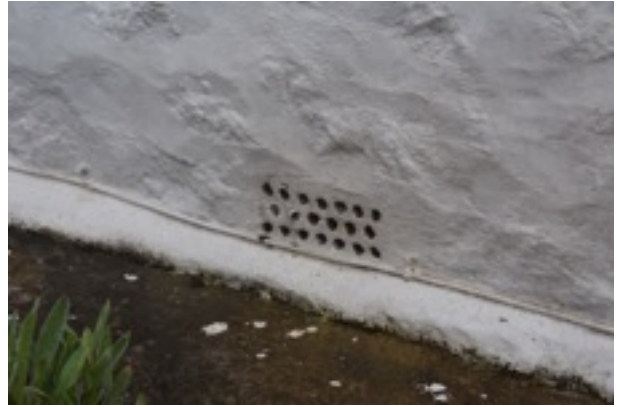
The side elevation wall of the main building is very obviously of stone that has been painted in the past, but a small area at high level has obviously not been decorated because the ladder wouldn't reach. We noted no evidence of any cracking, bowing or deflection, there being further air bricks present around the base to provide for sub-floor ventilation. Slight dirt staining was noted to the surface of the wall which will inevitably require to be redecorated in due course. Butting up to this wall where the side pedestrian gate is located there is a block built boundary. This has slightly pulled away from the wall due to, we suspect, differential movement and we noted no evidence of any physical or chemical damp proof course present in this location, which may result in damp bleeding through into the main structure.

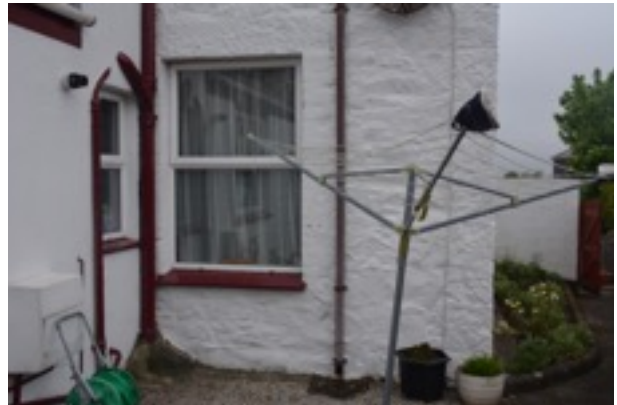
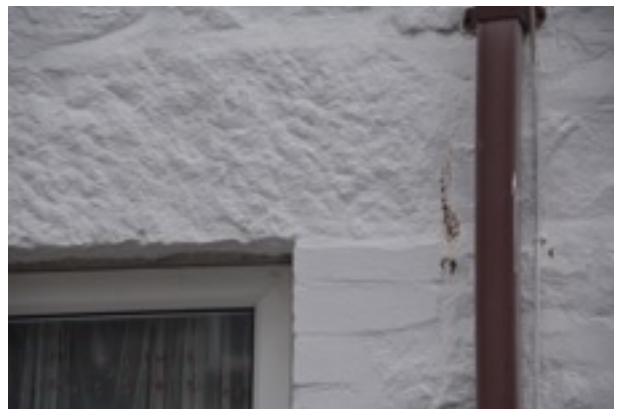
The rear elevation wall of the main body of the building is also quite clearly of stone and granite with some brickwork present surrounding the window openings, however that section to the left where the building protrudes where the separate WC is located has been rendered and partially painted. This is the section which is understood to be of brick. The elevation wall was seen to be vertical and again free from signs of cracking, bowing or deflection with window openings remaining square and cills being of solid slate that has been painted. Please note that to the rear of door and window openings on all parts of this building we are unable to comment as to the condition of any timber lintels that may be present. Against the rear elevation wall there is a satellite dish, but this was noted to be corroded and is probably now in need of replacement.

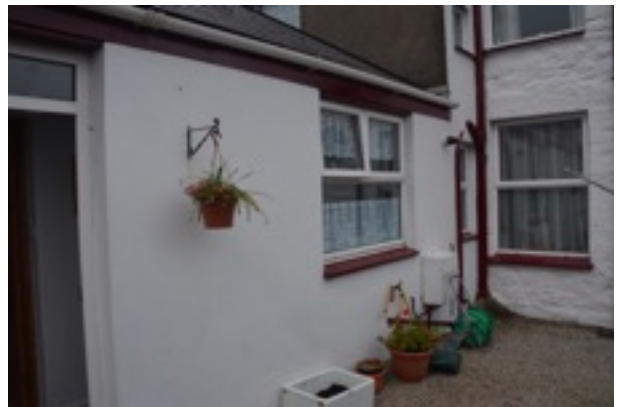
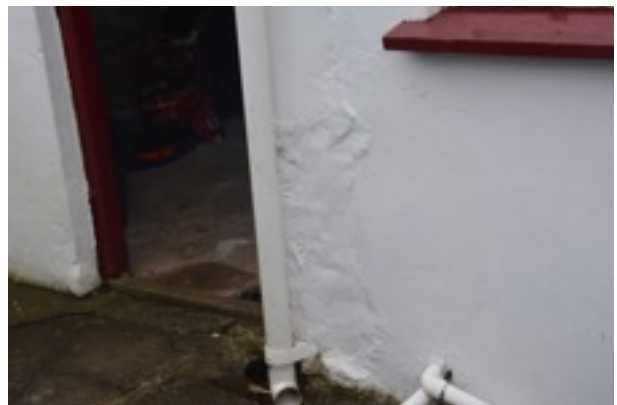
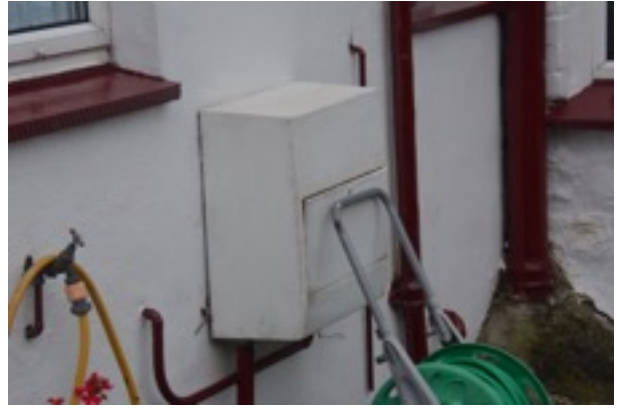
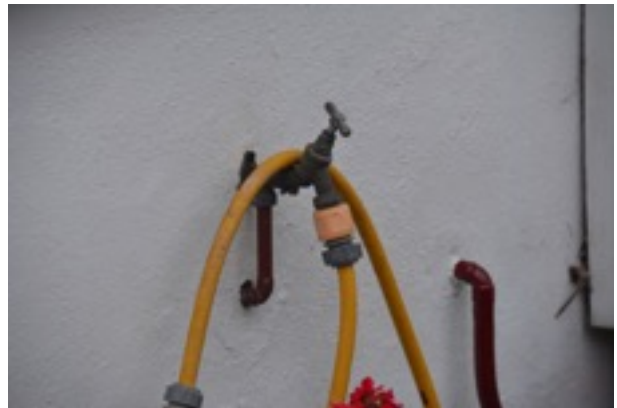
The side elevation wall of the back extension, which is also we understand of brick, was equally seen to be vertical and again free from signs of cracking, bowing or deflection, with the window openings remaining square and further slate cills present. In the corner, the soil vent pipe rises up between the small extension and the main building, but this stops short of the eaves and ideally this should be extended and goosenecked around the top with a suitable metal or plastic cage fitted. A balanced flue protrudes through the wall serving the internal boiler and at low level a gas meter box is positioned. To the left hand side of the back door position the wall was also seen to be generally vertical, but some patch repairs have obviously been undertaken at low level to the rear of the downpipe. Some brickwork is present to the right hand side of the back door where render is cracked and broken away (a foot scraper may possibly have been initially positioned in this location). Where the outside tap protrudes through the wall below the kitchen window this should ideally be fitted with insulation and a small lagging jacket to prevent the possible risk of frost damage.

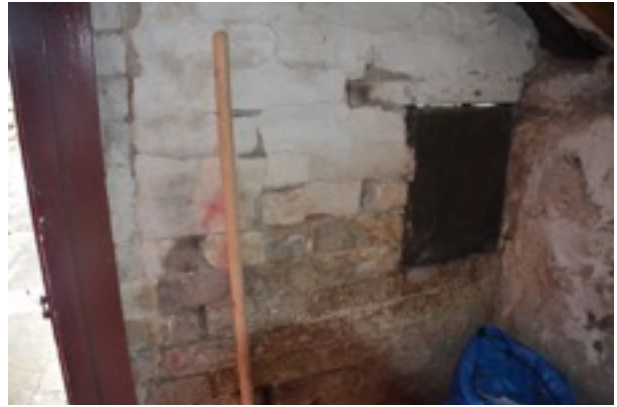
The rear elevation wall of the store is effectively built below ground and is not visible from the exterior, but from the interior we can confirm that this indeed is of solid stone construction, as is the back wall of the store where it butts up to the neighbouring property and the back wall of what is effectively the bathroom, these walls being given a slurry cement wash that has been painted in the past. The side wall of the store is of brick, this again being externally rendered and painted, but the brick is partly below the adjoining flower bed and inevitably this will give rise to internal damp problems.

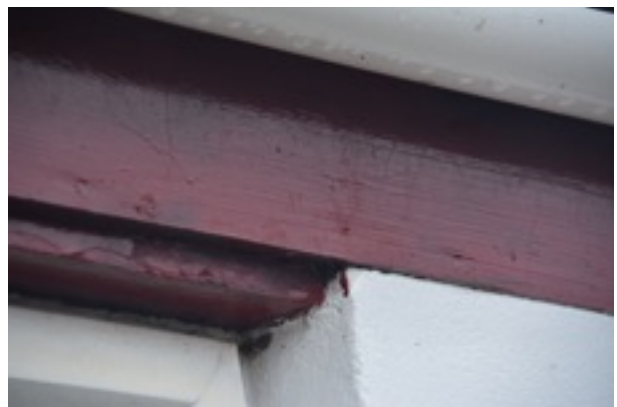
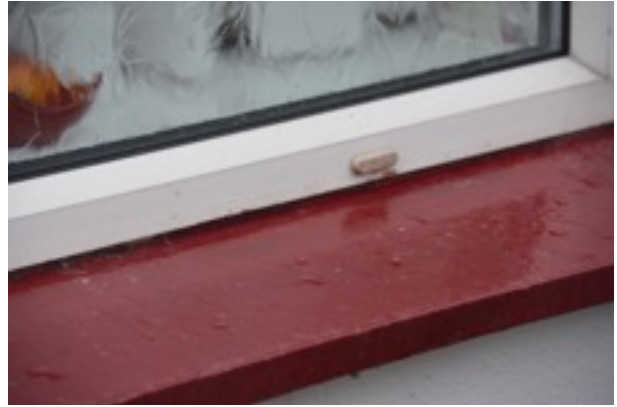
The various fascia boards, cills and wooden doors have been fairly well maintained during the history of this property, but they have suffered and gradually deteriorated over time, with small amounts of rot present around door frames. The fascia boards, which are painted, were seen to be in fair condition, but inevitably these too will require to be redecorated during the course of your occupation. The soffit boards have also been painted. Please note, we are unable to comment as to the nature of this material. The various other doors and windows are all of modern uPVC. These should remain relatively maintenance-free, but will inevitably require routine cleaning down in order to maintain their appearance. It was noted to the soffits where some electrical cabling is present this has dropped out of position and requires to be properly re-secured.

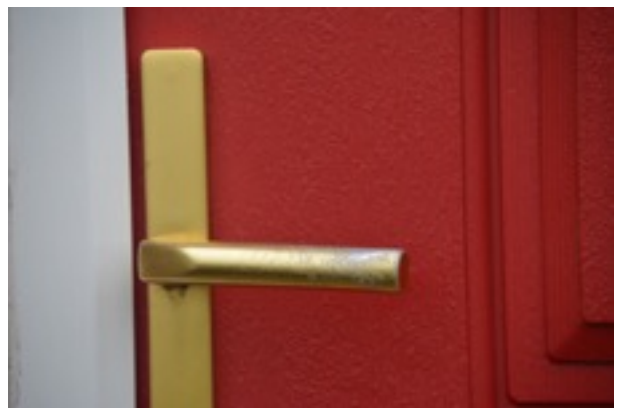
To the front of the building the same comments are largely applicable and, as already mentioned, it will probably be prudent to paint the bay area as this will considerably improve the overall appearance of the approach to the building. The main entrance door has more recently been replaced, but it was noted that the handle has become scratched and worn. Where the side pedestrian gate is present to the left hand side there is no proper gate stop and it would perhaps be beneficial to undertake some improvements in this location.

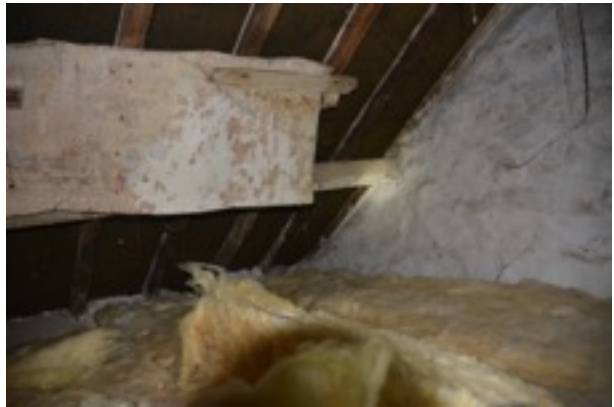
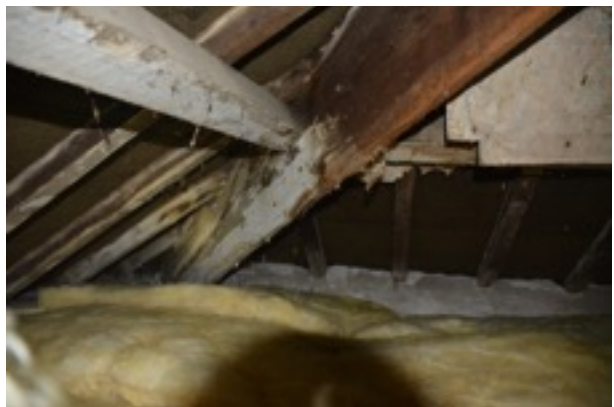
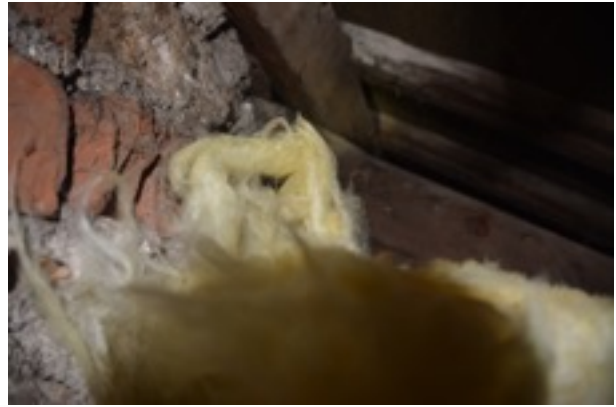
Access was available into the section of roof void immediately over the bathroom via a hatch positioned in the bathroom ceiling. We can confirm that immediately by the hatch rising up between the bathroom and the kitchen there is a further solid random stone wall, with a stone wall between the subject dwelling and adjoining property. These walls in the past have been covered over with a slurry cement wash and painted, but have obviously not received attention for many years as there is no point. The void was seen to be generally well insulated. Timbers within the void are the original timbers, which were seen to be in fair condition given their age, although there was evidence of past water staining due presumably to previous defective roofs. The undersides of the tiles have been protected with bitumen felt and the void has been generally well insulated. There is a very small opening to the right hand side leading through into the kitchen roof void where some lath and plaster was present. We can confirm that some further insulation has been stuffed into this area, but in all honesty no sensible inspection of the area beyond was possible. We can confirm that by pointing the camera into this area some brickwork was indeed present, but we suspect this to be associated with the chimney stack. Whilst the void has been generally well insulated, some pipework that is ducted through this part of the property has not been insulated and this should ideally be protected accordingly to prevent the possible risk of frost damage.

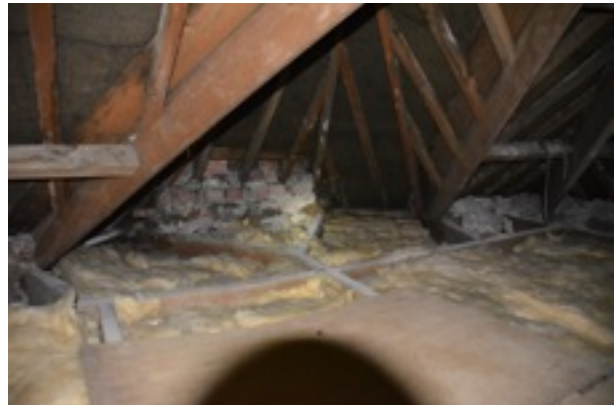
As you will recall, there is an attic room and therefore there is effectively no roof void; the attic room, which we suspect was always originally part of the structure of the building, effectively occupies this space. There is a hatch which gives access into the roof space beyond. A very small amount of boarding was present, but effectively inspection had to be undertaken from the hatch only. We can confirm that timbers were seen to be original and these were seen to be in fair condition with the undersides of the tiled roof surface being felted. We noted no evidence of any leaks through the valley areas surrounding the conical roof to the front where some rubble and brickwork was present to the uppermost part. Stonework was visible forming the upper parts of the walls surrounding this dwelling. The void has been generally well insulated, but ideally the depth of insulation should be further increased to a minimum depth of at least 12”.

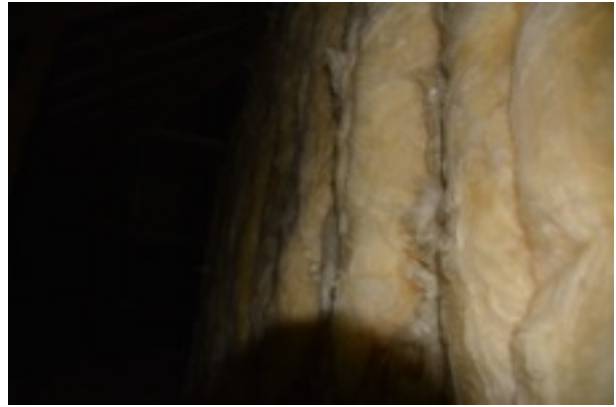
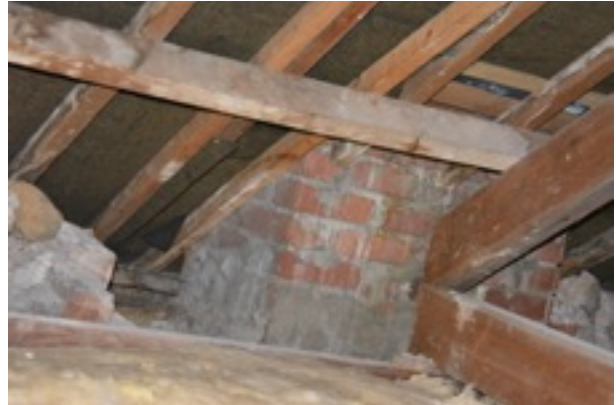
The very limited inspection of those parts of the void extending down the side revealed no obvious defects, with the roof again for the most part being clean, tidy and reasonably well insulated, to include for vertical insulation against the stud wall where the upper attic room has been formed. Where the chimney stack rises up on the gable end wall brickwork was visible, and this was seen to be in fair condition with no evidence of any rainwater penetration down through the uppermost parts.

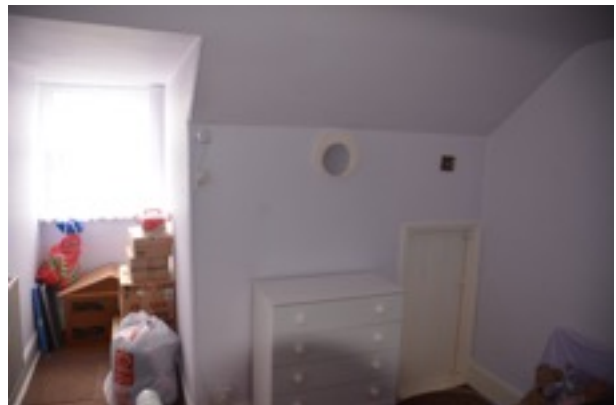
Within the attic room the ceiling is believed to be the original lath and plaster ceiling. We noted some evidence of cracking, but no evidence of imminent failure, however we would point out that where lath and plaster is present this does have a finite life expectancy, and the future longevity of this may therefore be limited. Where the dormer is located we noted slight disturbance to the surface, but again no obvious signs of imminent collapse, although some stains due to past leaks were present.

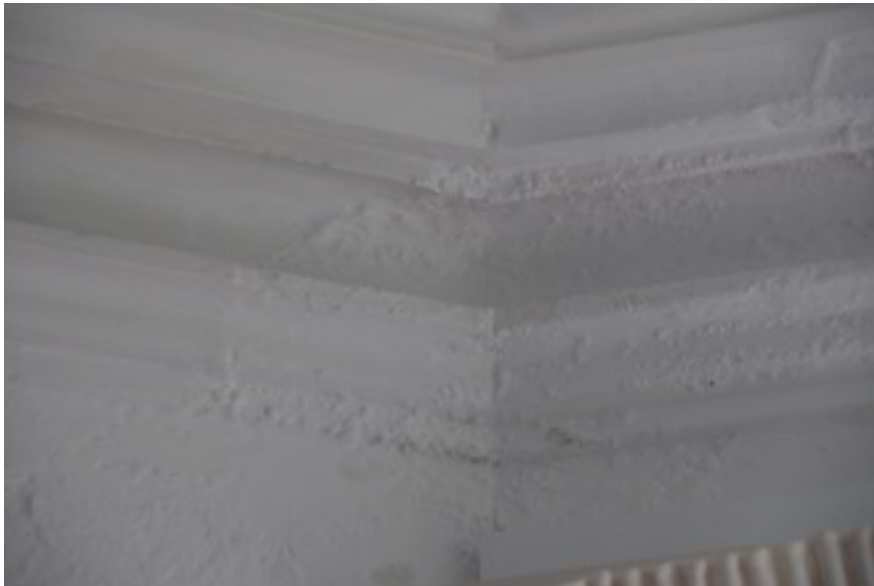
At ground floor level further artexing is present. Within the principal living room the ceiling is skimmed and painted, with some more original coving present. Where the bay is located some hairline cracking was noted to be present which has obviously been made good in the past, and we noted obvious signs of damp penetration around the cornicing, causing damage to the surface of paintwork. The dining room ceiling has also been covered over with artex. In the kitchen, whilst the ceiling is artexed, the adjoining bathroom ceiling comprises relatively lightweight match boarding and you may or may not wish to improve upon this at your discretion.

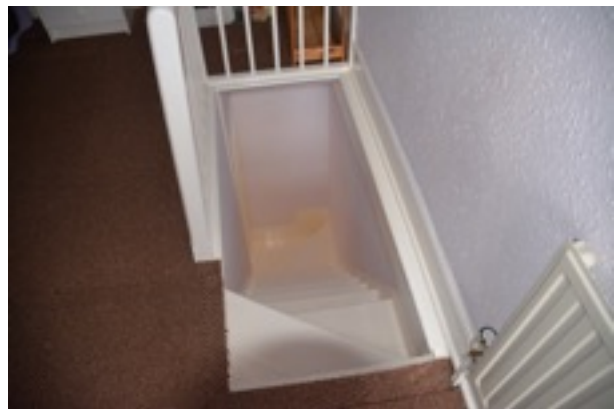
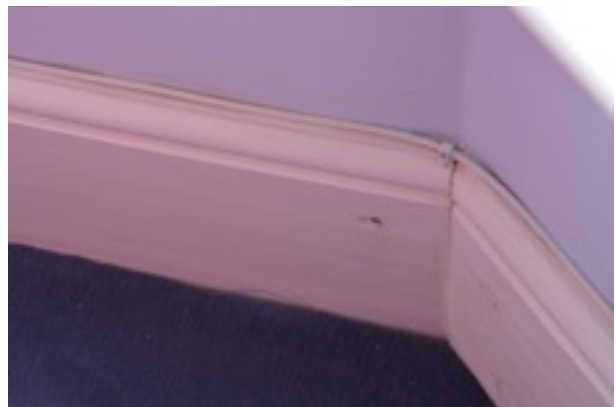
Where the attic room is located there is a small balustrade around the top of the attic stairwell, however this is loose and requires to be properly re-secured. The stairs have no adjoining grab rail, and as these have been painted they are potentially slippery and therefore also a potential hazard. We also noted that the balustrade to the stairway of the main part of the dwelling was loose, and this too should be additionally braced up. Elsewhere within the building woodwork was seen to be in fair condition, other than where it has naturally suffered from wear and tear. Where the door leads through into the kitchen from the hallway the upper part is glazed, but it is not known if glass is toughened or laminated. Skirtings and architraves to doors were seen to be in fair condition with a dado rail also present. Where the inner porch door is located further glass is present, to which the same comments apply. Inevitably doors will require easing and adjusting after redecoration, but subject to minor repairs and maintenance we see no reason as to why woodwork should not remain serviceable for its intended use. There was some evidence that skirtings in the front living room have been replaced with new skirting, indicating that there may have been a rot problem in this location in the past, and further decorative works are required.

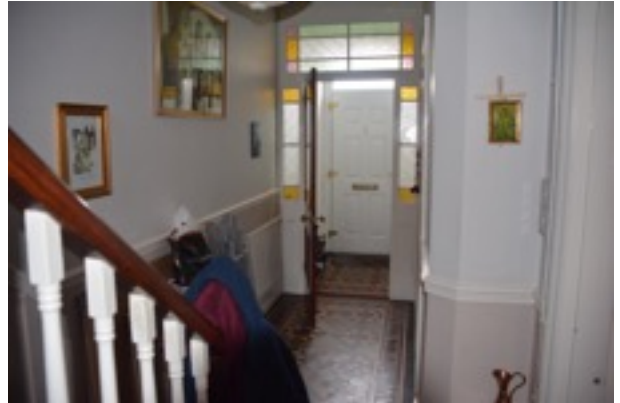
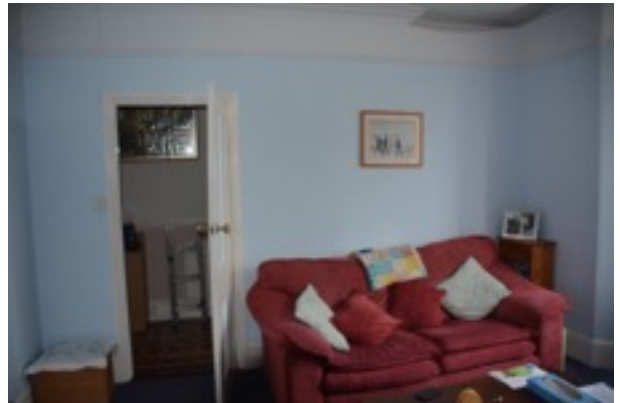
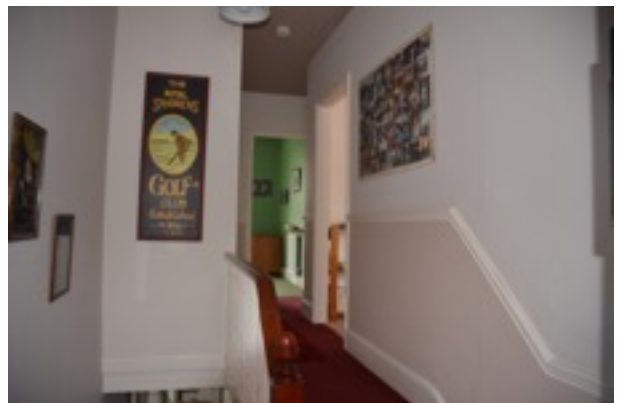
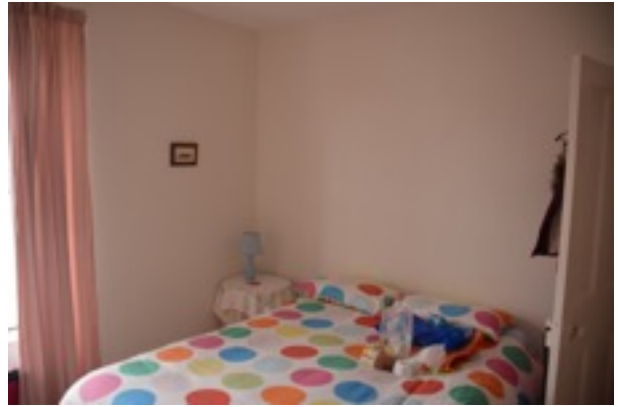
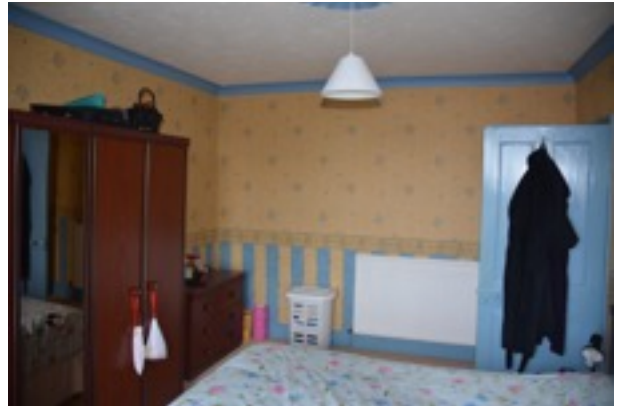
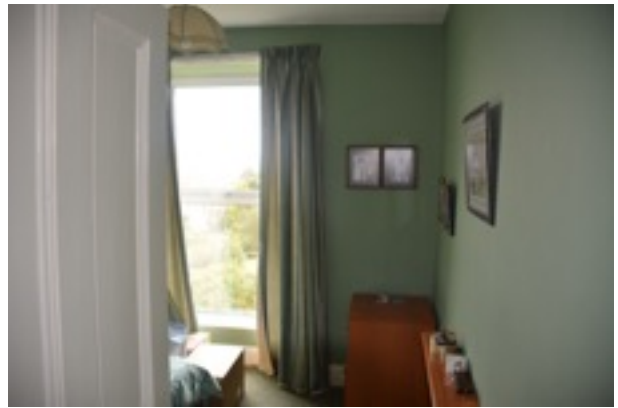
Throughout, this property has been relatively simply decorated, walls largely emulsioned and woodwork glossed or stained. The property is effectively ready for immediate occupation. We did note the use of some wood chip wallpaper, and in the event of this being removed it is quite feasible that the underlying plaster will pull away with it. Inevitably decorations will become lightly soiled and marked after the removal of furniture and fittings, and you will no doubt wish to redecorate in accordance with your own particular style and taste. Obviously some surface decorations are damaged where there have been high levels of damp and additional making good will be necessary in these locations.

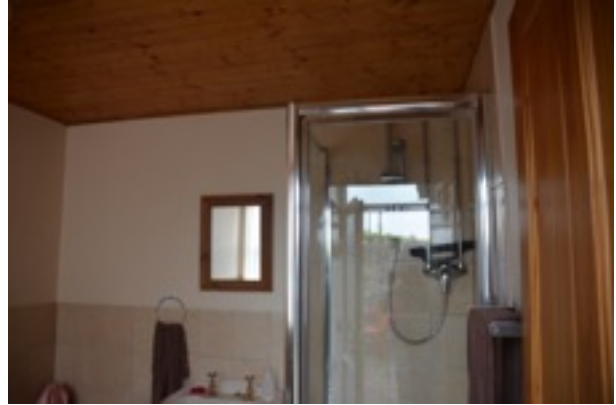
At ground floor level there is the principal bathroom, which we have to say is about as far away from all of the bedroom accommodation as you could possibly get. The bathroom comprises a bath, pedestal wash hand basin and WC together with a corner shower, these areas all being tiled. The facilities are perhaps dated in style and design, but should remain perfectly serviceable for their intended use, subject to normal routine cleaning down. None of the facilities were tested by ourselves.

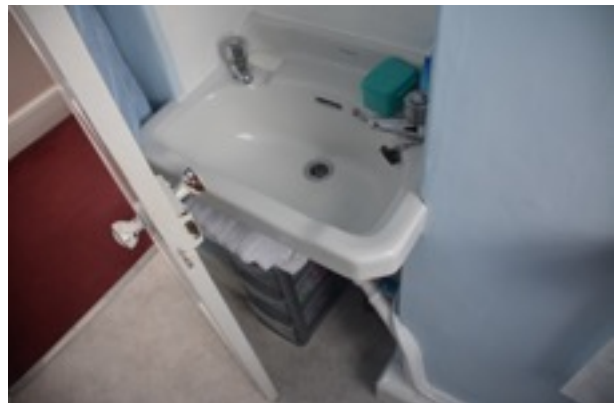
Where the separate WC is located there is a wash hand basin set into a small recess. Again, subject to cleaning down, these should remain serviceable for their intended use, but some of the pipework is surface mounted and relatively unsightly and there is an old lead waste serving the small wash hand basin. Please note that any lead service pipework present within this building should be stripped out and removed as it is obviously a potential health hazard.

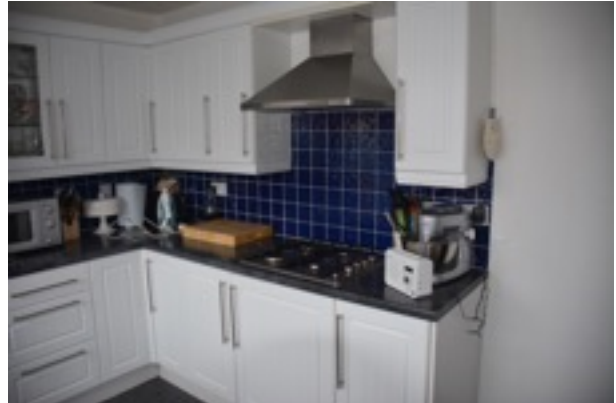
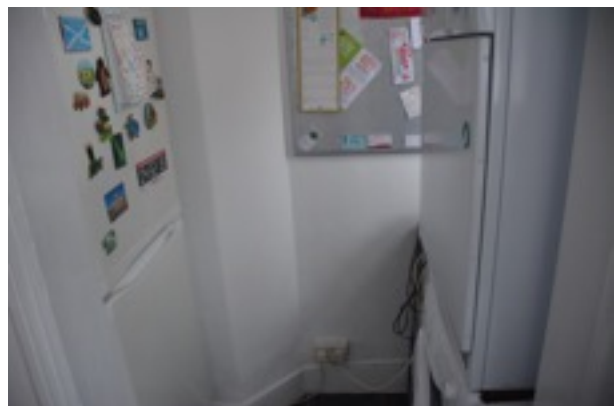
The kitchen comprises a range of base units with work surface above together with some eye-level cupboards, there being a built-in double oven and four burner gas hob. The work surface incorporates a single bowl, single drainer stainless steel sink unit with space in the recess which has been plumbed for a washing machine and tumble dryer for a freestanding fridge/freezer. There are a reasonable number of electrical points and sockets for modern day kitchen equipment, however none of the equipment present was tested by ourselves. Subject to normal cleaning down, we see no reason as to why the kitchen should not remain perfectly serviceable for its intended use.

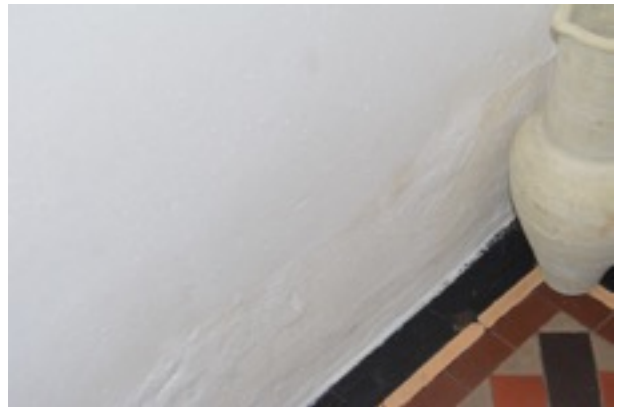
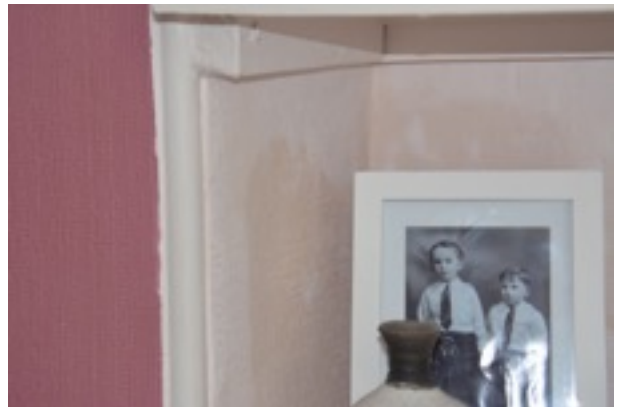
During the course of our inspection we noted some evidence of damp penetration, particularly through the front bay area where we suspect skirtings in the past have been affected. We also noted evidence of damp staining within the dining room where recesses are present on the external walls. Given the nature of the construction of this property we would inevitably anticipate it to be damp to a degree, this being very typical of this type of dwelling and probably impossible to eradicate on a comprehensive basis. There are further physical signs of damp within the entrance hall.

Moisture meter readings were taken throughout the dwelling at both high and low level. Needless to say, where staining was apparent these were unacceptably high and we have no choice but to now recommend that you please seek your own further specialist advice.

Please ensure that the external envelope of this building is adequately maintained in good order at all times, with particular attention to the main roof covering, rainwater goods and elevation walls as well as window reveals. Internally, it is important that the dwelling is adequately heated and ventilated at all times to prevent a build-up of condensation.

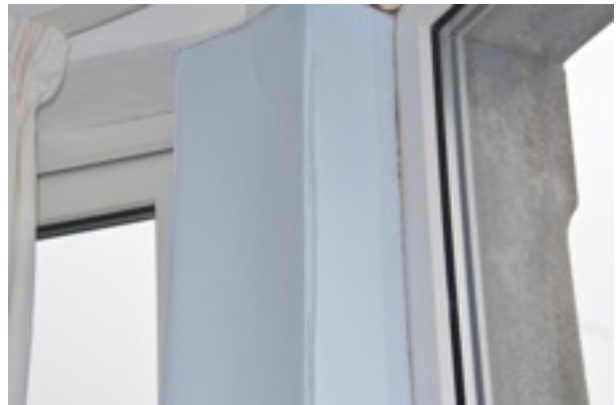
Where the bay area is located we noted Cotina to be present behind surface paintwork. Cotina is often used in an effort to repel damp and reduce levels of condensation. Where this has been applied to the two columns the standard of workmanship was noted to be poor.

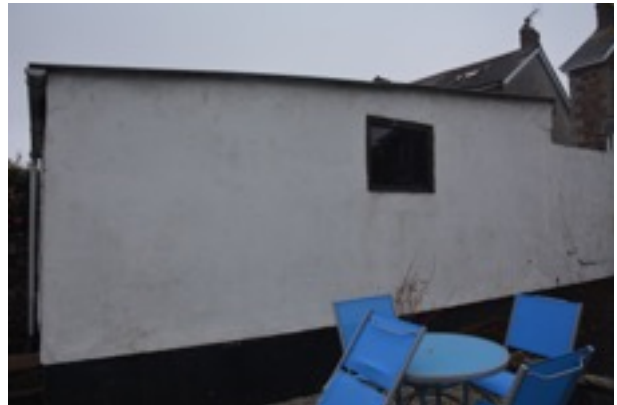
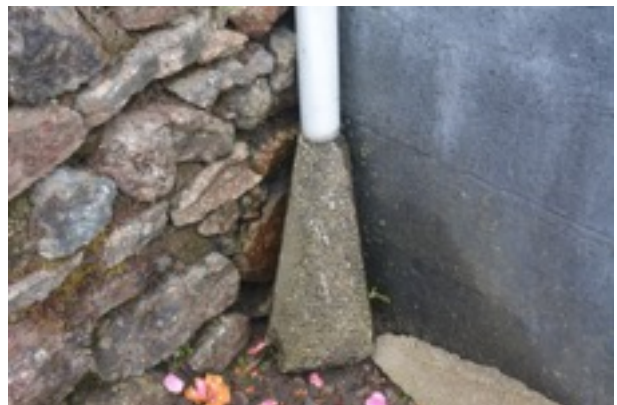
As you are aware, at the top end of the garden there is a single block-built garage below a corrugated asbestos sheeted roof which drains to the rear where there is a half-round plastic gutter, but this is perhaps not best positioned below the asbestos roof, and the downpipe in the corner is simply propped up by a piece of breeze block and ultimately drains into the adjoining flower bed. It was noted that the corrugated roof is a relatively new roof, but we are unable to comment as to whether or not the material is of a hazardous nature. To the front, the garage is accessed via side hung opening wooden doors (locked and not operated by ourselves).
