## **BUILDING CONDITION SURVEY REPORT**

**Property Address:**           **Any House**  
   **Any Street**  
   **Any Town**  
   **Any County**  
   **Any Postcode**

## BUILDING CONDITION SURVEY REPORT

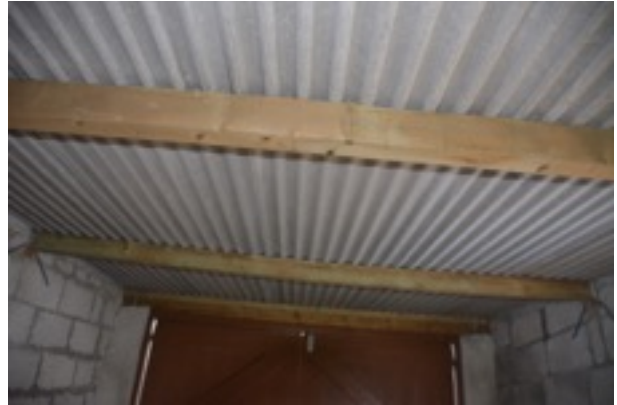
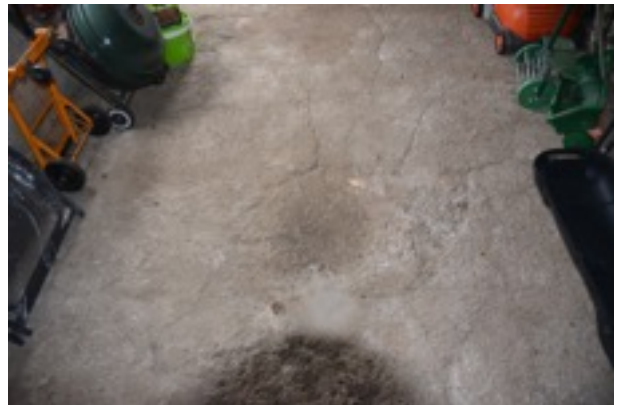
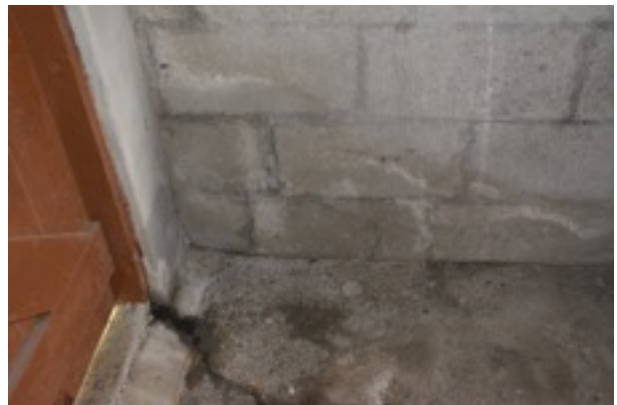
The internal walls of the garage were seen to be in fair condition, there being some stonework present roughly on the party wall line, with the garage having a solid concrete floor, although the floor was noted to be cracked and occasionally pitted, albeit that it remained generally clean and well presented. The roof is supported on new timber beams and, subject to normal routine maintenance works, we see no reason as to why the garage should not remain perfectly serviceable for its intended use, albeit that the structure is relatively basic. Please be aware that this area is always likely to remain cold, damp and prone to high levels of condensation. In the corner where the back wall adjoins the side wall on the party wall line there is obvious evidence of past movement, there being cracking present as a result of the blockwork not being properly stitched in in this location. We noted further evidence of slight cracking towards the front on the outer wall, due we suspect to minor settlement problems.

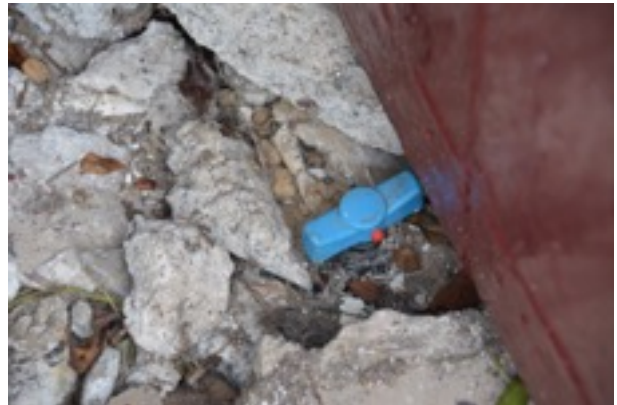
As you are aware, there is a small rear store present at the back of the bathroom, upon which we have commented above. This provides for some useful additional storage, but inevitably is likely to remain cold, damp and prone to high levels of condensation, the roof over this structure forming part of the roof to the rear addition itself. Within the store it was noted that the concrete flooring has cracked and broken open where the mains water enters the building, there being evidence of a relatively new stop tap being installed in this location, but the concrete flooring still requires to be made good.
