BUILDING SURVEY REPORT (LEVEL 3)

Property Address: **Any House**
 Any Street
 Any Town
 Any County
 Any Postcode

Prepared By: **Richard C K Hocking FRICS, F LAND INST**

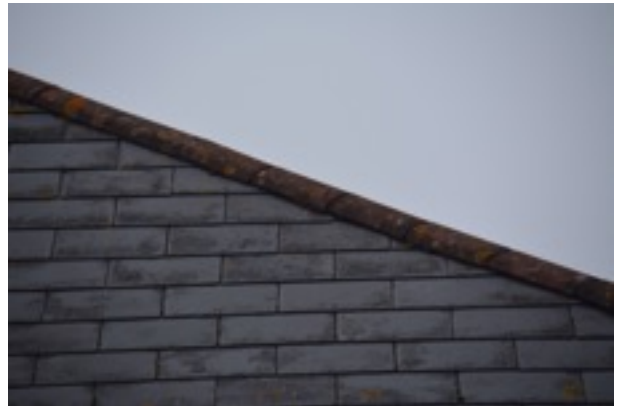
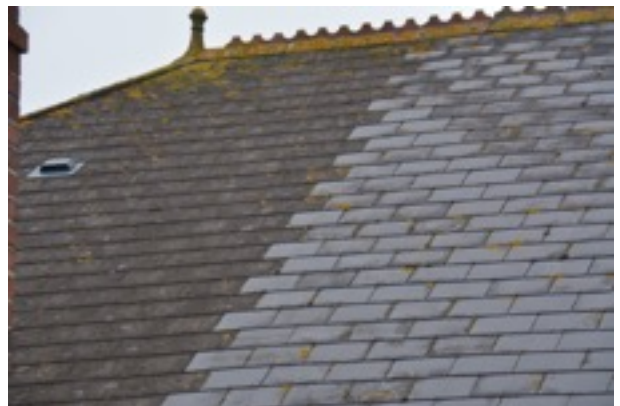
The main roof to the property is of pitched construction clad in manmade fibre tiles on a hollow timber frame. As viewed from the rear of the building the roof slope was seen to be even and free from signs of undulation or significant damage, the tiles being knitted into the tiled roof surface of the adjoining property, which is very obviously older. Ridge tiles to the apex of the roof are slightly ornate, these being level, even and well bedded onto cement with the hip ridge also being straight, there being a hip angle present at the base to provide for additional support. There is a certain amount of lichen growth over the surface of the roof, but we are not overly concerned about this in its present form.

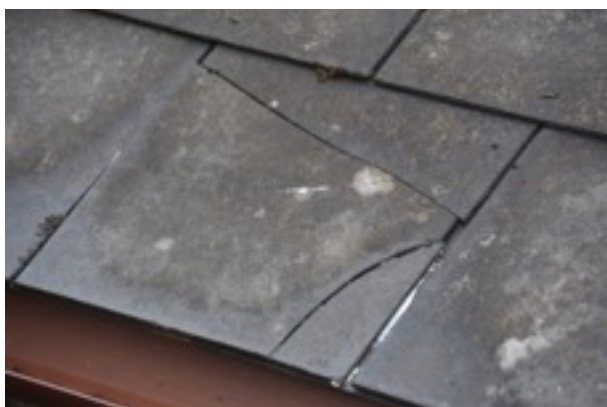
Where the rear extension is located there is a further pitched and hipped roof structure, this effectively extending over the kitchen and the bathroom as well as the small rear store, this also being clad over in manmade fibre tiles, but we believe some of these may contain a degree of asbestos, although we are unable to confirm. The rear roof slope of this extension has a slightly different pitch towards the lower sections, and at the base at the eaves at least one tile was noted to be smashed and broken, and one further asbestos tile has badly discoloured. A small amount of moss growth is present over the surface, but again we are not overly concerned about this in its present form, this roof also extending across the rear addition of the adjoining dwelling. Hip ridges have been formed out of cement and were seen to be in fair condition.

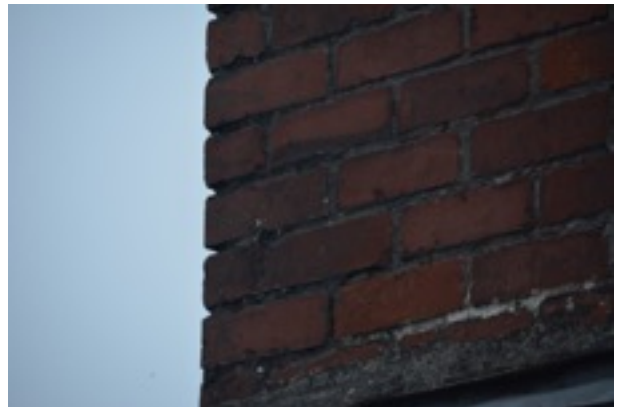
Rising up through the middle of the back addition there is a brick-built chimney stack which we suspect originally had four pots to the crown, although only three are presently visible. The crown and flaunching areas were largely hidden from view. The stack was seen to be generally vertical, but a small amount of plant growth was noted to be present to the brickwork. Some of the brickwork is beginning to spall and deteriorate, and there is also a need for attention to pointing. Flashings are present around the base of the stack. The chimney stack is, we presume, a shared liability and solicitors should please confirm.

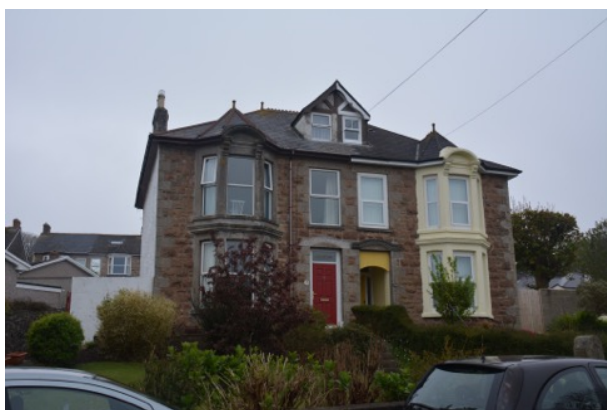
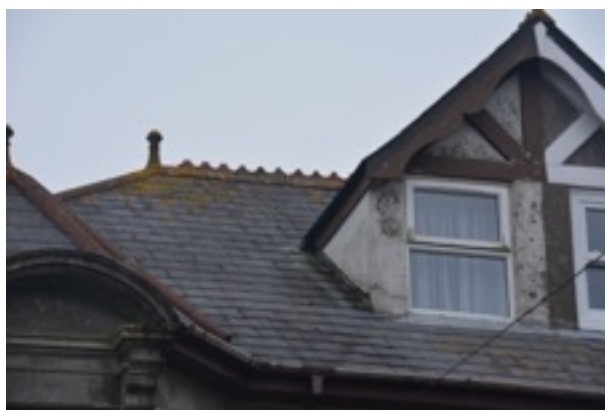
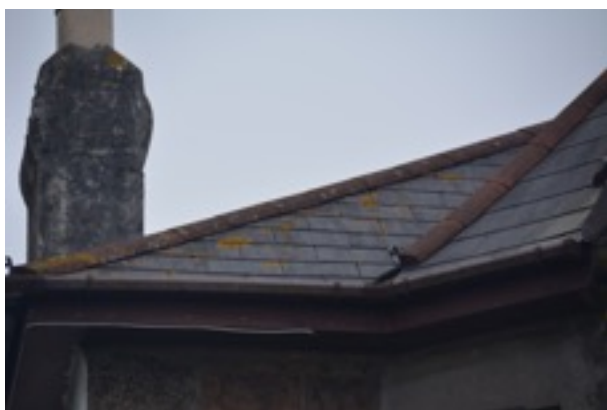
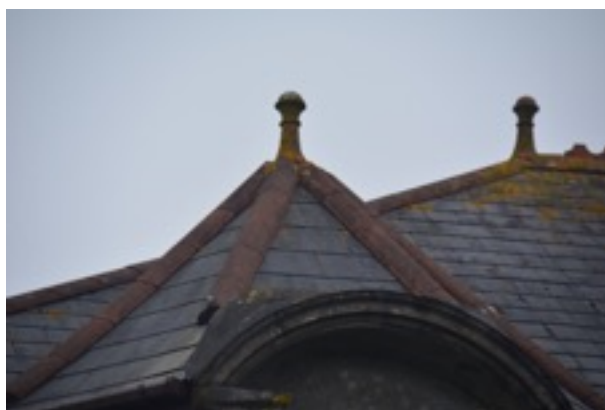
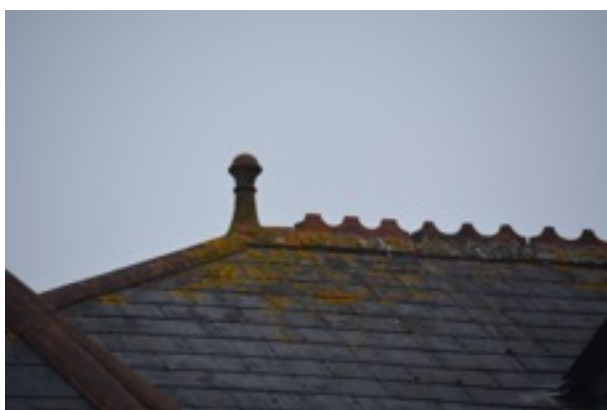
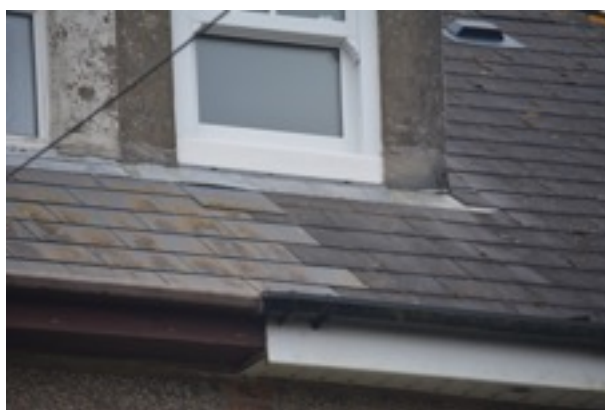
As viewed from the front of the property the roof was seen to be similarly clad over in manmade fibre tiles with a conical hipped roof positioned immediately over the bay. All parts visible were seen to be in fair condition with tiles again being generally well knitted into the roof over the adjoining dwelling. Where the dormer is located a sensible lead flashing is present immediately below the window. Where the conical roof is positioned over the bay this too was seen to be in fair condition with the hip ridges straight, with hip angle irons present at the base. As with other roof areas, a small amount of lichen growth is present over the surface, and should this become excessive it will need to be killed off and removed. Some valleys are present to either side of the conical roof as well as to the rear of the dormer, and we noted no obvious signs of blockage where easily visible at the time of inspection. The cheeks of the dormer have all been rendered and it is apparent that these have not been redecorated for some time. We suspect that these may be of timber framed construction. Those small areas of the roof over the dormer that we were able to see were again in satisfactory condition, but further lichen growth is present. Additional ornate ridge tiles were also seen to be located in this position.

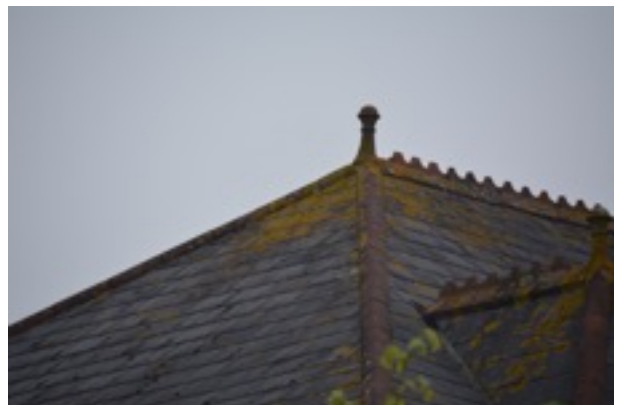
With regard to the hipped roof slope facing towards the adjoining bungalow, only a limited distant inspection was possible of this from the roadway. We can again confirm that the roof was seen to be even and free from signs of undulation, and those parts visible were in similar condition to the other roof areas already inspected. Further lichen growth is present close to the apex of the roof, to which the same comments apply, the hip ridges on either side being straight and free from damage or defect as far as we could ascertain, but obviously a close inspection was simply not practical.

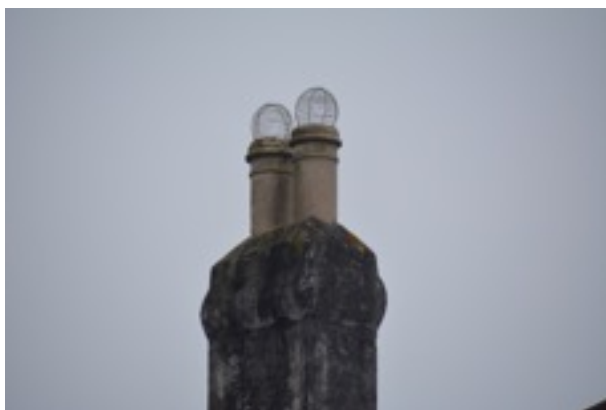
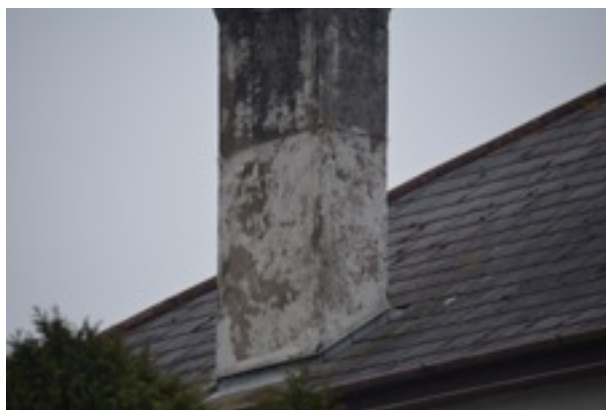
Rising up through this hipped roof slope there is a chimney stack, which we suspect is of brick, this all being externally rendered with two pots to the crown of the stack, but the crown and flaunching areas were largely hidden from view, both of the chimney pots being covered over with mesh cages. The stack has been painted in the past, but has obviously not been decorated for very many years. There is some evidence to suggest lead flashings and soakers around the base of the stack may have more recently been replaced.

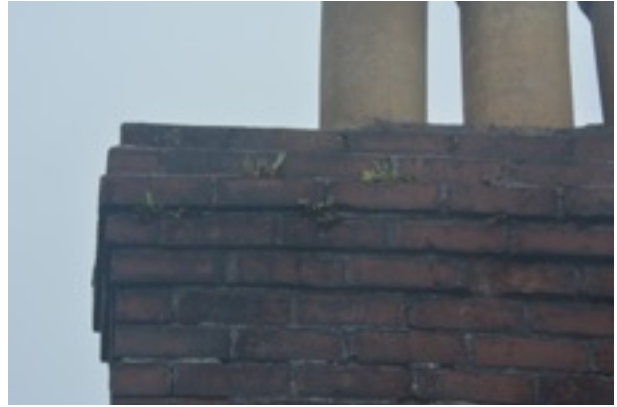
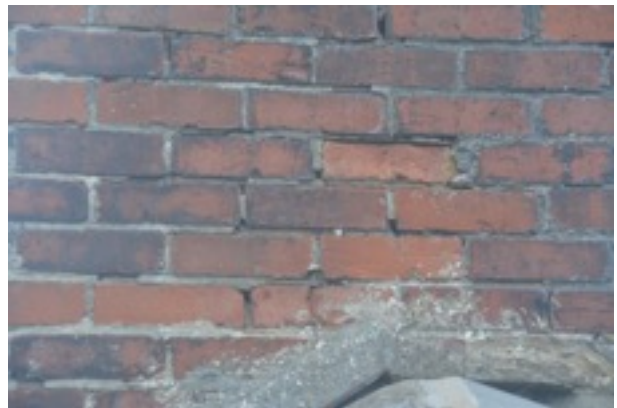
The rear hipped roof slope of the back addition could be inspected from the half-landing window. We can again confirm that the tiled roof surface was seen to be in fair condition and free from damage or defect, but a small amount of moss growth is present, as indeed was visible to other roof slopes. The roof drains down to a lead-lined valley at the base of the wall which ultimately feeds to the side of the property. Those rear sections of the chimney stack visible again showed evidence of plant growth as well as damage and deterioration to pointing and brickwork, thus emphasising the need for works in this location.

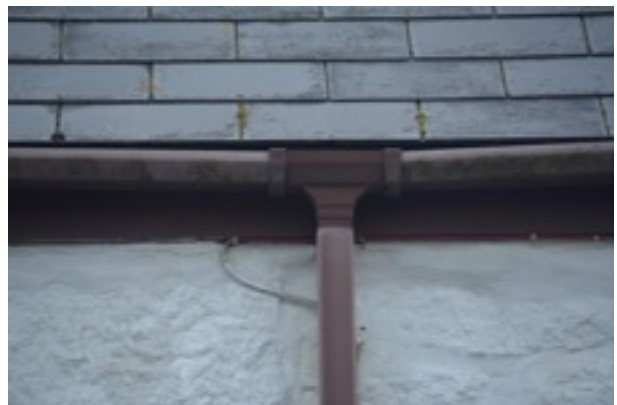
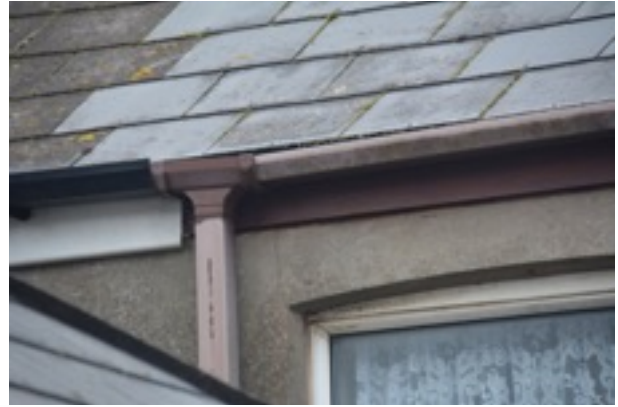
As viewed from the back of the building guttering serving the main roof slope has been run in brown box-shaped plastic sections. Guttering was seen to be in fair condition and free from any obvious leaks on this relatively dry day. To the right hand side of the first floor WC guttering does not extend totally into the corner, and in this location a small amount of lead flashing is present in order to divert water runoff from the roof into the guttering itself. Guttering would all now benefit from being cleaned and flushed through. The downpipe was well secured to the elevation wall, this ultimately jettisoning stormwater down into a sealed gully at the base of the wall.

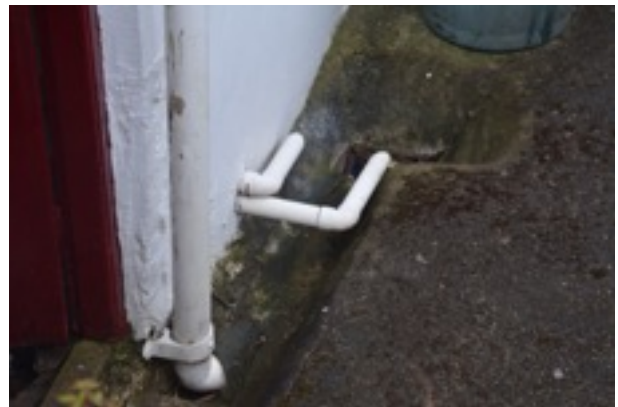
Guttering serving the side of the extension has been run in white half-round plastic sections. This too was seen to be in fair condition, there being a downpipe secured to the elevation wall by the store door, this ultimately jettisoning stormwater into the nearby gully, which also collects waste water from the bathroom. It was noted that the fixing bracket at the base of the downpipe has worked loose.

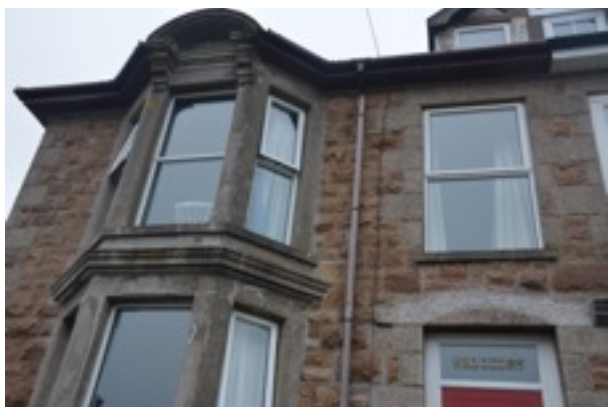
As viewed from the front of the dwelling the elevation wall was seen to be generally vertical, this largely comprising both stone and granite, with granite quoins and lintels around door and window openings. Where the bay is located, the bays have been rendered and the nature of the material below is not known, but we suspect stone or brickwork. This has obviously not been decorated and it would perhaps be greatly enhanced if the whole of the bay area was painted accordingly. Pointing to the stonework was seen to be in fair condition, there being one air brick present at low level below the bay providing for sub-floor ventilation.

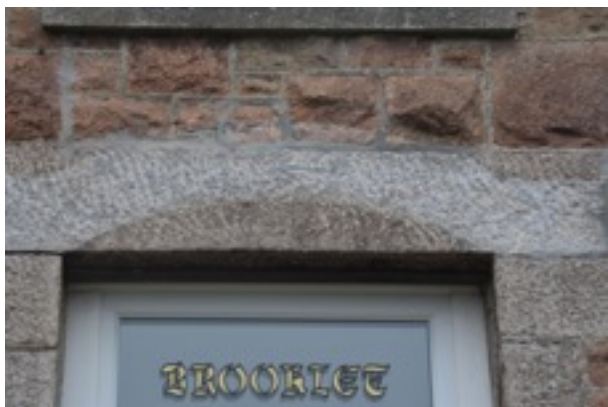
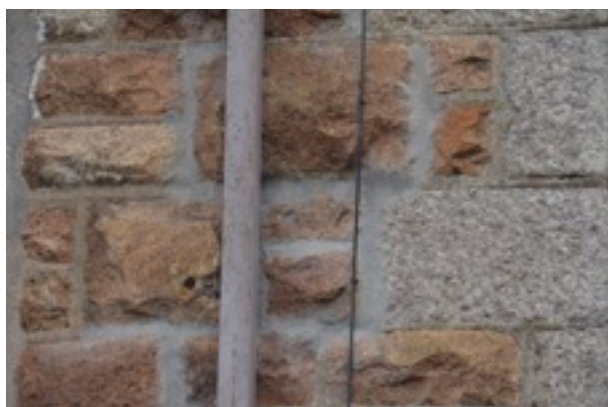
Some patch repairs have been undertaken to the pointing during the history of this dwelling. Where the entrance door is located originally there was some ornate cornicing immediately above the door, similar to that on No. 34, but this has obviously long since cracked and broken away, there now being a light scar on the granite where this was originally positioned.

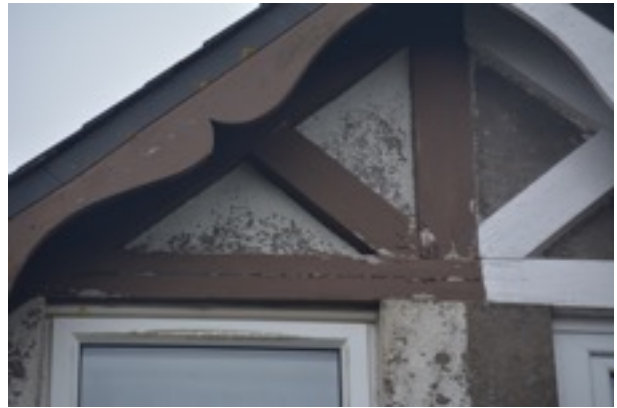
Where the dormer is located at the uppermost level we noted evidence of cracking to the rendered surface and suspect that the render may well be blown in this location. This obviously has not been decorated for very many years, to include for the wooden timberwork present in the uppermost part.

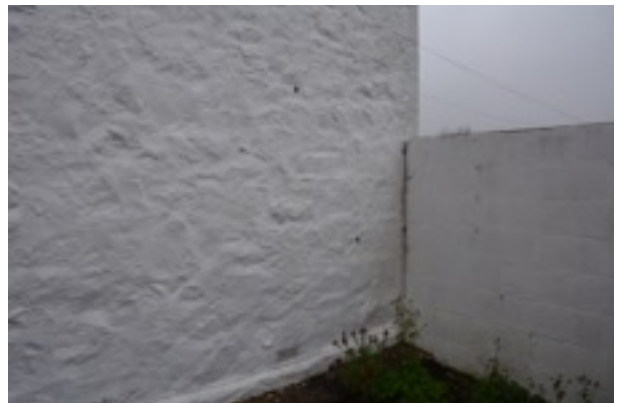
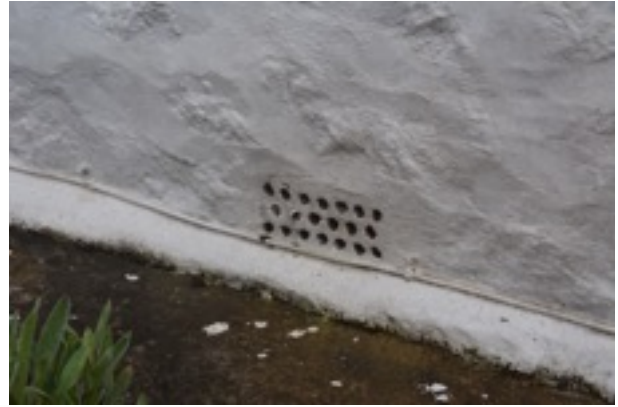
The side elevation wall of the main building is very obviously of stone that has been painted in the past, but a small area at high level has obviously not been decorated because the ladder wouldn't reach. We noted no evidence of any cracking, bowing or deflection, there being further air bricks present around the base to provide for sub-floor ventilation. Slight dirt staining was noted to the surface of the wall which will inevitably require to be redecorated in due course. Butting up to this wall where the side pedestrian gate is located there is a block built boundary. This has slightly pulled away from the wall due to, we suspect, differential movement and we noted no evidence of any physical or chemical damp proof course present in this location, which may result in damp bleeding through into the main structure.

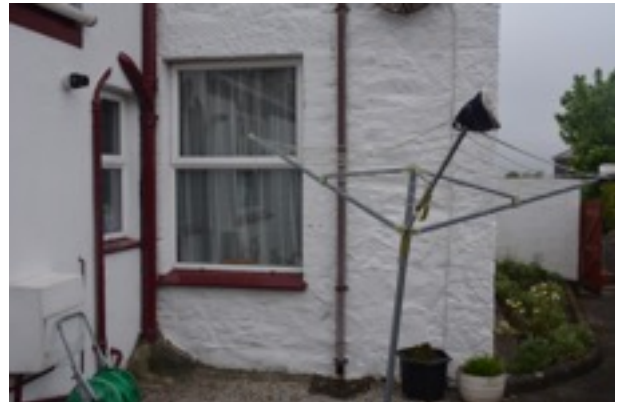
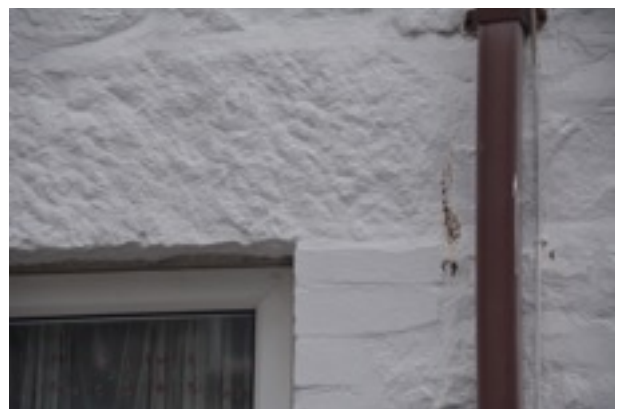
The rear elevation wall of the main body of the building is also quite clearly of stone and granite with some brickwork present surrounding the window openings, however that section to the left where the building protrudes where the separate WC is located has been rendered and partially painted. This is the section which is understood to be of brick. The elevation wall was seen to be vertical and again free from signs of cracking, bowing or deflection with window openings remaining square and cills being of solid slate that has been painted. Please note that to the rear of door and window openings on all parts of this building we are unable to comment as to the condition of any timber lintels that may be present. Against the rear elevation wall there is a satellite dish, but this was noted to be corroded and is probably now in need of replacement.

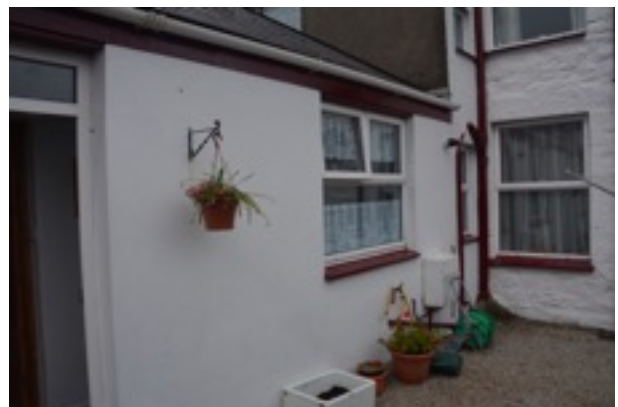
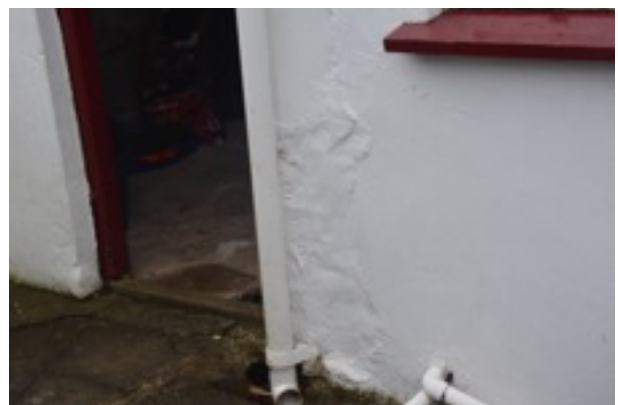
The side elevation wall of the back extension, which is also we understand of brick, was equally seen to be vertical and again free from signs of cracking, bowing or deflection, with the window openings remaining square and further slate cills present. In the corner, the soil vent pipe rises up between the small extension and the main building, but this stops short of the eaves and ideally this should be extended and goosenecked around the top with a suitable metal or plastic cage fitted. A balanced flue protrudes through the wall serving the internal boiler and at low level a gas meter box is positioned. To the left hand side of the back door position the wall was also seen to be generally vertical, but some patch repairs have obviously been undertaken at low level to the rear of the downpipe. Some brickwork is present to the right hand side of the back door where render is cracked and broken away (a foot scraper may possibly have been initially positioned in this location). Where the outside tap protrudes through the wall below the kitchen window this should ideally be fitted with insulation and a small lagging jacket to prevent the possible risk of frost damage.

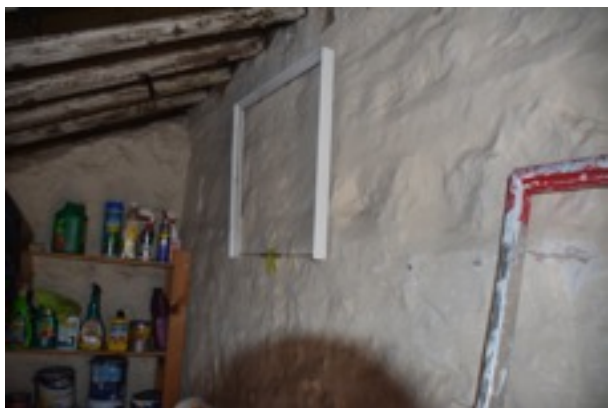
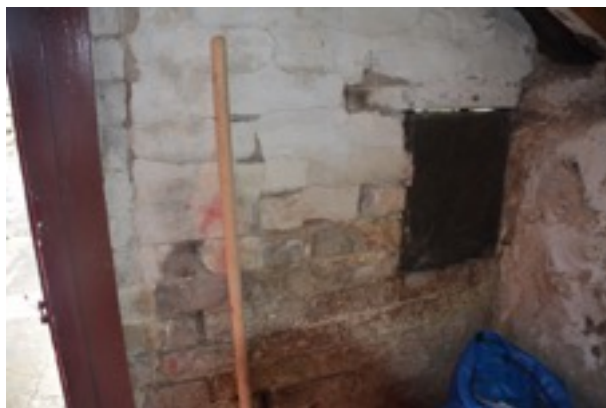
The rear elevation wall of the store is effectively built below ground and is not visible from the exterior, but from the interior we can confirm that this indeed is of solid stone construction, as is the back wall of the store where it butts up to the neighbouring property and the back wall of what is effectively the bathroom, these walls being given a slurry cement wash that has been painted in the past. The side wall of the store is of brick, this again being externally rendered and painted, but the brick is partly below the adjoining flower bed and inevitably this will give rise to internal damp problems.

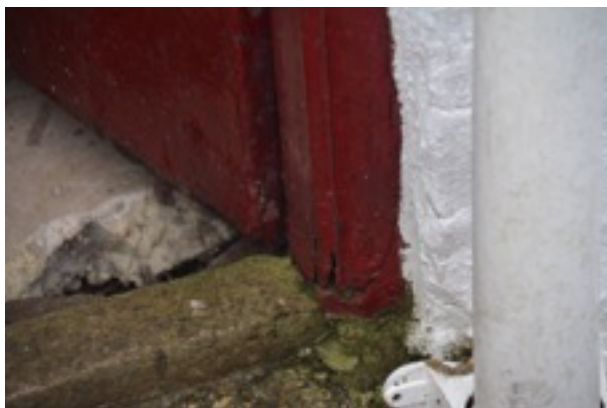
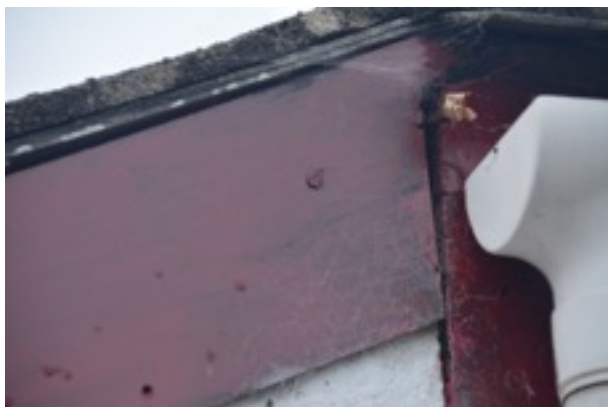
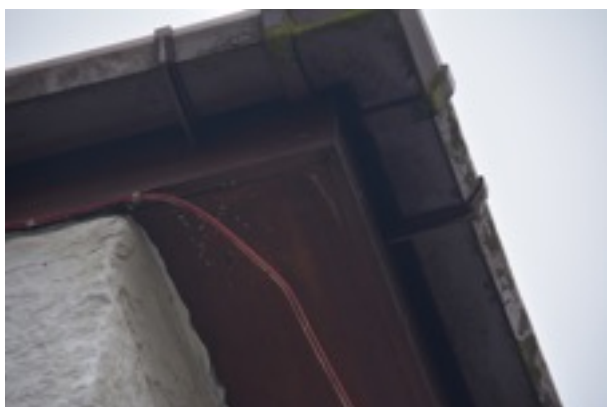
The various fascia boards, cills and wooden doors have been fairly well maintained during the history of this property, but they have suffered and gradually deteriorated over time, with small amounts of rot present around door frames. The fascia boards, which are painted, were seen to be in fair condition, but inevitably these too will require to be redecorated during the course of your occupation. The soffit boards have also been painted. Please note, we are unable to comment as to the nature of this material. The various other doors and windows are all of modern uPVC. These should remain relatively maintenance-free, but will inevitably require routine cleaning down in order to maintain their appearance. It was noted to the soffits where some electrical cabling is present this has dropped out of position and requires to be properly re-secured.

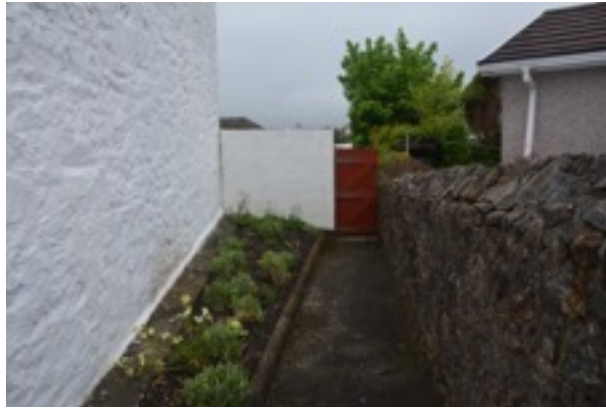
To the front of the building the same comments are largely applicable and, as already mentioned, it will probably be prudent to paint the bay area as this will considerably improve the overall appearance of the approach to the building. The main entrance door has more recently been replaced, but it was noted that the handle has become scratched and worn. Where the side pedestrian gate is present to the left hand side there is no proper gate stop and it would perhaps be beneficial to undertake some improvements in this location.

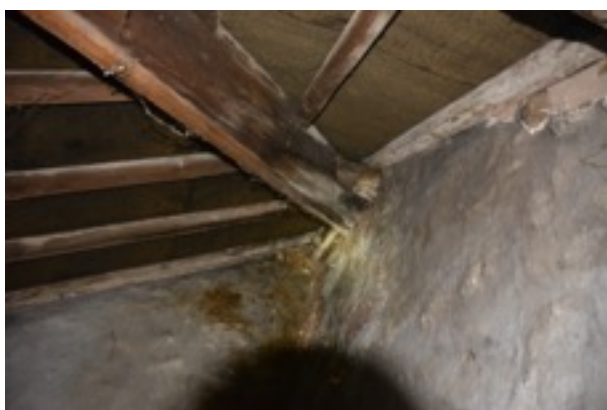
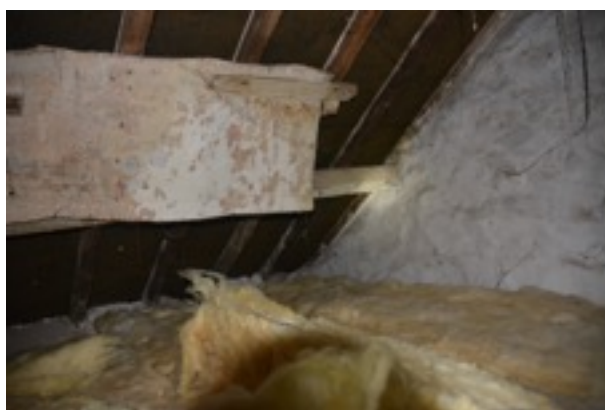
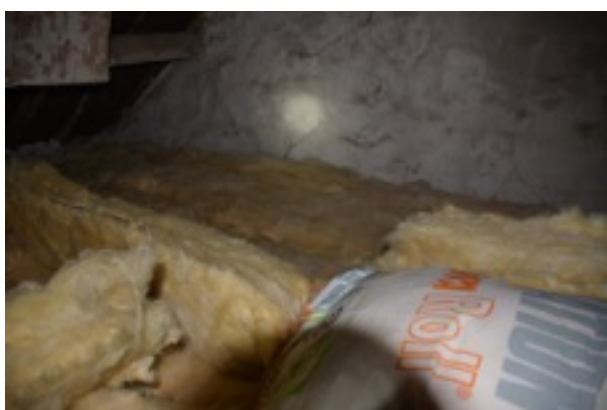
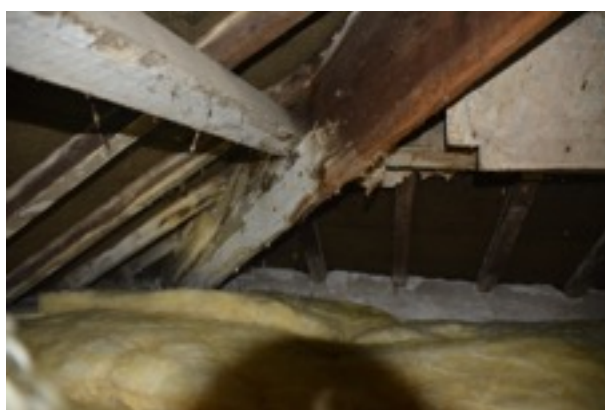
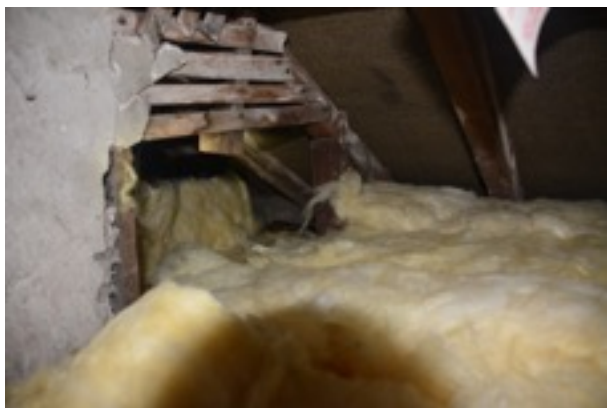
Access was available into the section of roof void immediately over the bathroom via a hatch positioned in the bathroom ceiling. We can confirm that immediately by the hatch rising up between the bathroom and the kitchen there is a further solid random stone wall, with a stone wall between the subject dwelling and adjoining property. These walls in the past have been covered over with a slurry cement wash and painted, but have obviously not received attention for many years as there is no point. The void was seen to be generally well insulated. Timbers within the void are the original timbers, which were seen to be in fair condition given their age, although there was evidence of past water staining due presumably to previous defective roofs. The undersides of the tiles have been protected with bitumen felt and the void has been generally well insulated. There is a very small opening to the right hand side leading through into the kitchen roof void where some lath and plaster was present. We can confirm that some further insulation has been stuffed into this area, but in all honesty no sensible inspection of the area beyond was possible. We can confirm that by pointing the camera into this area some brickwork was indeed present, but we suspect this to be associated with the chimney stack. Whilst the void has been generally well insulated, some pipework that is ducted through this part of the property has not been insulated and this should ideally be protected accordingly to prevent the possible risk of frost damage.

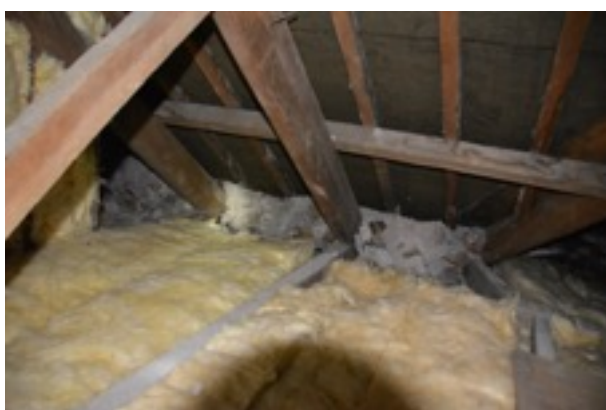
As you will recall, there is an attic room and therefore there is effectively no roof void; the attic room, which we suspect was always originally part of the structure of the building, effectively occupies this space. There is a hatch which gives access into the roof space beyond. A very small amount of boarding was present, but effectively inspection had to be undertaken from the hatch only. We can confirm that timbers were seen to be original and these were seen to be in fair condition with the undersides of the tiled roof surface being felted. We noted no evidence of any leaks through the valley areas surrounding the conical roof to the front where some rubble and brickwork was present to the uppermost part. Stonework was visible forming the upper parts of the walls surrounding this dwelling. The void has been generally well insulated, but ideally the depth of insulation should be further increased to a minimum depth of at least 12".

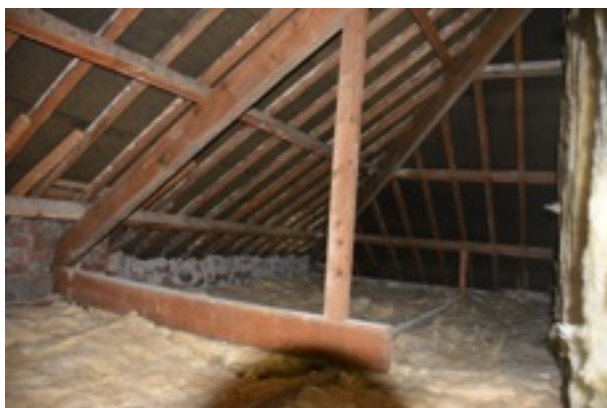
The very limited inspection of those parts of the void extending down the side revealed no obvious defects, with the roof again for the most part being clean, tidy and reasonably well insulated, to include for vertical insulation against the stud wall where the upper attic room has been formed. Where the chimney stack rises up on the gable end wall brickwork was visible, and this was seen to be in fair condition with no evidence of any rainwater penetration down through the uppermost parts.

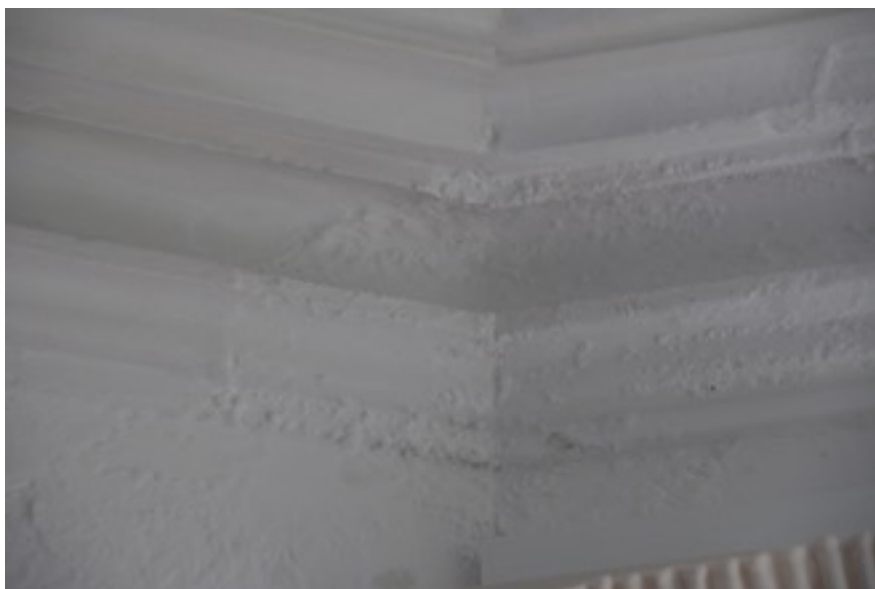
At ground floor level further artexing is present. Within the principal living room the ceiling is skimmed and painted, with some more original coving present. Where the bay is located some hairline cracking was noted to be present which has obviously been made good in the past, and we noted obvious signs of damp penetration around the cornicing, causing damage to the surface of paintwork. The dining room ceiling has also been covered over with artex. In the kitchen, whilst the ceiling is artexed, the adjoining bathroom ceiling comprises relatively lightweight match boarding and you may or may not wish to improve upon this at your discretion.

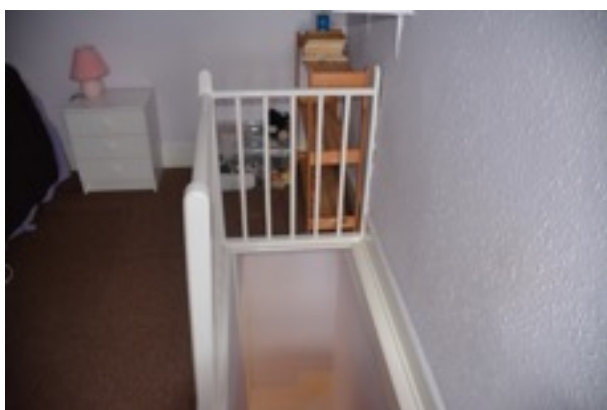
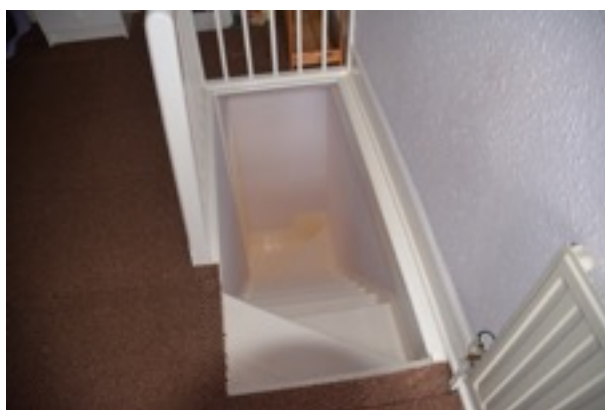
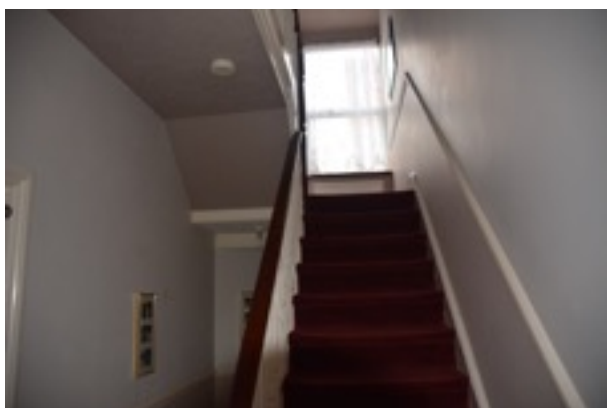
Where the attic room is located there is a small balustrade around the top of the attic stairwell, however this is loose and requires to be properly re-secured. The stairs have no adjoining grab rail, and as these have been painted they are potentially slippery and therefore also a potential hazard. We also noted that the balustrade to the stairway of the main part of the dwelling was loose, and this too should be additionally braced up. Elsewhere within the building woodwork was seen to be in fair condition, other than where it has naturally suffered from wear and tear. Where the door leads through into the kitchen from the hallway the upper part is glazed, but it is not known if glass is toughened or laminated. Skirtings and architraves to doors were seen to be in fair condition with a dado rail also present. Where the inner porch door is located further glass is present, to which the same comments apply. Inevitably doors will require easing and adjusting after redecoration, but subject to minor repairs and maintenance we see no reason as to why woodwork should not remain serviceable for its intended use. There was some evidence that skirtings in the front living room have been replaced with new skirting, indicating that there may have been a rot problem in this location in the past, and further decorative works are required.

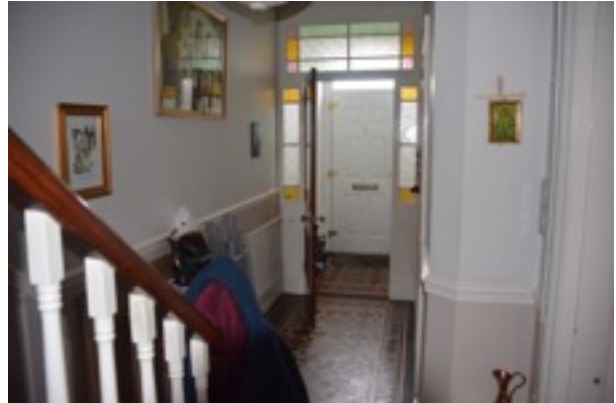
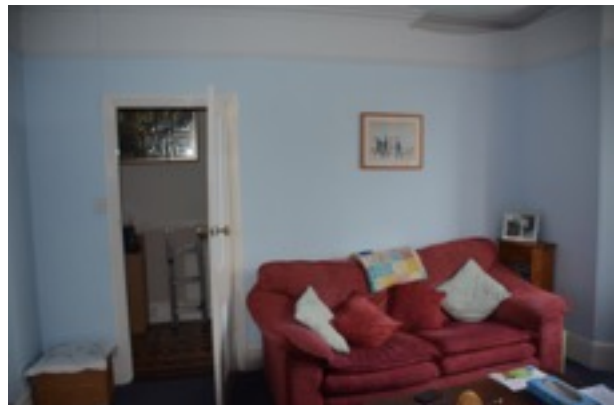
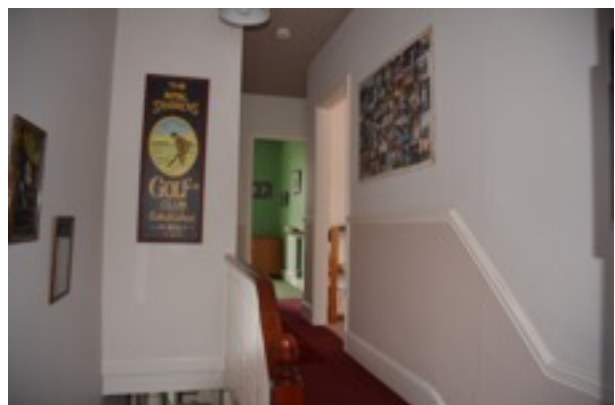
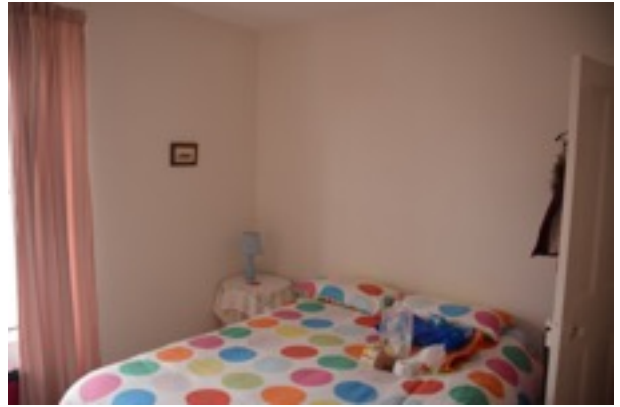
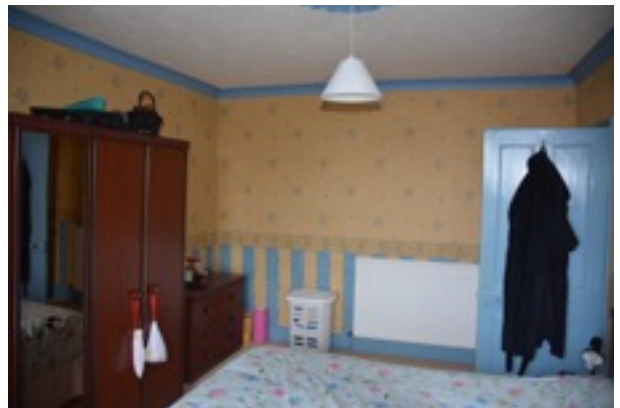
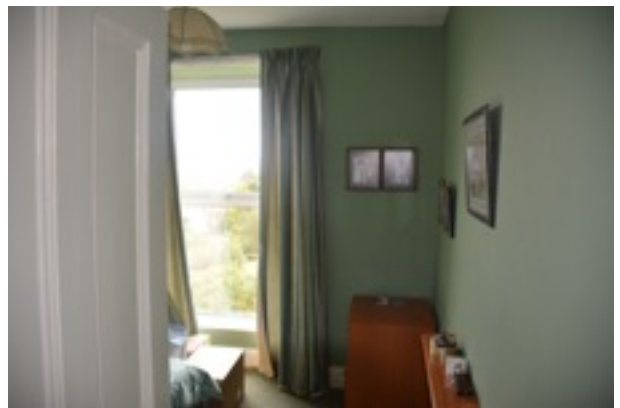
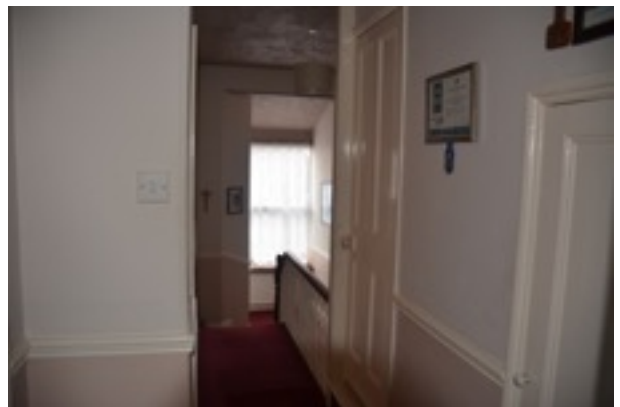
Throughout, this property has been relatively simply decorated, walls largely emulsioned and woodwork glossed or stained. The property is effectively ready for immediate occupation. We did note the use of some wood chip wallpaper, and in the event of this being removed it is quite feasible that the underlying plaster will pull away with it. Inevitably decorations will become lightly soiled and marked after the removal of furniture and fittings, and you will no doubt wish to redecorate in accordance with your own particular style and taste. Obviously some surface decorations are damaged where there have been high levels of damp and additional making good will be necessary in these locations.

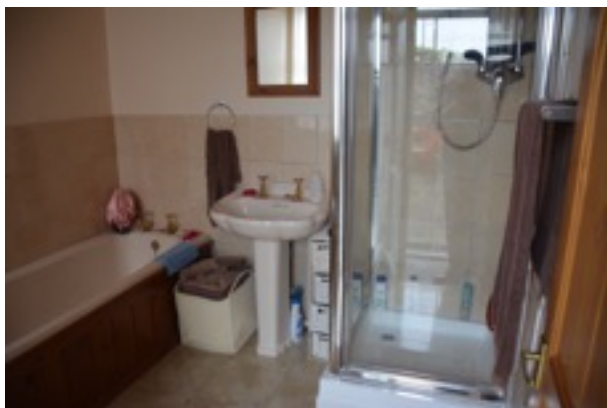
At ground floor level there is the principal bathroom, which we have to say is about as far away from all of the bedroom accommodation as you could possibly get. The bathroom comprises a bath, pedestal wash hand basin and WC together with a corner shower, these areas all being tiled. The facilities are perhaps dated in style and design, but should remain perfectly serviceable for their intended use, subject to normal routine cleaning down. None of the facilities were tested by ourselves.

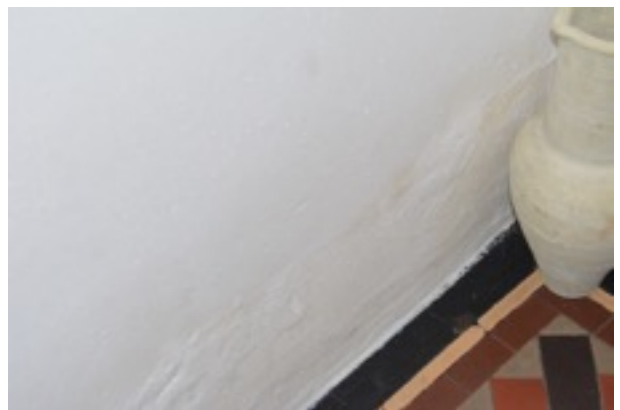
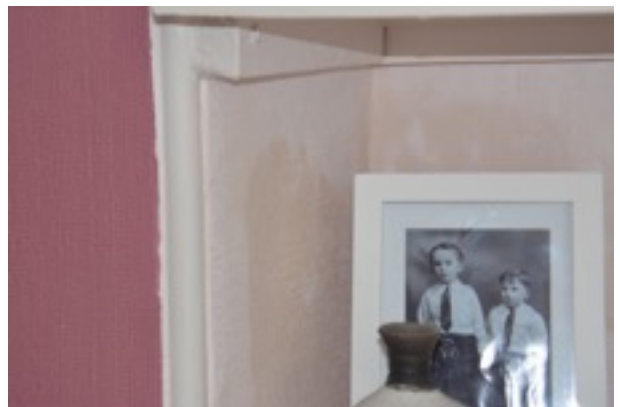
During the course of our inspection we noted some evidence of damp penetration, particularly through the front bay area where we suspect skirtings in the past have been affected. We also noted evidence of damp staining within the dining room where recesses are present on the external walls. Given the nature of the construction of this property we would inevitably anticipate it to be damp to a degree, this being very typical of this type of dwelling and probably impossible to eradicate on a comprehensive basis. There are further physical signs of damp within the entrance hall.

Please ensure that the external envelope of this building is adequately maintained in good order at all times, with particular attention to the main roof covering, rainwater goods and elevation walls as well as window reveals. Internally, it is important that the dwelling is adequately heated and ventilated at all times to prevent a build-up of condensation.

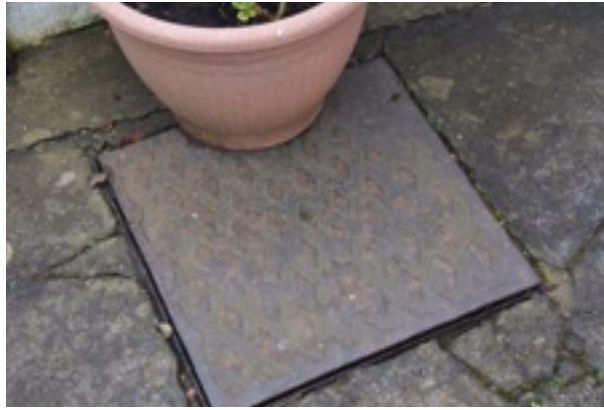
The property is connected to the mains drainage system, there being one manhole cover located outside the store room. This was raised and the chamber within seen to be in fair condition, but there is a need for a small amount of attention to cement benching in the base around the gully, and we also noted a small amount of effluent present. The drains are believed to run from this position below the store across to the adjoining dwelling. Solicitors should please raise enquiries to ascertain whether or not there have been any past problems with the drainage runs serving this dwelling and as to whether or not the drains remain your responsibility or have been adopted by the Local Authority.

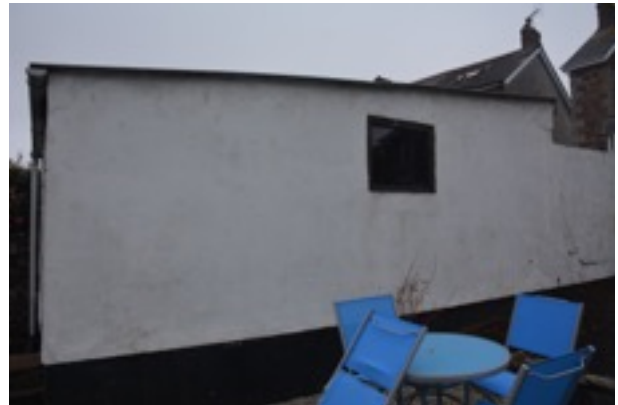
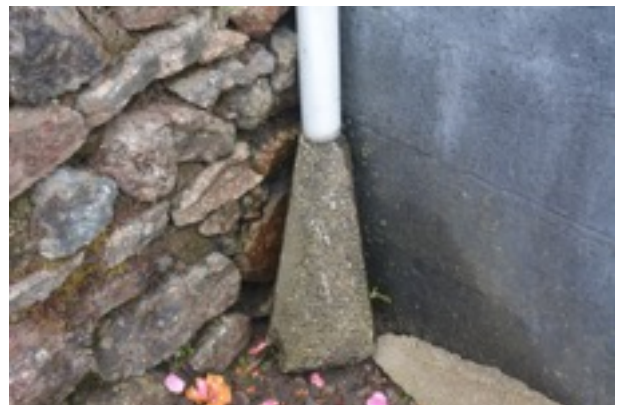
As you are aware, at the top end of the garden there is a single block-built garage below a corrugated asbestos sheeted roof which drains to the rear where there is a half-round plastic gutter, but this is perhaps not best positioned below the asbestos roof, and the downpipe in the corner is simply propped up by a piece of breeze block and ultimately drains into the adjoining flower bed. It was noted that the corrugated roof is a relatively new roof, but we are unable to comment as to whether or not the material is of a hazardous nature. To the front, the garage is accessed via side hung opening wooden doors (locked and not operated by ourselves).

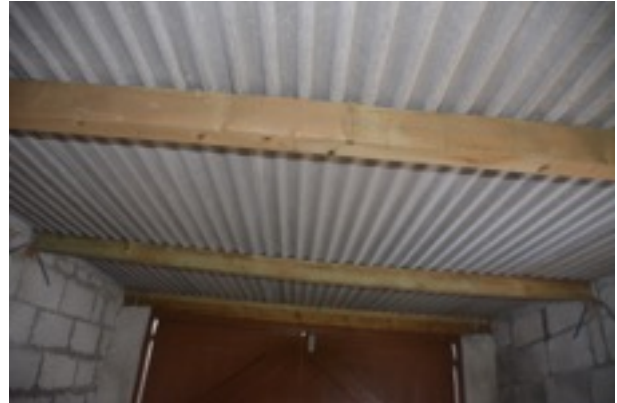
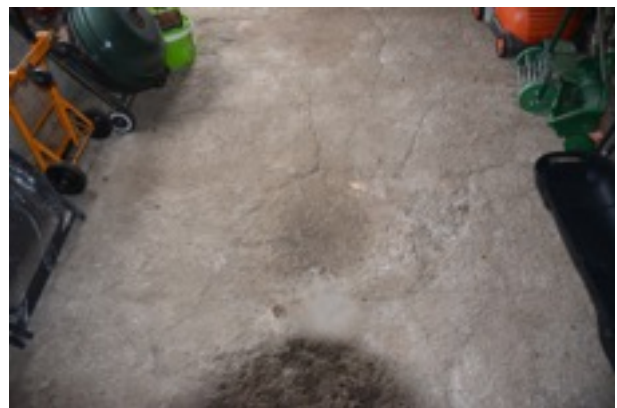
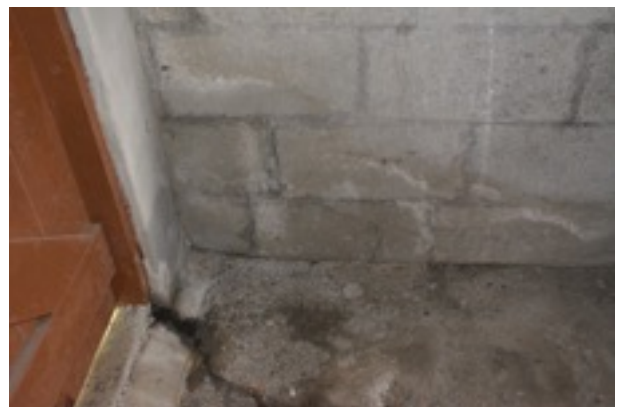
The internal walls of the garage were seen to be in fair condition, there being some stonework present roughly on the party wall line, with the garage having a solid concrete floor, although the floor was noted to be cracked and occasionally pitted, albeit that it remained generally clean and well presented. The roof is supported on new timber beams and, subject to normal routine maintenance works, we see no reason as to why the garage should not remain perfectly serviceable for its intended use, albeit that the structure is relatively basic. Please be aware that this area is always likely to remain cold, damp and prone to high levels of condensation. In the corner where the back wall adjoins the side wall on the party wall line there is obvious evidence of past movement, there being cracking present as a result of the blockwork not being properly stitched in in this location. We noted further evidence of slight cracking towards the front on the outer wall, due we suspect to minor settlement problems.
