## **BUILDING CONDITION SURVEY REPORT**

**Property Address:**           **Any House**  
   **Any Street**  
   **Any Town**  
   **Any County**  
   **Any Postcode**

## BUILDING CONDITION SURVEY REPORT

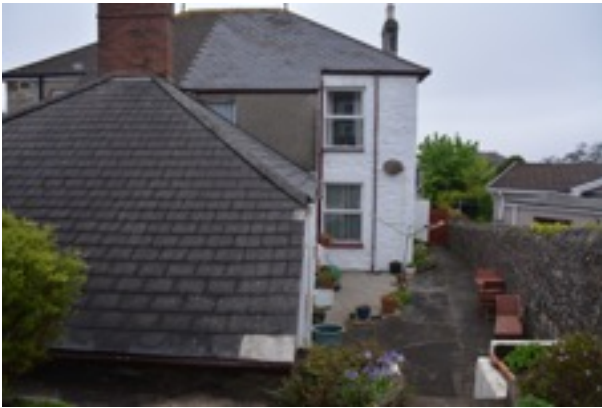
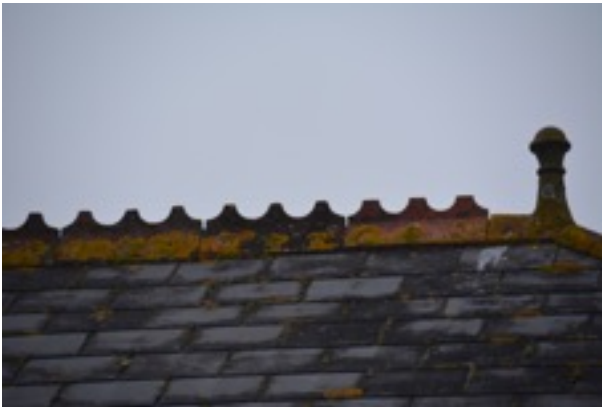
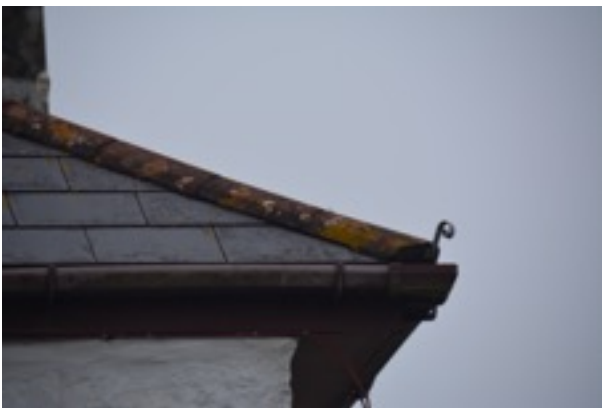
The main roof to the property is of pitched construction clad in manmade fibre tiles on a hollow timber frame. As viewed from the rear of the building the roof slope was seen to be even and free from signs of undulation or significant damage, the tiles being knitted into the tiled roof surface of the adjoining property, which is very obviously older. Ridge tiles to the apex of the roof are slightly ornate, these being level, even and well bedded onto cement with the hip ridge also being straight, there being a hip angle present at the base to provide for additional support. There is a certain amount of lichen growth over the surface of the roof, but we are not overly concerned about this in its present form.

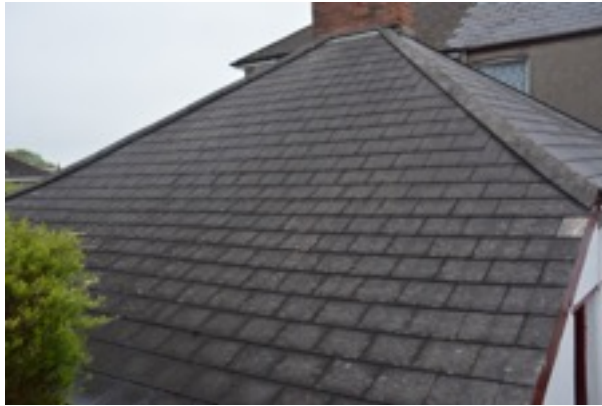
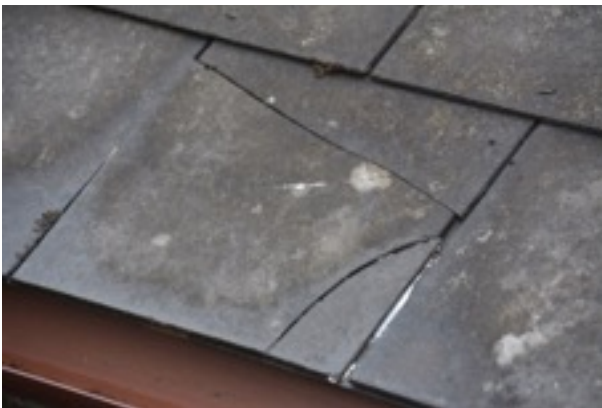
Where the rear extension is located there is a further pitched and hipped roof structure, this effectively extending over the kitchen and the bathroom as well as the small rear store, this also being clad over in manmade fibre tiles, but we believe some of these may contain a degree of asbestos, although we are unable to confirm. The rear roof slope of this extension has a slightly different pitch towards the lower sections, and at the base at the eaves at least one tile was noted to be smashed and broken, and one further asbestos tile has badly discoloured. A small amount of moss growth is present over the surface, but again we are not overly concerned about this in its present form, this roof also extending across the rear addition of the adjoining dwelling. Hip ridges have been formed out of cement and were seen to be in fair condition.

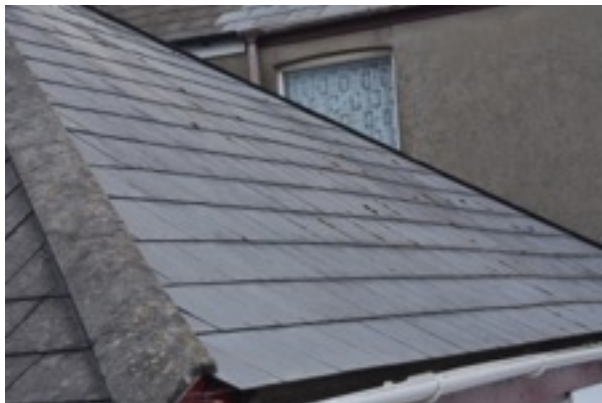
The roof slope facing towards the side yard was also seen to be in fair condition and free from damage or defect, but again a further small amount of moss growth was noted to be present.

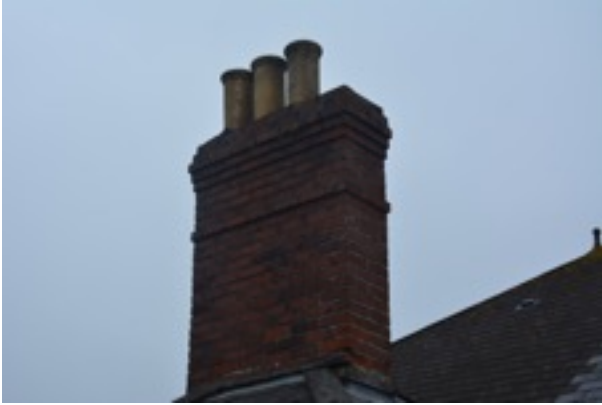
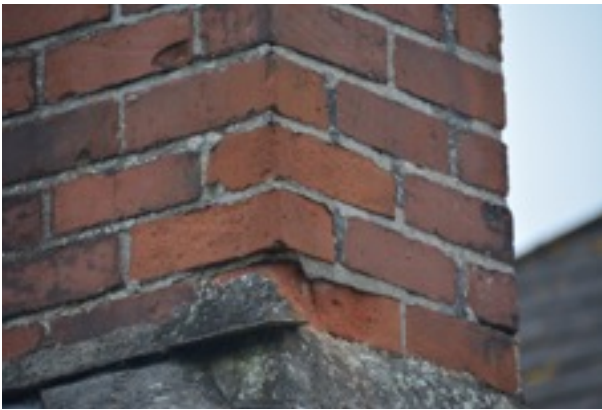
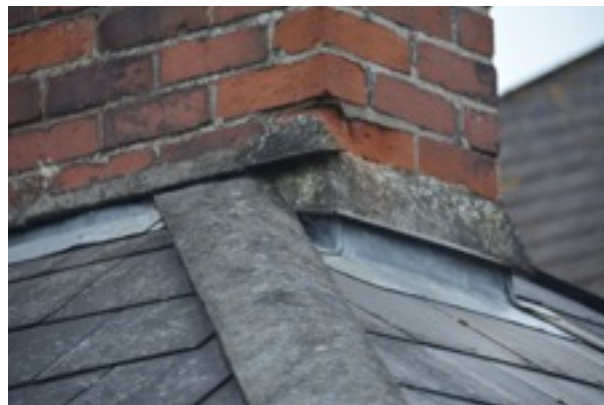
Rising up through the middle of the back addition there is a brick-built chimney stack which we suspect originally had four pots to the crown, although only three are presently visible. The crown and flaunching areas were largely hidden from view. The stack was seen to be generally vertical, but a small amount of plant growth was noted to be present to the brickwork. Some of the brickwork is beginning to spall and deteriorate, and there is also a need for attention to pointing. Flashings are present around the base of the stack. The chimney stack is, we presume, a shared liability and solicitors should please confirm.

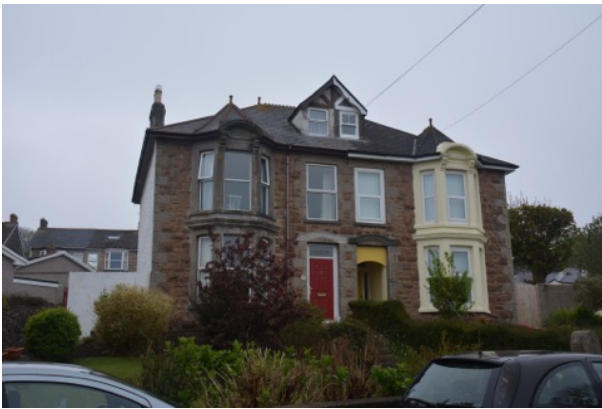
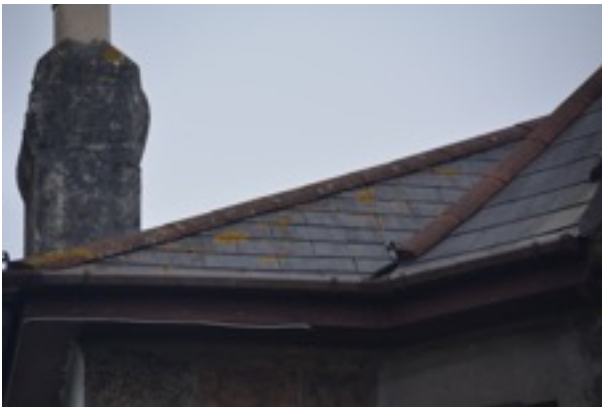
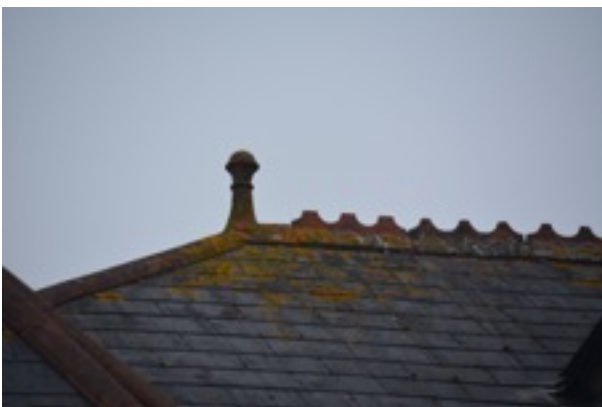
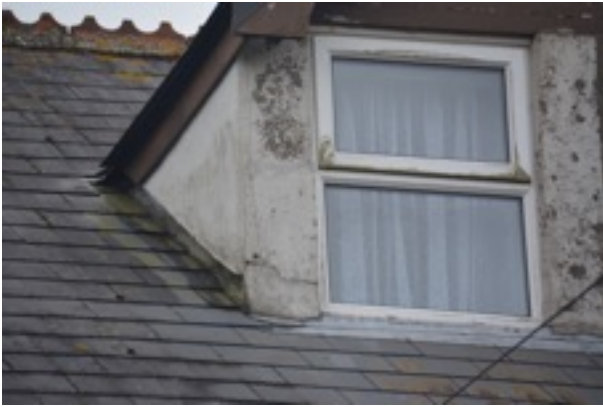
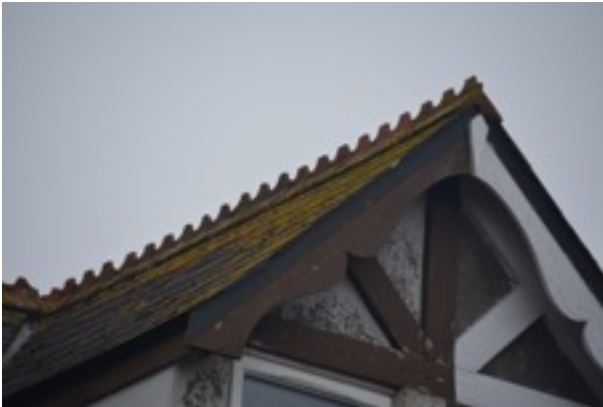
As viewed from the front of the property the roof was seen to be similarly clad over in manmade fibre tiles with a conical hipped roof positioned immediately over the bay. All parts visible were seen to be in fair condition with tiles again being generally well knitted into the roof over the adjoining dwelling. Where the dormer is located a sensible lead flashing is present immediately below the window. Where the conical roof is positioned over the bay this too was seen to be in fair condition with the hip ridges straight, with hip angle irons present at the base. As with other roof areas, a small amount of lichen growth is present over the surface, and should this become excessive it will need to be killed off and removed. Some valleys are present to either side of the conical roof as well as to the rear of the dormer, and we noted no obvious signs of blockage where easily visible at the time of inspection. The cheeks of the dormer have all been rendered and it is apparent that these have not been redecorated for some time. We suspect that these may be of timber framed construction. Those small areas of the roof over the dormer that we were able to see were again in satisfactory condition, but further lichen growth is present. Additional ornate ridge tiles were also seen to be located in this position.

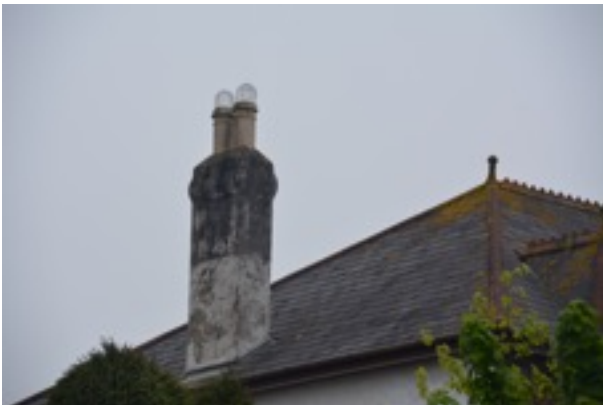
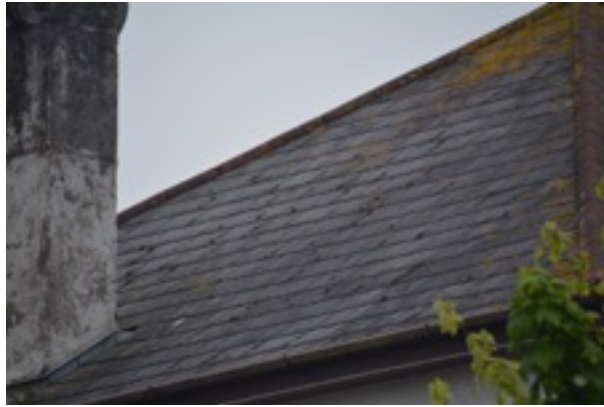
With regard to the hipped roof slope facing towards the adjoining bungalow, only a limited distant inspection was possible of this from the roadway. We can again confirm that the roof was seen to be even and free from signs of undulation, and those parts visible were in similar condition to the other roof areas already inspected. Further lichen growth is present close to the apex of the roof, to which the same comments apply, the hip ridges on either side being straight and free from damage or defect as far as we could ascertain, but obviously a close inspection was simply not practical.

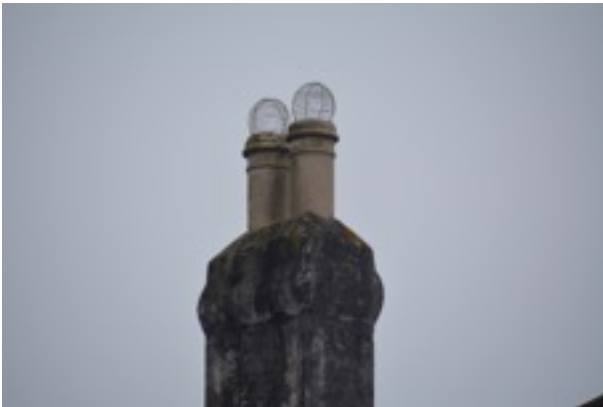
Rising up through this hipped roof slope there is a chimney stack, which we suspect is of brick, this all being externally rendered with two pots to the crown of the stack, but the crown and flaunching areas were largely hidden from view, both of the chimney pots being covered over with mesh cages. The stack has been painted in the past, but has obviously not been decorated for very many years. There is some evidence to suggest lead flashings and soakers around the base of the stack may have more recently been replaced.

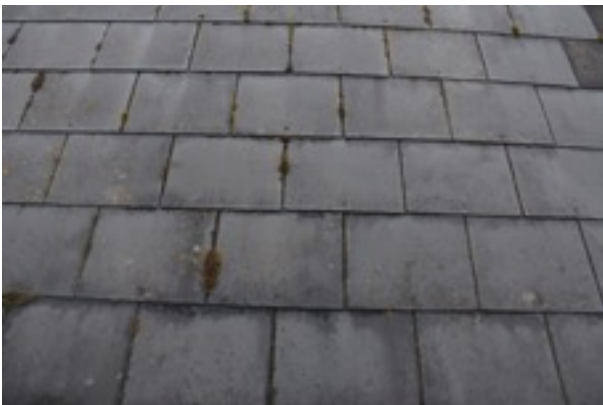
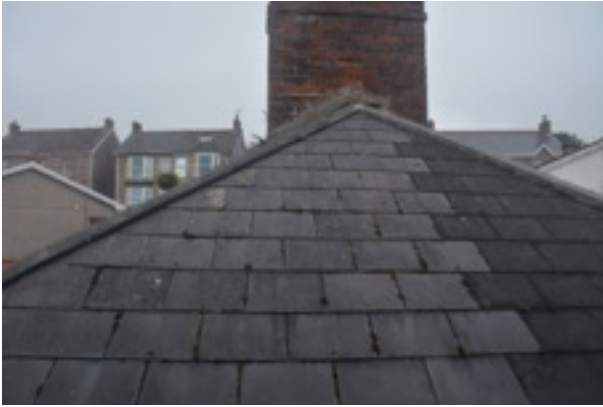
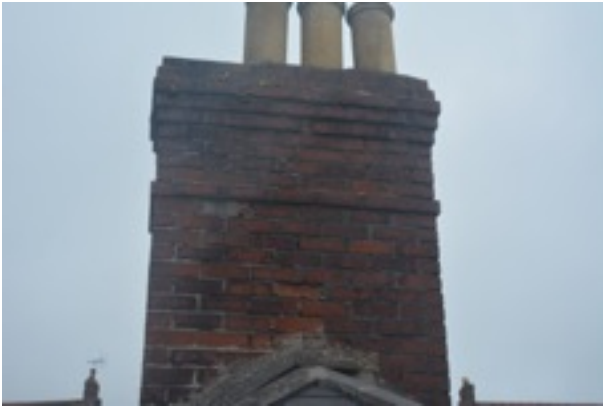
The rear hipped roof slope of the back addition could be inspected from the half-landing window. We can again confirm that the tiled roof surface was seen to be in fair condition and free from damage or defect, but a small amount of moss growth is present, as indeed was visible to other roof slopes. The roof drains down to a lead-lined valley at the base of the wall which ultimately feeds to the side of the property. Those rear sections of the chimney stack visible again showed evidence of plant growth as well as damage and deterioration to pointing and brickwork, thus emphasising the need for works in this location.

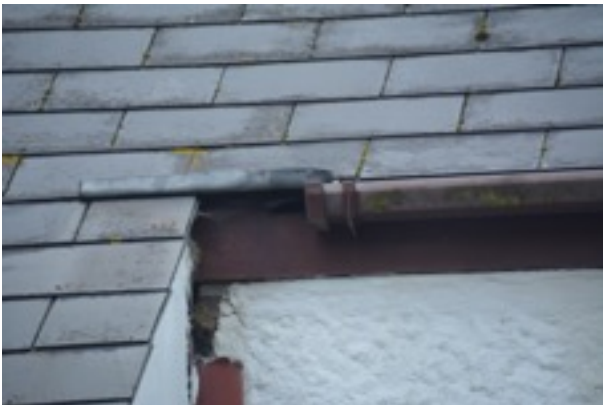
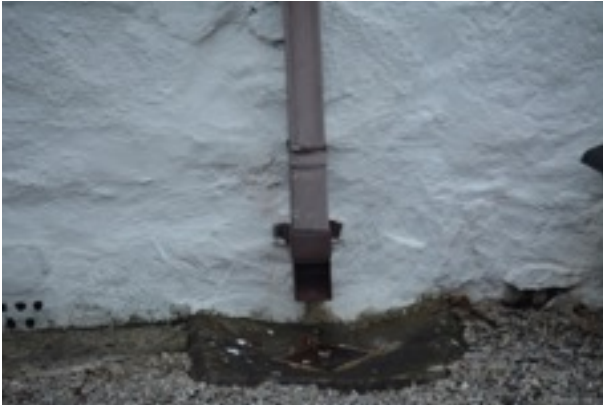
As viewed from the back of the building guttering serving the main roof slope has been run in brown box-shaped plastic sections. Guttering was seen to be in fair condition and free from any obvious leaks on this relatively dry day. To the right hand side of the first floor WC guttering does not extend totally into the corner, and in this location a small amount of lead flashing is present in order to divert water runoff from the roof into the guttering itself. Guttering would all now benefit from being cleaned and flushed through. The downpipe was well secured to the elevation wall, this ultimately jettisoning stormwater down into a sealed gully at the base of the wall.

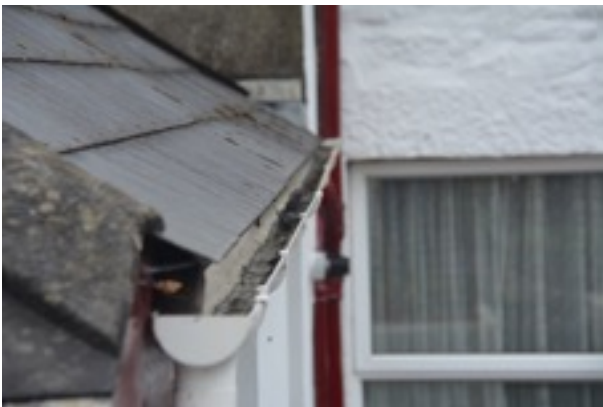
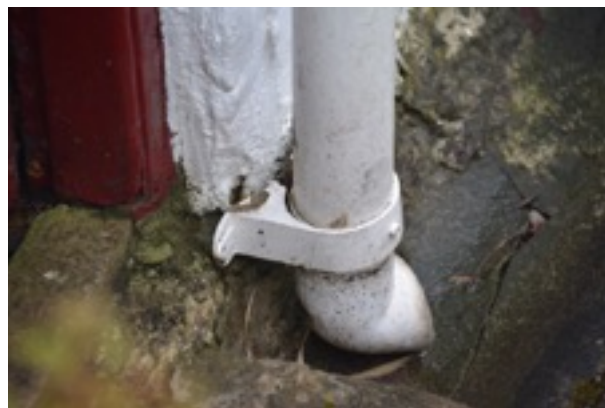
Guttering serving the side of the extension has been run in white half-round plastic sections. This too was seen to be in fair condition, there being a downpipe secured to the elevation wall by the store door, this ultimately jettisoning stormwater into the nearby gully, which also collects waste water from the bathroom. It was noted that the fixing bracket at the base of the downpipe has worked loose.

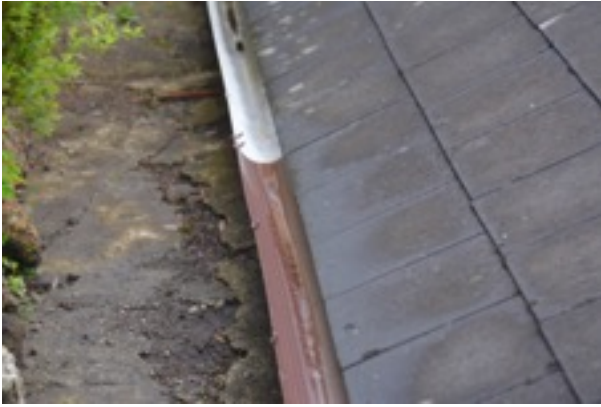
Guttering serving the rear roof slope has been run in a mixture of both brown and white plastic sections. This is shared with the adjoining dwelling and extends across and ultimately jettisons stormwater onto the side of the adjoining dwelling. The guttering extends down the side of the building where it is also run in brown box-shaped sections. Whilst we noted no obvious signs of any leaks, it is quite apparent that the guttering is dirt stained in this location and again requires to be cleaned and flushed through. The guttering wraps around the front of the building to where the bay is located.

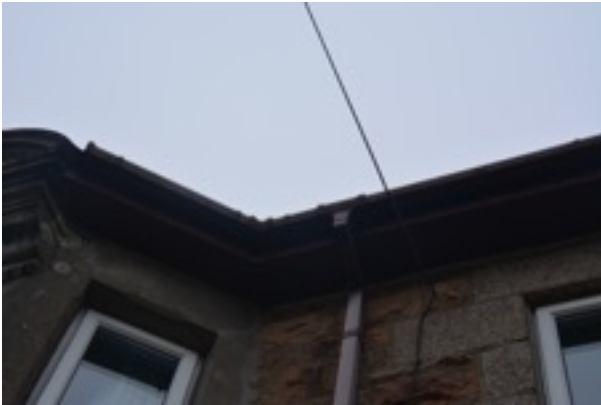
The final section of guttering is positioned to the right hand side of the bay where there is a further downpipe, this ultimately jettisoning stormwater into an open, although protected, gully at the base of the wall. It was noted that some of the cement benching surrounding the gully has now washed and weathered away, and this should be repaired to prevent water soaking down through into the foundation areas, which will ultimately cause damage and settlement problems.

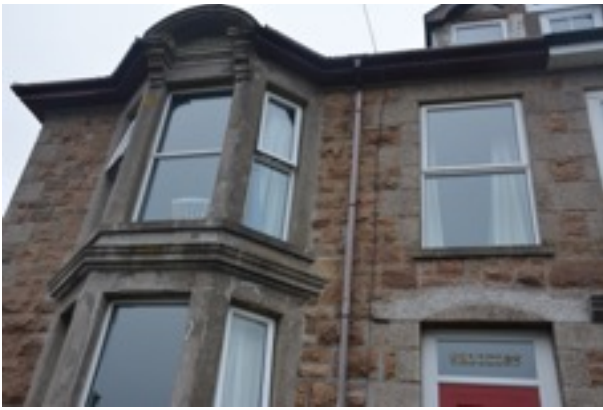
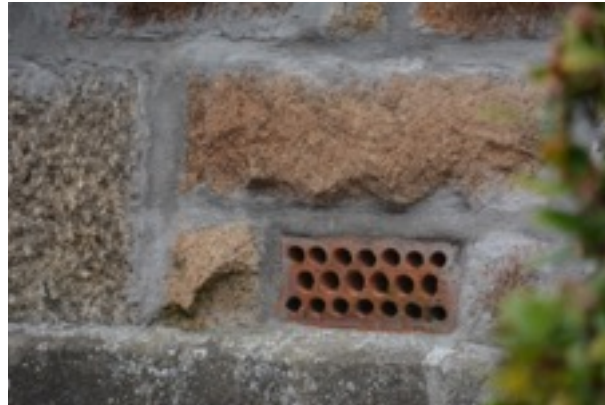
As viewed from the front of the dwelling the elevation wall was seen to be generally vertical, this largely comprising both stone and granite, with granite quoins and lintels around door and window openings. Where the bay is located, the bays have been rendered and the nature of the material below is not known, but we suspect stone or brickwork. This has obviously not been decorated and it would perhaps be greatly enhanced if the whole of the bay area was painted accordingly. Pointing to the stonework was seen to be in fair condition, there being one air brick present at low level below the bay providing for sub-floor ventilation.

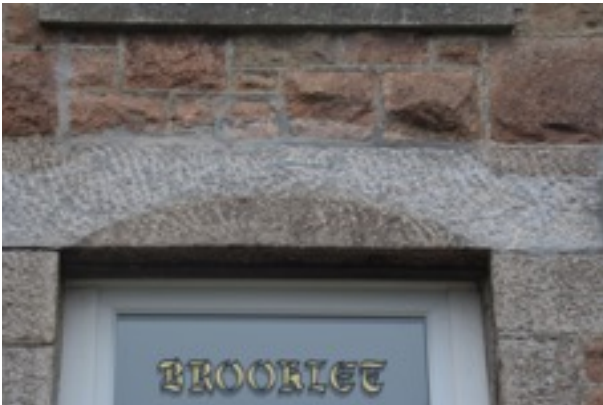
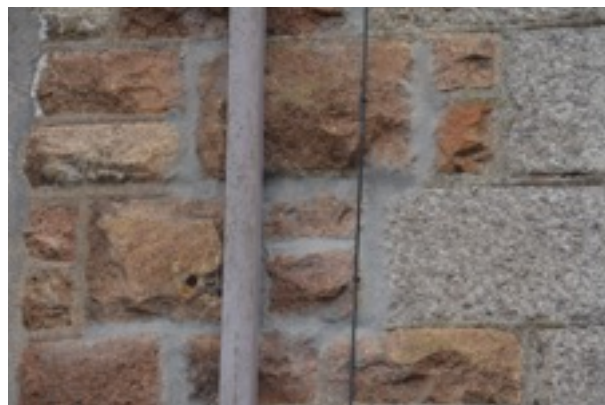
Some patch repairs have been undertaken to the pointing during the history of this dwelling. Where the entrance door is located originally there was some ornate cornicing immediately above the door, similar to that on No. 34, but this has obviously long since cracked and broken away, there now being a light scar on the granite where this was originally positioned.

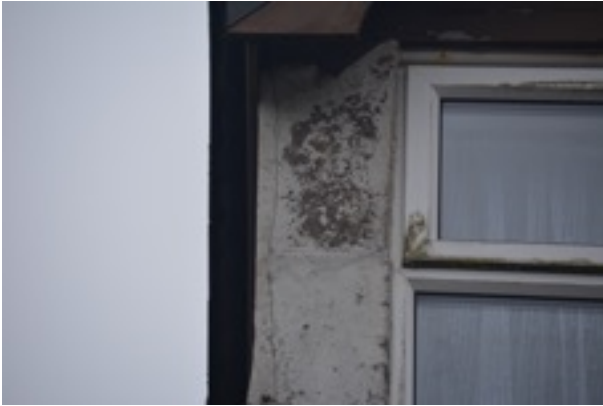
Where the dormer is located at the uppermost level we noted evidence of cracking to the rendered surface and suspect that the render may well be blown in this location. This obviously has not been decorated for very many years, to include for the wooden timberwork present in the uppermost part.

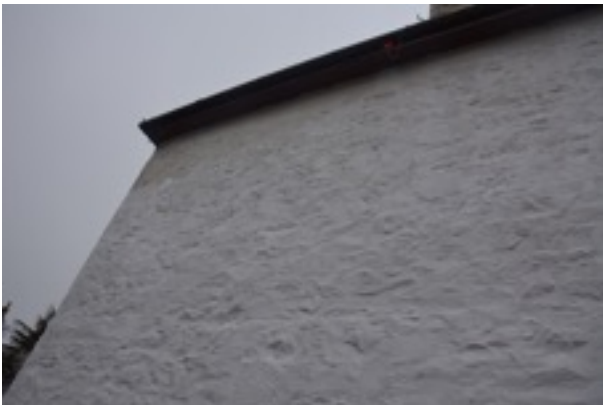
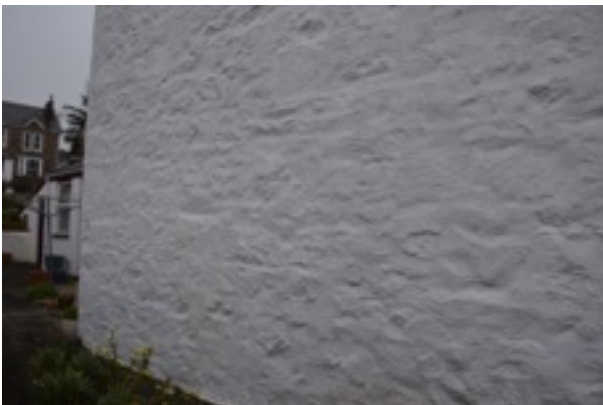
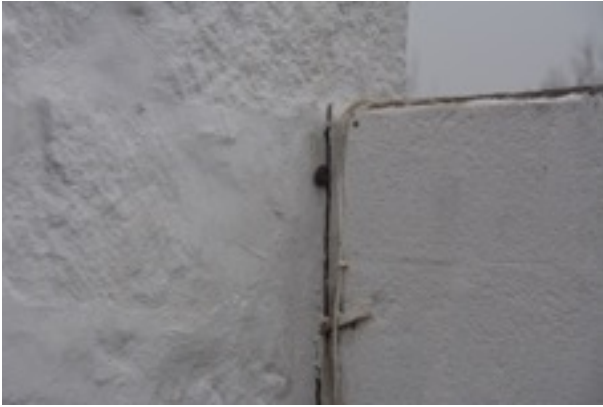
The side elevation wall of the main building is very obviously of stone that has been painted in the past, but a small area at high level has obviously not been decorated because the ladder wouldn't reach. We noted no evidence of any cracking, bowing or deflection, there being further air bricks present around the base to provide for sub-floor ventilation. Slight dirt staining was noted to the surface of the wall which will inevitably require to be redecorated in due course. Butting up to this wall where the side pedestrian gate is located there is a block built boundary. This has slightly pulled away from the wall due to, we suspect, differential movement and we noted no evidence of any physical or chemical damp proof course present in this location, which may result in damp bleeding through into the main structure.

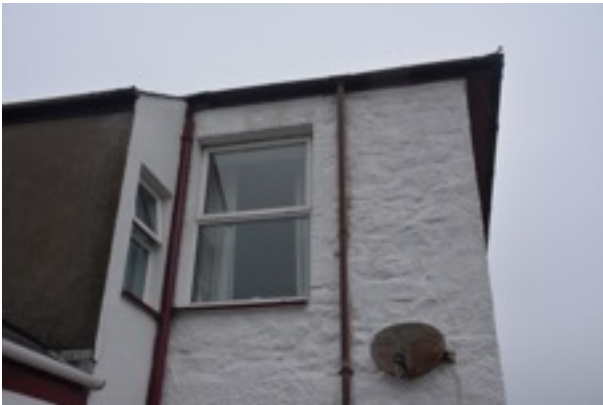
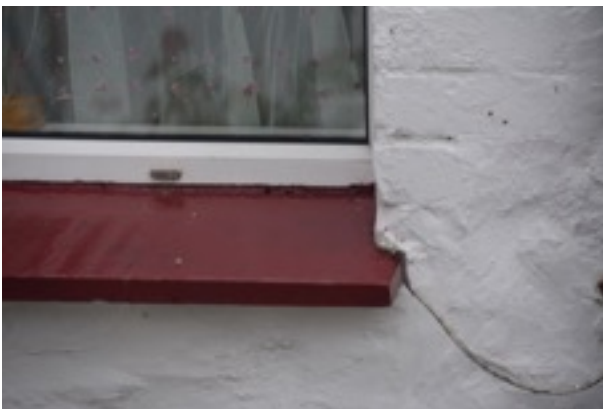
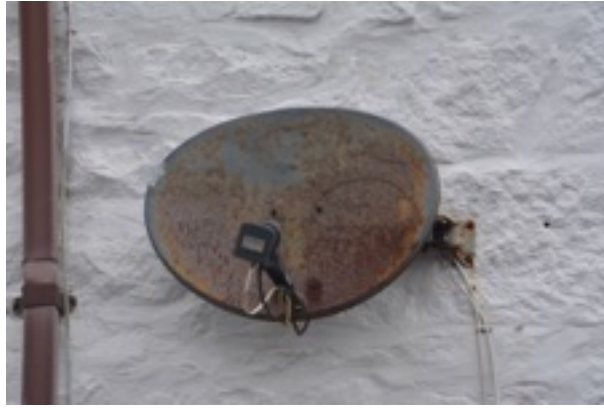
The rear elevation wall of the main body of the building is also quite clearly of stone and granite with some brickwork present surrounding the window openings, however that section to the left where the building protrudes where the separate WC is located has been rendered and partially painted. This is the section which is understood to be of brick. The elevation wall was seen to be vertical and again free from signs of cracking, bowing or deflection with window openings remaining square and cills being of solid slate that has been painted. Please note that to the rear of door and window openings on all parts of this building we are unable to comment as to the condition of any timber lintels that may be present. Against the rear elevation wall there is a satellite dish, but this was noted to be corroded and is probably now in need of replacement.

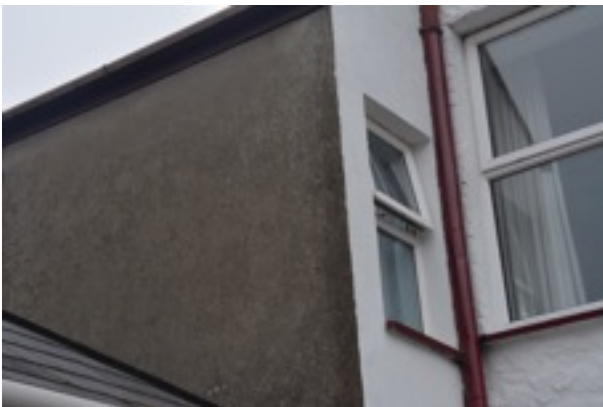
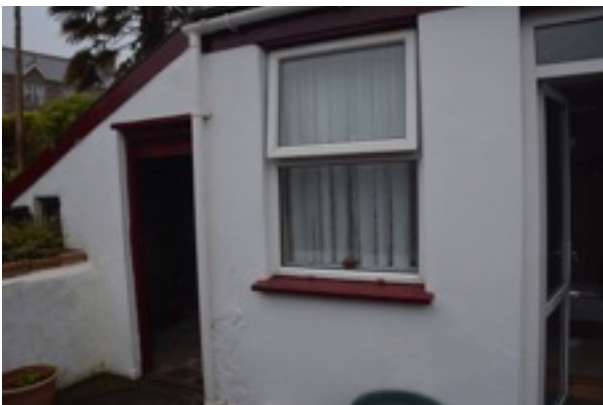
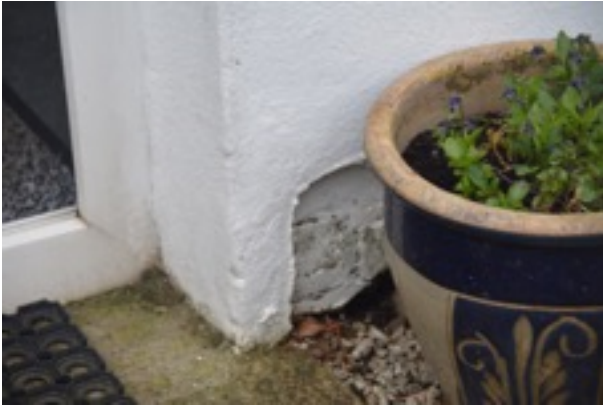
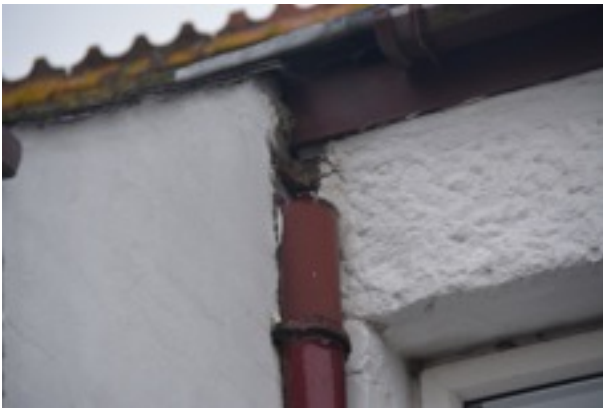
The side elevation wall of the back extension, which is also we understand of brick, was equally seen to be vertical and again free from signs of cracking, bowing or deflection, with the window openings remaining square and further slate cills present. In the corner, the soil vent pipe rises up between the small extension and the main building, but this stops short of the eaves and ideally this should be extended and goosenecked around the top with a suitable metal or plastic cage fitted. A balanced flue protrudes through the wall serving the internal boiler and at low level a gas meter box is positioned. To the left hand side of the back door position the wall was also seen to be generally vertical, but some patch repairs have obviously been undertaken at low level to the rear of the downpipe. Some brickwork is present to the right hand side of the back door where render is cracked and broken away (a foot scraper may possibly have been initially positioned in this location). Where the outside tap protrudes through the wall below the kitchen window this should ideally be fitted with insulation and a small lagging jacket to prevent the possible risk of frost damage.

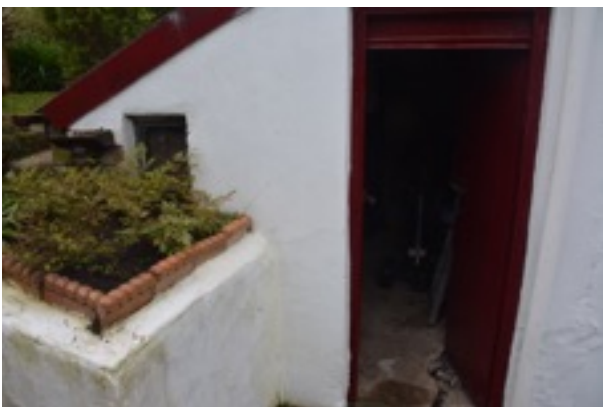
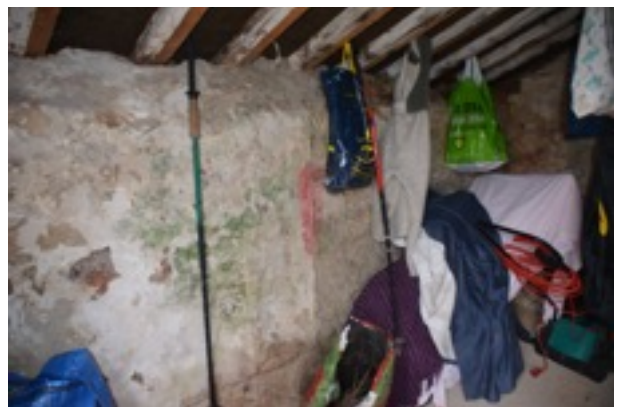
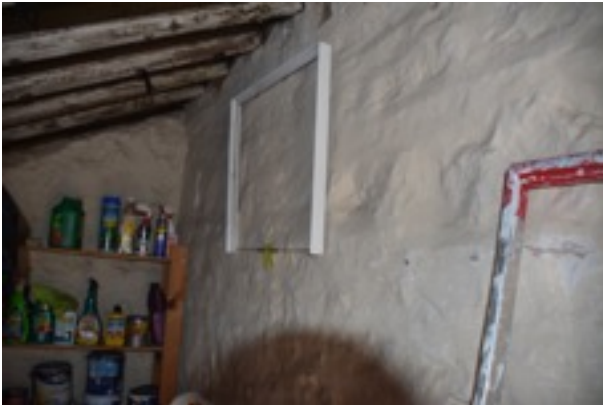
The rear elevation wall of the store is effectively built below ground and is not visible from the exterior, but from the interior we can confirm that this indeed is of solid stone construction, as is the back wall of the store where it butts up to the neighbouring property and the back wall of what is effectively the bathroom, these walls being given a slurry cement wash that has been painted in the past. The side wall of the store is of brick, this again being externally rendered and painted, but the brick is partly below the adjoining flower bed and inevitably this will give rise to internal damp problems.

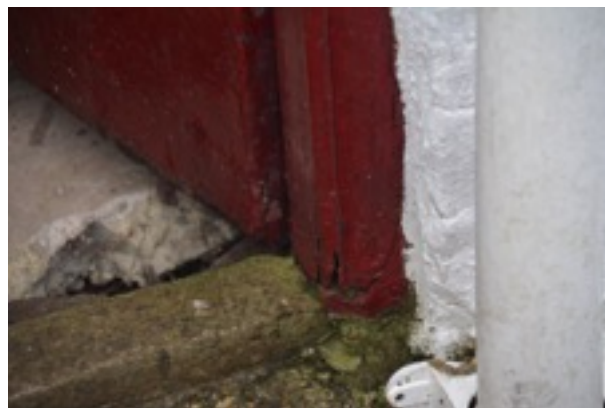
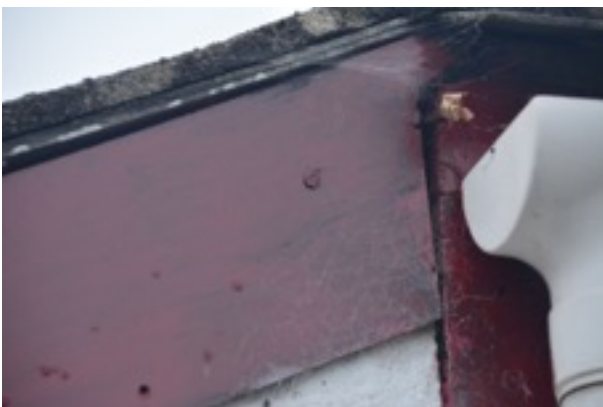
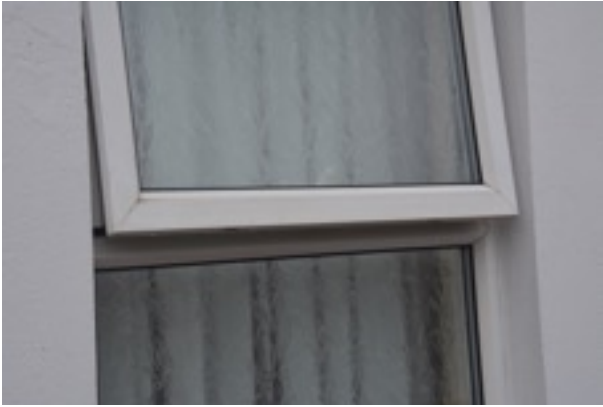
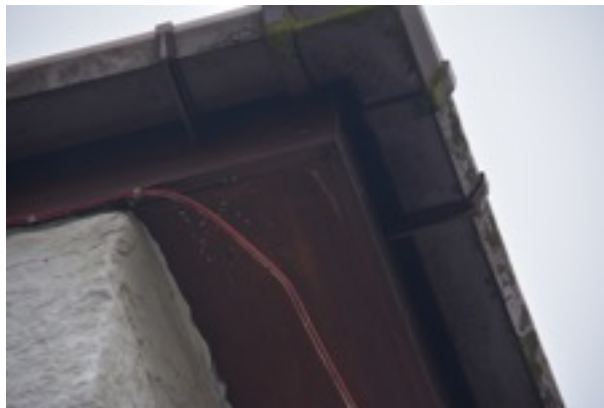
The various fascia boards, cills and wooden doors have been fairly well maintained during the history of this property, but they have suffered and gradually deteriorated over time, with small amounts of rot present around door frames. The fascia boards, which are painted, were seen to be in fair condition, but inevitably these too will require to be redecorated during the course of your occupation. The soffit boards have also been painted. Please note, we are unable to comment as to the nature of this material. The various other doors and windows are all of modern uPVC. These should remain relatively maintenance-free, but will inevitably require routine cleaning down in order to maintain their appearance. It was noted to the soffits where some electrical cabling is present this has dropped out of position and requires to be properly re-secured.

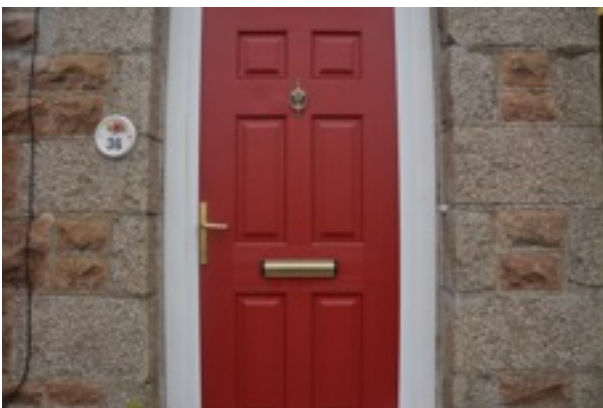
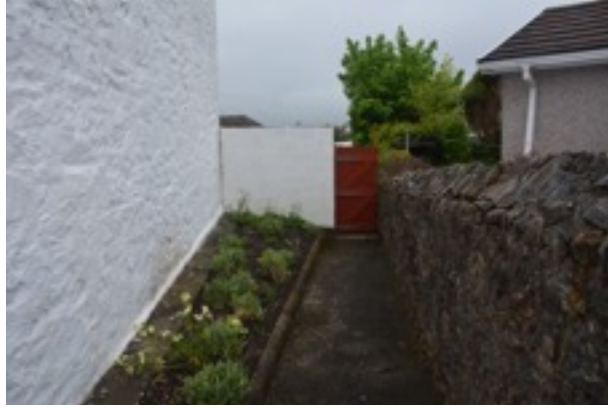
To the front of the building the same comments are largely applicable and, as already mentioned, it will probably be prudent to paint the bay area as this will considerably improve the overall appearance of the approach to the building. The main entrance door has more recently been replaced, but it was noted that the handle has become scratched and worn. Where the side pedestrian gate is present to the left hand side there is no proper gate stop and it would perhaps be beneficial to undertake some improvements in this location.

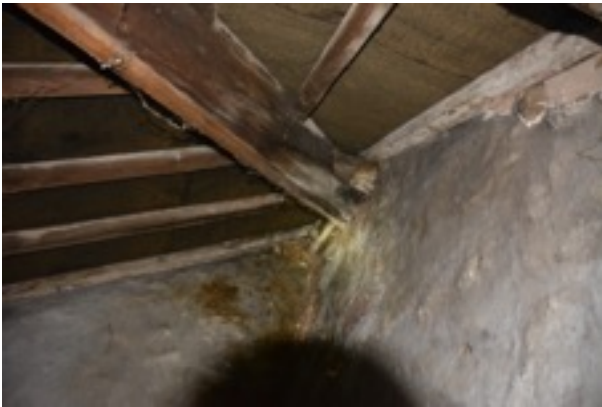
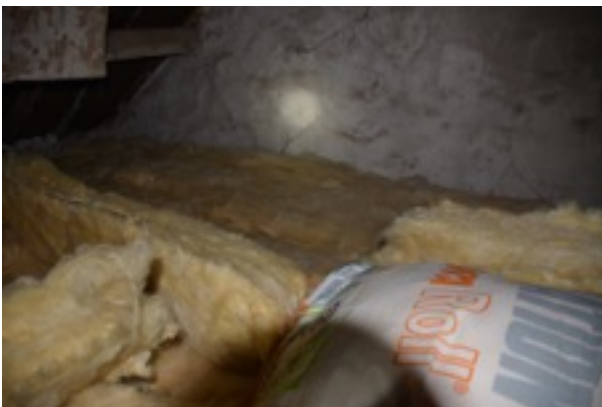
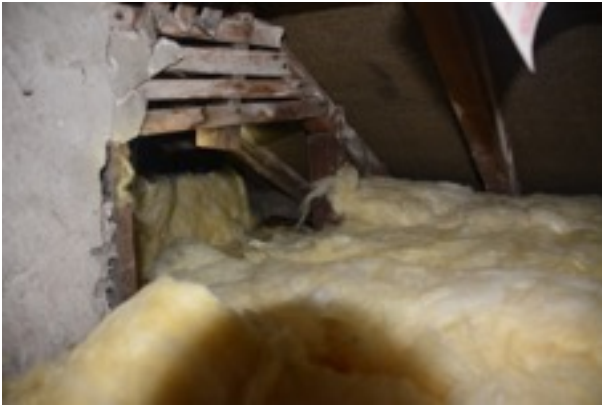
Access was available into the section of roof void immediately over the bathroom via a hatch positioned in the bathroom ceiling. We can confirm that immediately by the hatch rising up between the bathroom and the kitchen there is a further solid random stone wall, with a stone wall between the subject dwelling and adjoining property. These walls in the past have been covered over with a slurry cement wash and painted, but have obviously not received attention for many years as there is no point. The void was seen to be generally well insulated. Timbers within the void are the original timbers, which were seen to be in fair condition given their age, although there was evidence of past water staining due presumably to previous defective roofs. The undersides of the tiles have been protected with bitumen felt and the void has been generally well insulated. There is a very small opening to the right hand side leading through into the kitchen roof void where some lath and plaster was present. We can confirm that some further insulation has been stuffed into this area, but in all honesty no sensible inspection of the area beyond was possible. We can confirm that by pointing the camera into this area some brickwork was indeed present, but we suspect this to be associated with the chimney stack. Whilst the void has been generally well insulated, some pipework that is ducted through this part of the property has not been insulated and this should ideally be protected accordingly to prevent the possible risk of frost damage.

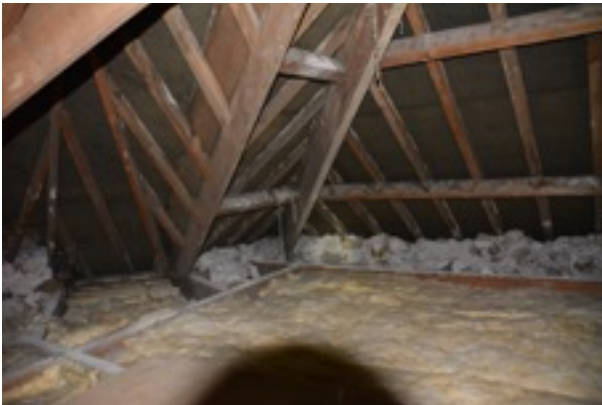
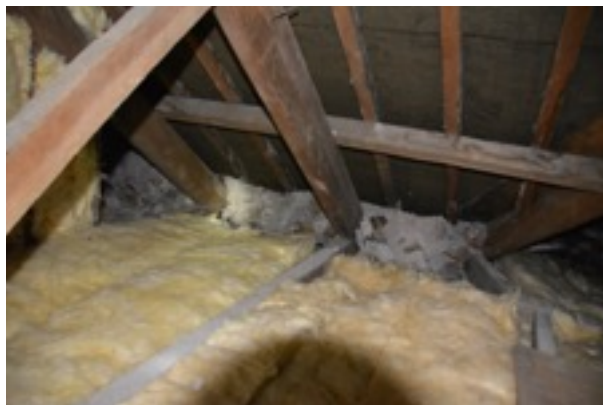
As you will recall, there is an attic room and therefore there is effectively no roof void; the attic room, which we suspect was always originally part of the structure of the building, effectively occupies this space. There is a hatch which gives access into the roof space beyond. A very small amount of boarding was present, but effectively inspection had to be undertaken from the hatch only. We can confirm that timbers were seen to be original and these were seen to be in fair condition with the undersides of the tiled roof surface being felted. We noted no evidence of any leaks through the valley areas surrounding the conical roof to the front where some rubble and brickwork was present to the uppermost part. Stonework was visible forming the upper parts of the walls surrounding this dwelling. The void has been generally well insulated, but ideally the depth of insulation should be further increased to a minimum depth of at least 12”.

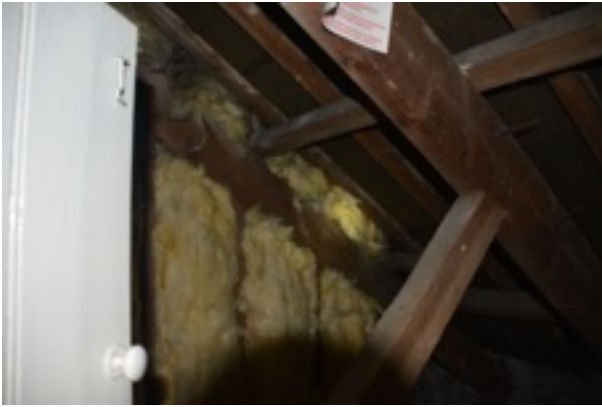
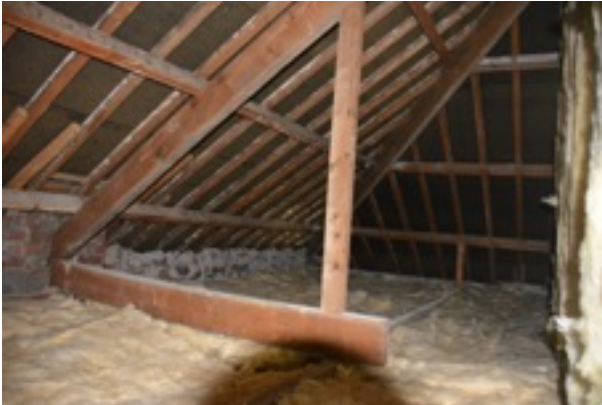
The very limited inspection of those parts of the void extending down the side revealed no obvious defects, with the roof again for the most part being clean, tidy and reasonably well insulated, to include for vertical insulation against the stud wall where the upper attic room has been formed. Where the chimney stack rises up on the gable end wall brickwork was visible, and this was seen to be in fair condition with no evidence of any rainwater penetration down through the uppermost parts.

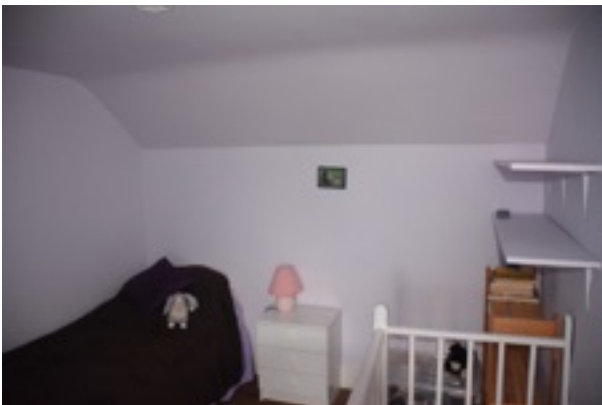
Within the attic room the ceiling is believed to be the original lath and plaster ceiling. We noted some evidence of cracking, but no evidence of imminent failure, however we would point out that where lath and plaster is present this does have a finite life expectancy, and the future longevity of this may therefore be limited. Where the dormer is located we noted slight disturbance to the surface, but again no obvious signs of imminent collapse, although some stains due to past leaks were present.

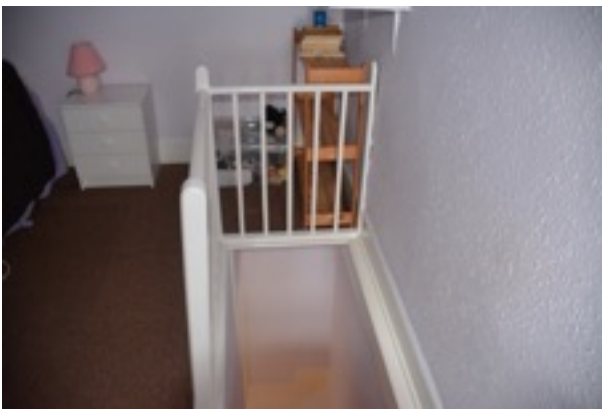
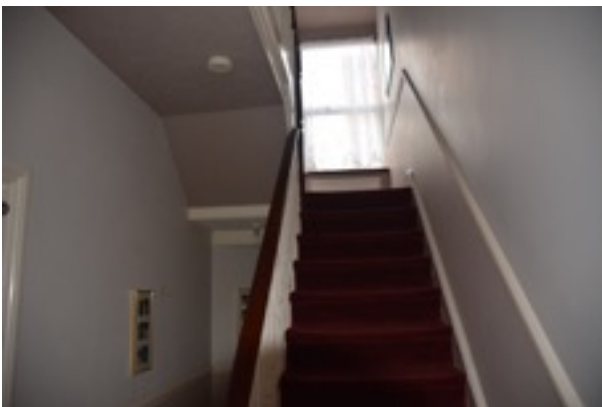
Where the attic room is located there is a small balustrade around the top of the attic stairwell, however this is loose and requires to be properly re-secured. The stairs have no adjoining grab rail, and as these have been painted they are potentially slippery and therefore also a potential hazard. We also noted that the balustrade to the stairway of the main part of the dwelling was loose, and this too should be additionally braced up. Elsewhere within the building woodwork was seen to be in fair condition, other than where it has naturally suffered from wear and tear. Where the door leads through into the kitchen from the hallway the upper part is glazed, but it is not known if glass is toughened or laminated. Skirtings and architraves to doors were seen to be in fair condition with a dado rail also present. Where the inner porch door is located further glass is present, to which the same comments apply. Inevitably doors will require easing and adjusting after redecoration, but subject to minor repairs and maintenance we see no reason as to why woodwork should not remain serviceable for its intended use. There was some evidence that skirtings in the front living room have been replaced with new skirting, indicating that there may have been a rot problem in this location in the past, and further decorative works are required.

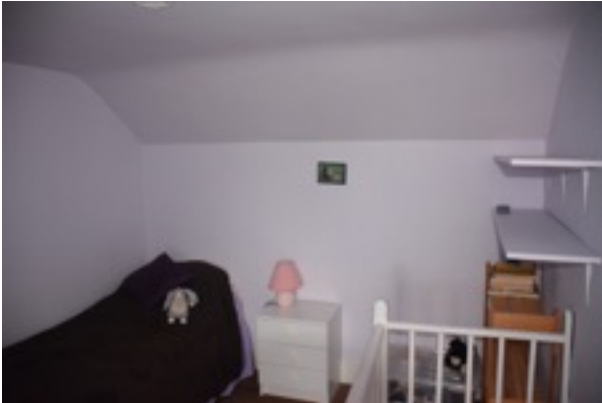
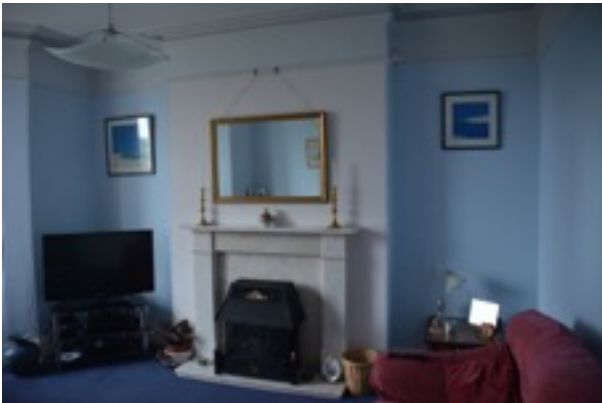
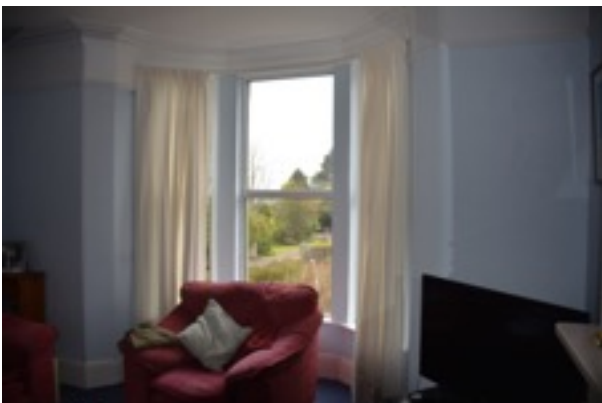
Throughout, this property has been relatively simply decorated, walls largely emulsioned and woodwork glossed or stained. The property is effectively ready for immediate occupation. We did note the use of some wood chip wallpaper, and in the event of this being removed it is quite feasible that the underlying plaster will pull away with it. Inevitably decorations will become lightly soiled and marked after the removal of furniture and fittings, and you will no doubt wish to redecorate in accordance with your own particular style and taste. Obviously some surface decorations are damaged where there have been high levels of damp and additional making good will be necessary in these locations.

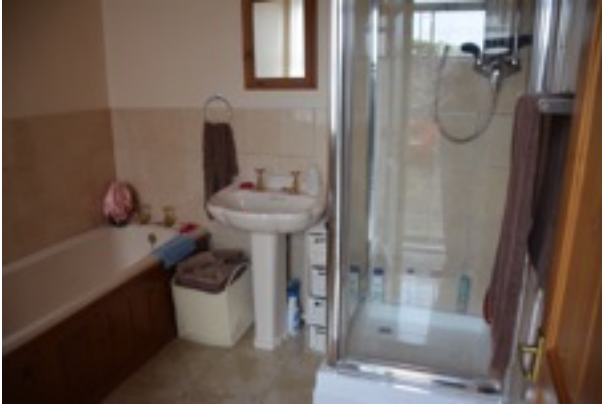
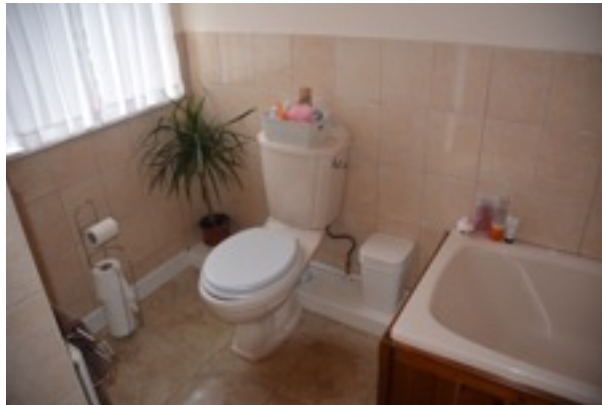
At ground floor level there is the principal bathroom, which we have to say is about as far away from all of the bedroom accommodation as you could possibly get. The bathroom comprises a bath, pedestal wash hand basin and WC together with a corner shower, these areas all being tiled. The facilities are perhaps dated in style and design, but should remain perfectly serviceable for their intended use, subject to normal routine cleaning down. None of the facilities were tested by ourselves.

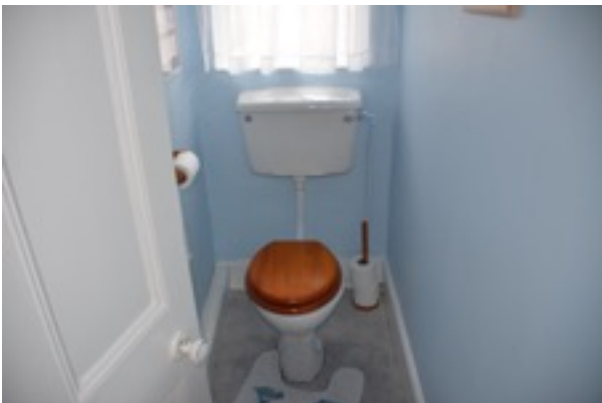
Where the separate WC is located there is a wash hand basin set into a small recess. Again, subject to cleaning down, these should remain serviceable for their intended use, but some of the pipework is surface mounted and relatively unsightly and there is an old lead waste serving the small wash hand basin. Please note that any lead service pipework present within this building should be stripped out and removed as it is obviously a potential health hazard.
