## **BUILDING CONDITION SURVEY REPORT**

**Property Address:**           **Any House**  
   **Any Street**  
   **Any Town**  
   **Any County**  
   **Any Postcode**

## BUILDING CONDITION SURVEY REPORT

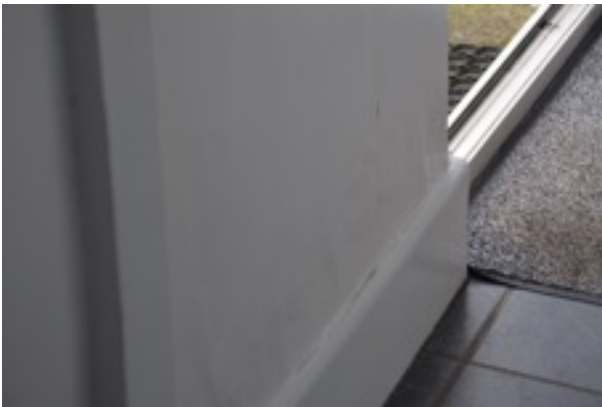
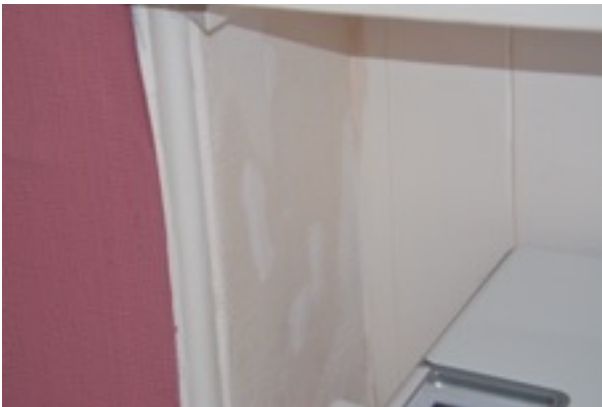
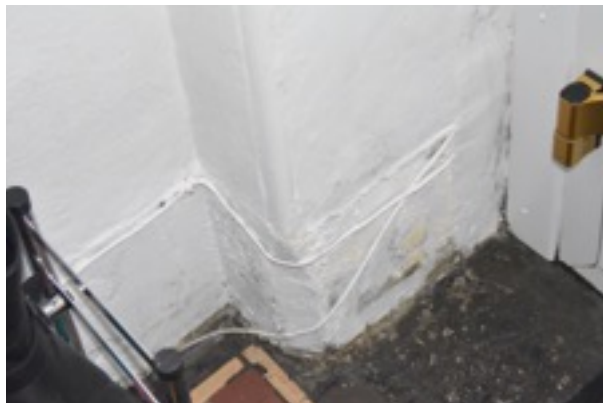
During the course of our inspection we noted some evidence of damp penetration, particularly through the front bay area where we suspect skirtings in the past have been affected. We also noted evidence of damp staining within the dining room where recesses are present on the external walls. Given the nature of the construction of this property we would inevitably anticipate it to be damp to a degree, this being very typical of this type of dwelling and probably impossible to eradicate on a comprehensive basis. There are further physical signs of damp within the entrance hall.

Moisture meter readings were taken throughout the dwelling at both high and low level. Needless to say, where staining was apparent these were unacceptably high and we have no choice but to now recommend that you please seek your own further specialist advice.

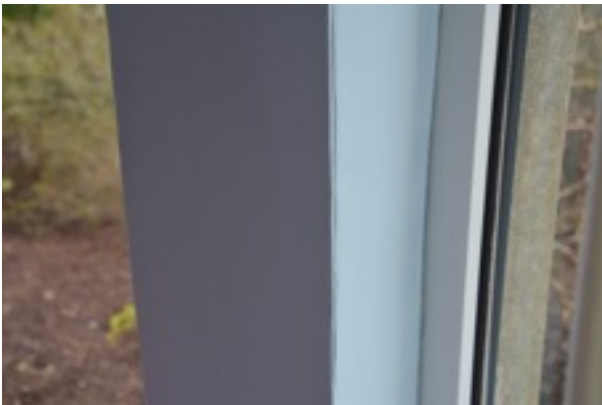
Where the bay area is located we noted Cotina to be present behind surface paintwork. Cotina is often used in an effort to repel damp and reduce levels of condensation. Where this has been applied to the two columns the standard of workmanship was noted to be poor.

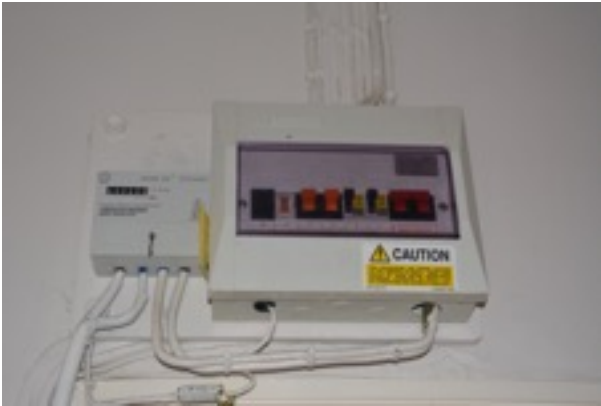
### **9.1 Electricity:**

Mains electricity is connected, the mains electrical riser entering the property beside the dining room door, the meter and consumer board being located at high level immediately above, the meter reading at the time of inspection being 40069.2. The consumer board is a relatively modern consumer board incorporating independent circuit breakers.

In our experience, domestic wiring normally has a life expectancy of approximately 25 years and should ideally be tested at least every 10 and on change of ownership. It is now recommended that a suitable test is put in hand by a qualified electrician who can advise as to the overall condition of wiring circuits within this dwelling and the extent of any upgrading/rewiring now necessary. Almost certainly, you will wish to improve upon the number of electrical points and sockets within principal locations in order to accommodate for modern day living requirements. We did note some old switchgear which should also ideally be upgraded. Please ensure that smoke alarms are incorporated within this dwelling at both ground and upper levels. No tests were undertaken by ourselves.

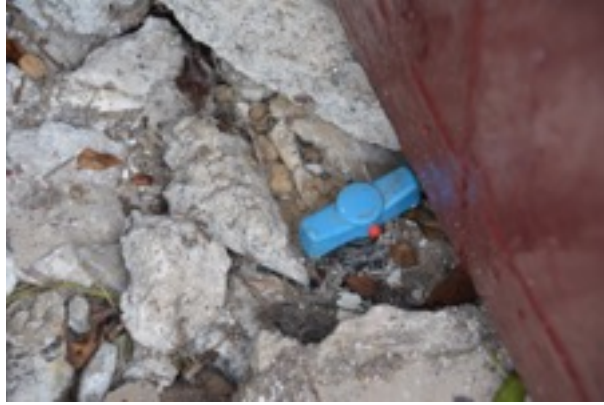
### **9.3 Water:**

Believed to be connected to the mains water supply, there being evidence of a fairly new stop cock being located within the store at the back of the property, but the floor surrounding this requires to be properly made good. Pipework internally was run in a mixture of copper and plastic, and we noted no obvious signs of any leaks at the time of inspection, but no tests were undertaken by ourselves. We noted no evidence of any cold or hot water storage tanks present within this dwelling. Obviously should you wish to improve either kitchen or bathroom facilities then inevitably there will be a need to upgrade associated plumbing, which is likely to include for additional electrical work in terms of earth bonding.

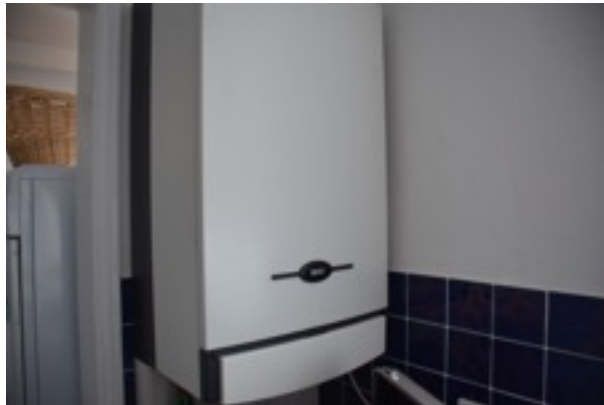
#### **9.4 Central Heating and Fireplaces:**

Gas fired central heating is installed, this being operated via the wall mounted combination Baxi boiler located in the kitchen. This was seen to be on and was working at the time of inspection, but the equipment was not operated by ourselves. Please raise enquiries to ascertain the service history of the boiler together with its age and as to whether or not there are any maintenance or service contracts associated with this. Radiators are present within principal locations, these benefiting from additional thermostatic valves, and we would envisage that these adequately heat the dwelling during the colder months of the year, but obviously cannot confirm, and we are equally unable to comment as to the future longevity of the boiler itself. The gas fire in the living room was not operated by ourselves and, as mentioned above, this should also be checked by a Gas Safe engineer.

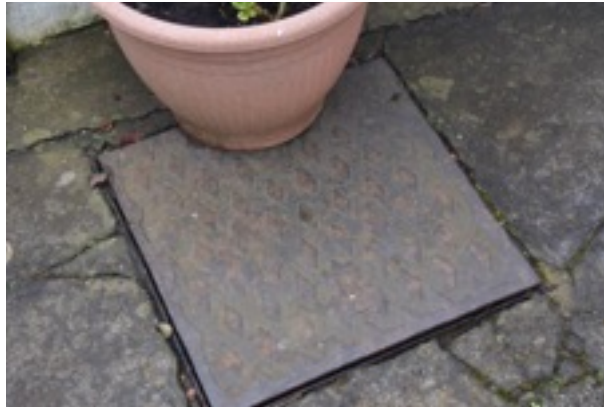
#### **9.5 Foul Drains:**

The property is connected to the mains drainage system, there being one manhole cover located outside the store room. This was raised and the chamber within seen to be in fair condition, but there is a need for a small amount of attention to cement benching in the base around the gully, and we also noted a small amount of effluent present. The drains are believed to run from this position below the store across to the adjoining dwelling. Solicitors should please raise enquiries to ascertain whether or not there have been any past problems with the drainage runs serving this dwelling and as to whether or not the drains remain your responsibility or have been adopted by the Local Authority.

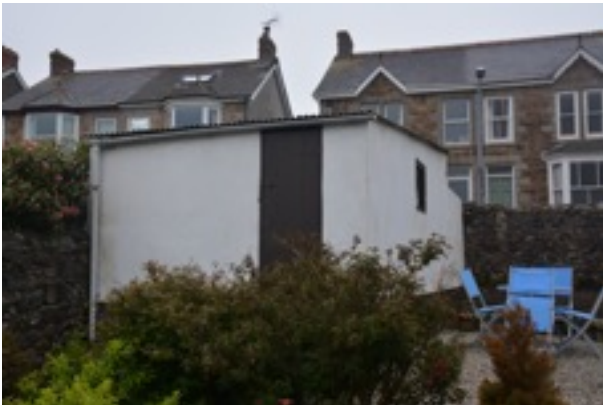
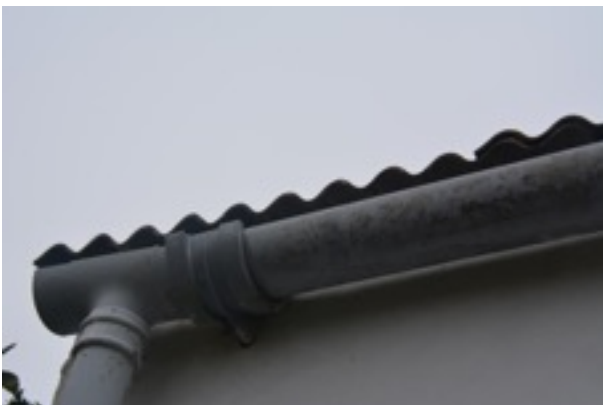
**10 Garage(s) and Outbuildings:**

As you are aware, at the top end of the garden there is a single block-built garage below a corrugated asbestos sheeted roof which drains to the rear where there is a half-round plastic gutter, but this is perhaps not best positioned below the asbestos roof, and the downpipe in the corner is simply propped up by a piece of breeze block and ultimately drains into the adjoining flower bed. It was noted that the corrugated roof is a relatively new roof, but we are unable to comment as to whether or not the material is of a hazardous nature. To the front, the garage is accessed via side hung opening wooden doors (locked and not operated by ourselves).

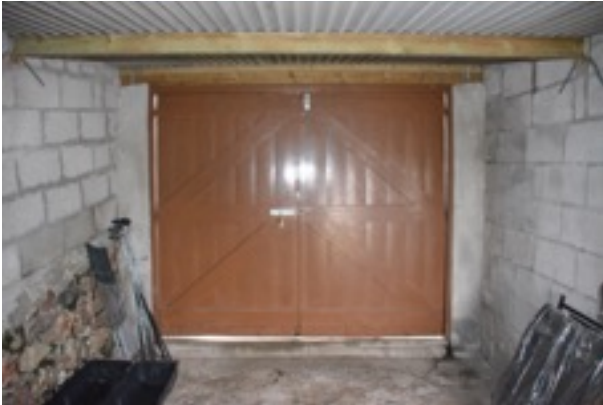
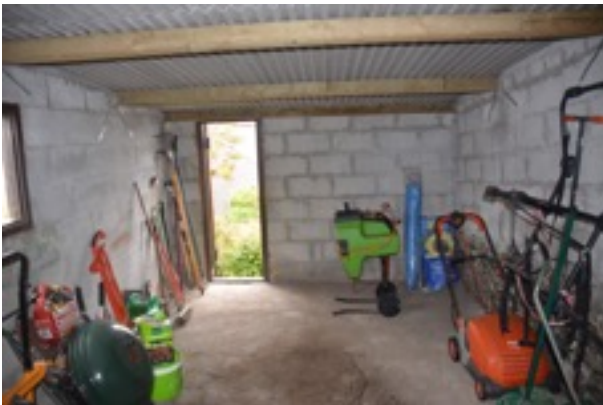
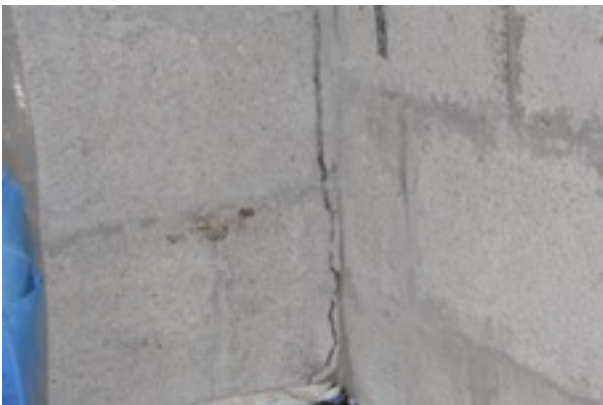
The internal walls of the garage were seen to be in fair condition, there being some stonework present roughly on the party wall line, with the garage having a solid concrete floor, although the floor was noted to be cracked and occasionally pitted, albeit that it remained generally clean and well presented. The roof is supported on new timber beams and, subject to normal routine maintenance works, we see no reason as to why the garage should not remain perfectly serviceable for its intended use, albeit that the structure is relatively basic. Please be aware that this area is always likely to remain cold, damp and prone to high levels of condensation. In the corner where the back wall adjoins the side wall on the party wall line there is obvious evidence of past movement, there being cracking present as a result of the blockwork not being properly stitched in in this location. We noted further evidence of slight cracking towards the front on the outer wall, due we suspect to minor settlement problems.

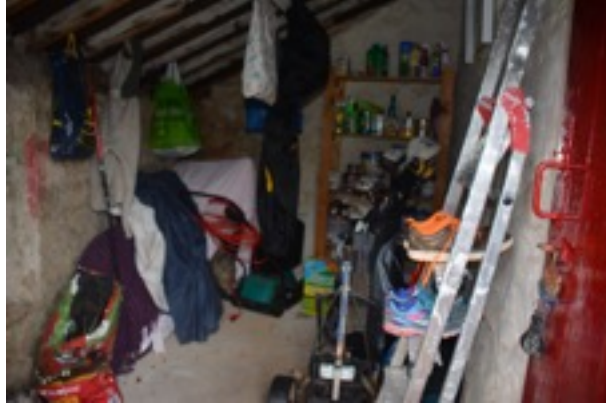
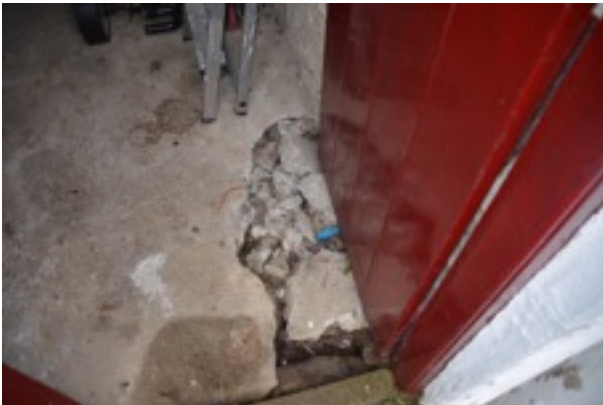
As you are aware, there is a small rear store present at the back of the bathroom, upon which we have commented above. This provides for some useful additional storage, but inevitably is likely to remain cold, damp and prone to high levels of condensation, the roof over this structure forming part of the roof to the rear addition itself. Within the store it was noted that the concrete flooring has cracked and broken open where the mains water enters the building, there being evidence of a relatively new stop tap being installed in this location, but the concrete flooring still requires to be made good.
