BUILDING SURVEY REPORT (LEVEL 3)

Property Address: **Any House**
 Any Street
 Any Town
 Any County
 Any Postcode

Prepared By: **Richard C K Hocking FRICS, F LAND INST**

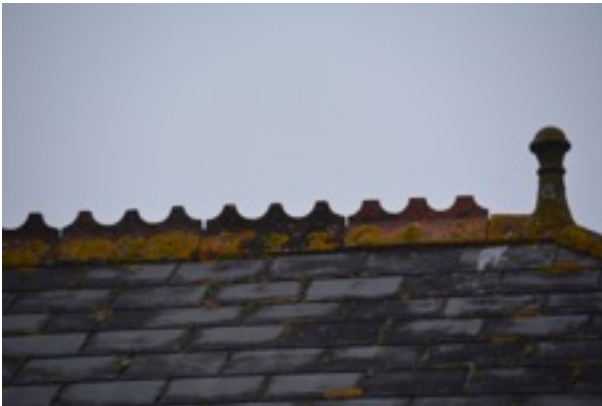
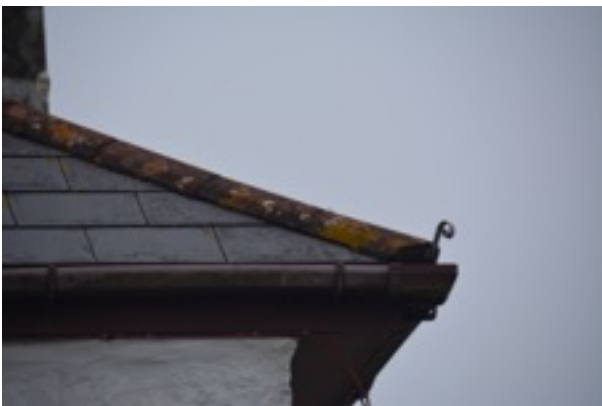
The main roof to the property is of pitched construction clad in manmade fibre tiles on a hollow timber frame. As viewed from the rear of the building the roof slope was seen to be even and free from signs of undulation or significant damage, the tiles being knitted into the tiled roof surface of the adjoining property, which is very obviously older. Ridge tiles to the apex of the roof are slightly ornate, these being level, even and well bedded onto cement with the hip ridge also being straight, there being a hip angle present at the base to provide for additional support. There is a certain amount of lichen growth over the surface of the roof, but we are not overly concerned about this in its present form.

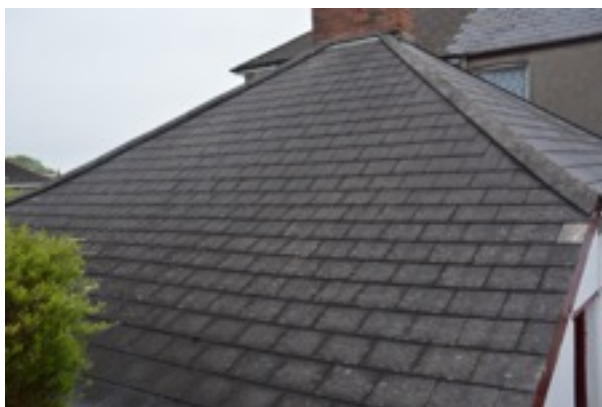
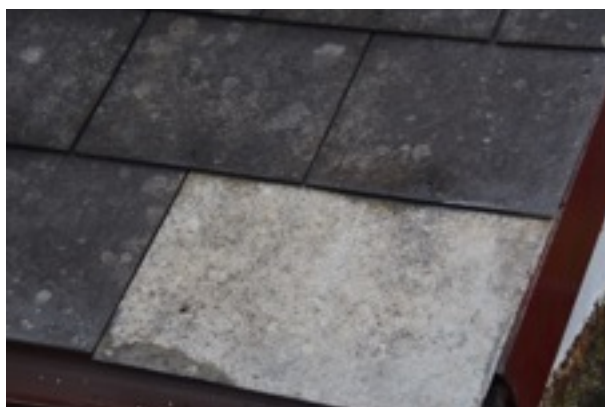
Where the rear extension is located there is a further pitched and hipped roof structure, this effectively extending over the kitchen and the bathroom as well as the small rear store, this also being clad over in manmade fibre tiles, but we believe some of these may contain a degree of asbestos, although we are unable to confirm. The rear roof slope of this extension has a slightly different pitch towards the lower sections, and at the base at the eaves at least one tile was noted to be smashed and broken, and one further asbestos tile has badly discoloured. A small amount of moss growth is present over the surface, but again we are not overly concerned about this in its present form, this roof also extending across the rear addition of the adjoining dwelling. Hip ridges have been formed out of cement and were seen to be in fair condition.

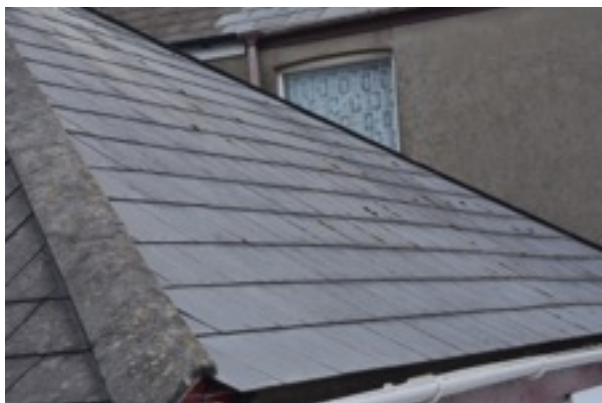
The roof slope facing towards the side yard was also seen to be in fair condition and free from damage or defect, but again a further small amount of moss growth was noted to be present.

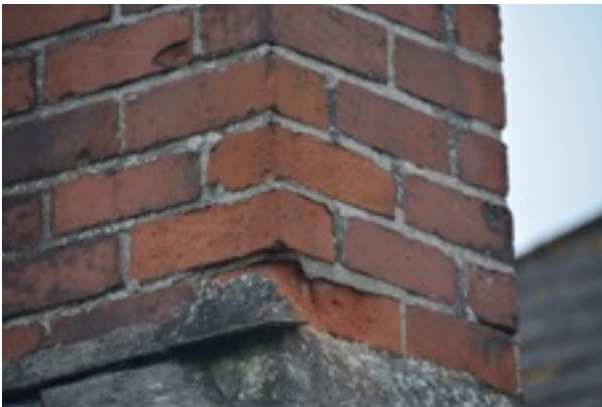
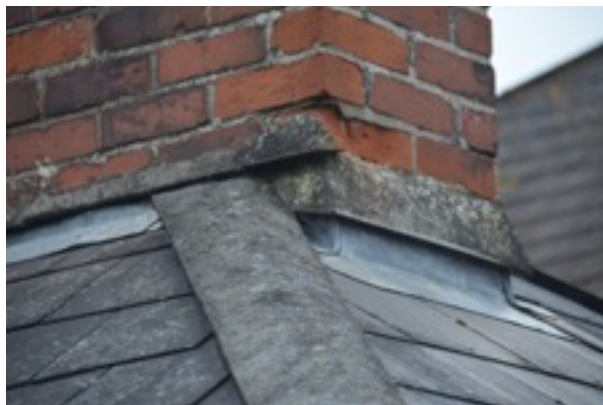
Rising up through the middle of the back addition there is a brick-built chimney stack which we suspect originally had four pots to the crown, although only three are presently visible. The crown and flaunching areas were largely hidden from view. The stack was seen to be generally vertical, but a small amount of plant growth was noted to be present to the brickwork. Some of the brickwork is beginning to spall and deteriorate, and there is also a need for attention to pointing. Flashings are present around the base of the stack. The chimney stack is, we presume, a shared liability and solicitors should please confirm.

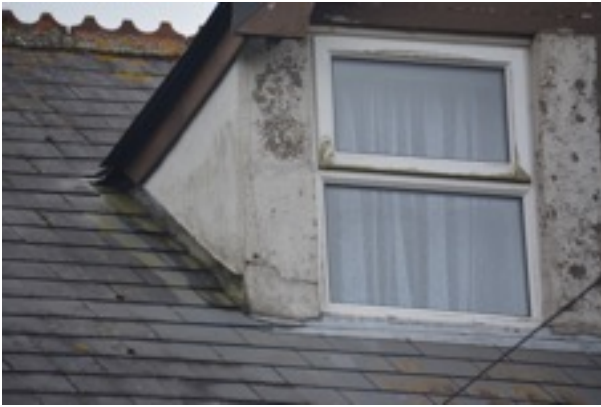
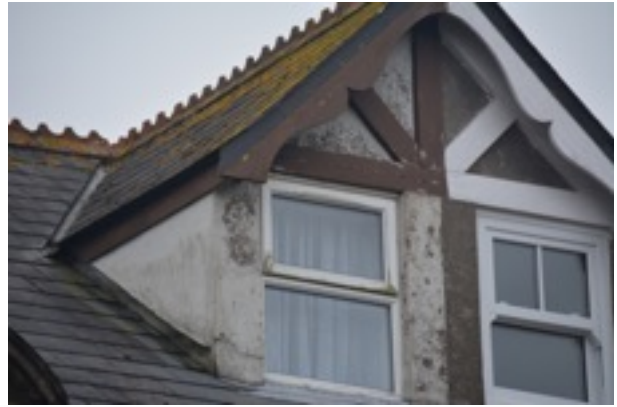
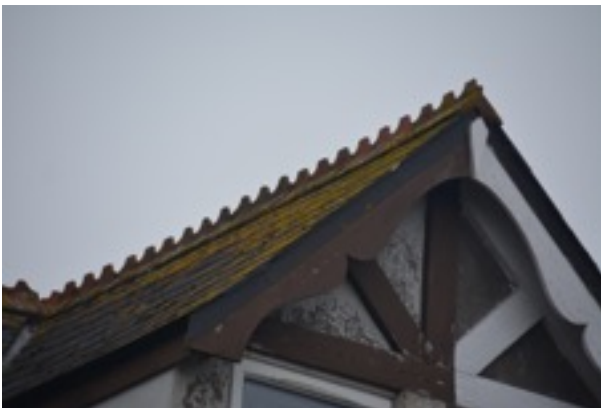
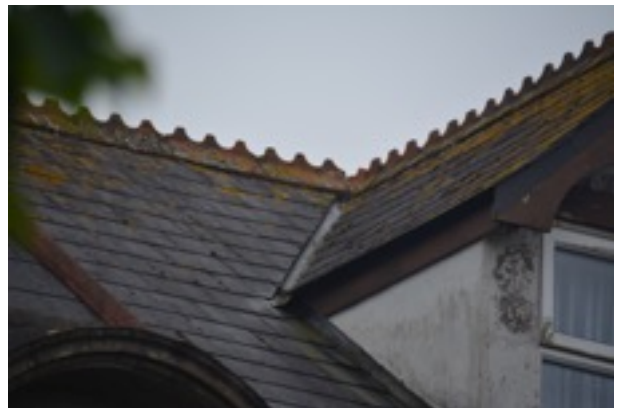
As viewed from the front of the property the roof was seen to be similarly clad over in manmade fibre tiles with a conical hipped roof positioned immediately over the bay. All parts visible were seen to be in fair condition with tiles again being generally well knitted into the roof over the adjoining dwelling. Where the dormer is located a sensible lead flashing is present immediately below the window. Where the conical roof is positioned over the bay this too was seen to be in fair condition with the hip ridges straight, with hip angle irons present at the base. As with other roof areas, a small amount of lichen growth is present over the surface, and should this become excessive it will need to be killed off and removed. Some valleys are present to either side of the conical roof as well as to the rear of the dormer, and we noted no obvious signs of blockage where easily visible at the time of inspection. The cheeks of the dormer have all been rendered and it is apparent that these have not been redecorated for some time. We suspect that these may be of timber framed construction. Those small areas of the roof over the dormer that we were able to see were again in satisfactory condition, but further lichen growth is present. Additional ornate ridge tiles were also seen to be located in this position.

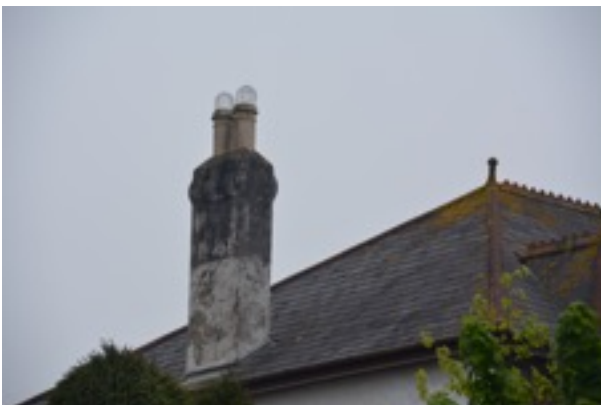
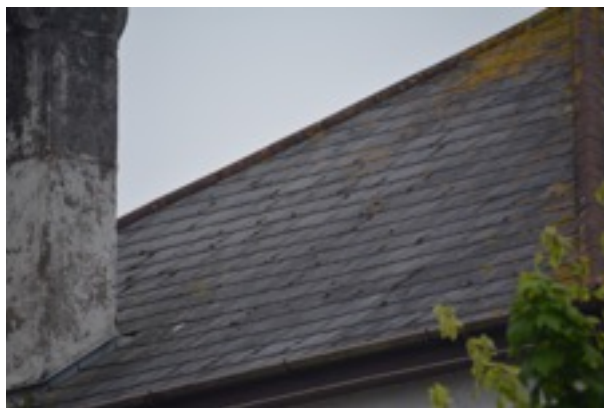
With regard to the hipped roof slope facing towards the adjoining bungalow, only a limited distant inspection was possible of this from the roadway. We can again confirm that the roof was seen to be even and free from signs of undulation, and those parts visible were in similar condition to the other roof areas already inspected. Further lichen growth is present close to the apex of the roof, to which the same comments apply, the hip ridges on either side being straight and free from damage or defect as far as we could ascertain, but obviously a close inspection was simply not practical.

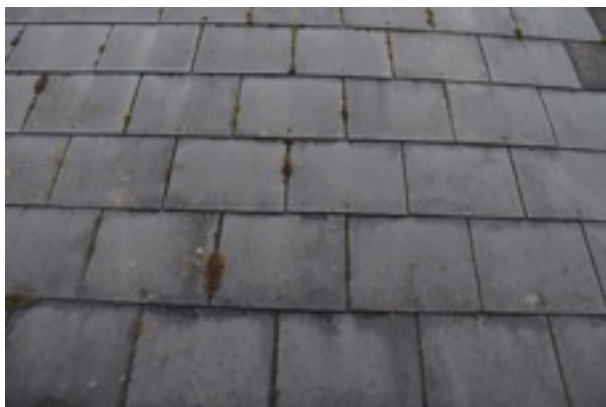
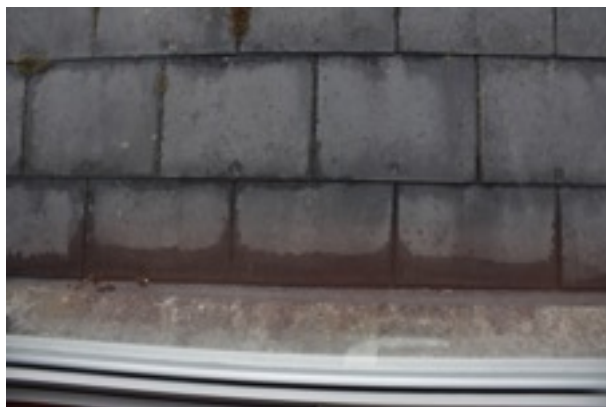
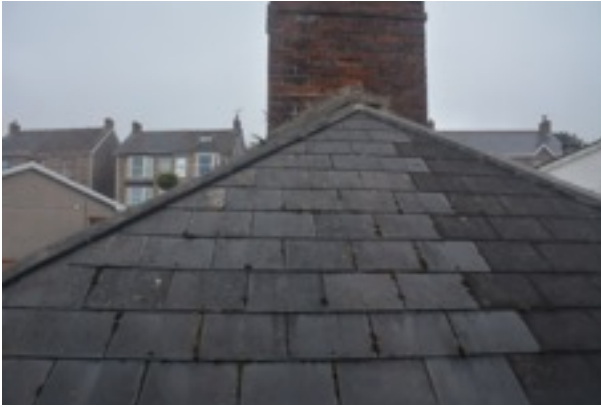
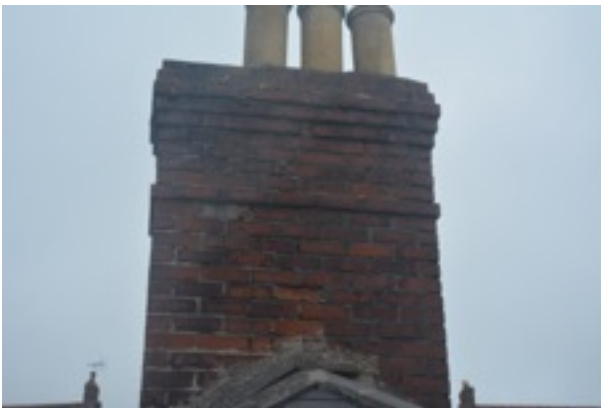
The rear hipped roof slope of the back addition could be inspected from the half-landing window. We can again confirm that the tiled roof surface was seen to be in fair condition and free from damage or defect, but a small amount of moss growth is present, as indeed was visible to other roof slopes. The roof drains down to a lead-lined valley at the base of the wall which ultimately feeds to the side of the property. Those rear sections of the chimney stack visible again showed evidence of plant growth as well as damage and deterioration to pointing and brickwork, thus emphasising the need for works in this location.

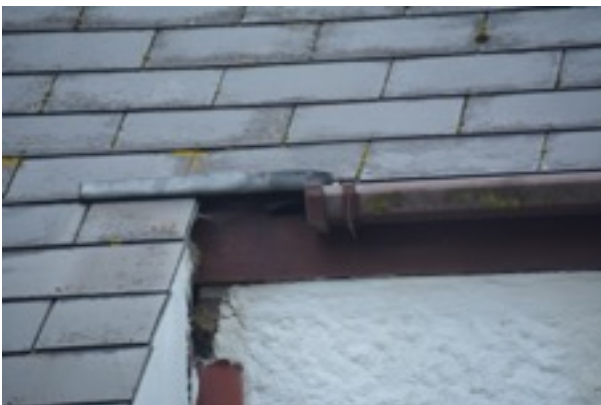
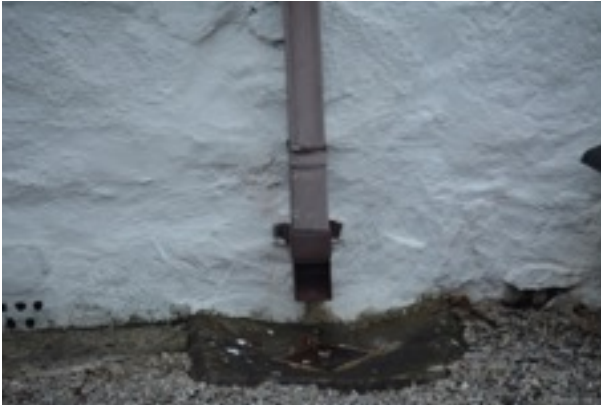
As viewed from the back of the building guttering serving the main roof slope has been run in brown box-shaped plastic sections. Guttering was seen to be in fair condition and free from any obvious leaks on this relatively dry day. To the right hand side of the first floor WC guttering does not extend totally into the corner, and in this location a small amount of lead flashing is present in order to divert water runoff from the roof into the guttering itself. Guttering would all now benefit from being cleaned and flushed through. The downpipe was well secured to the elevation wall, this ultimately jettisoning stormwater down into a sealed gully at the base of the wall.

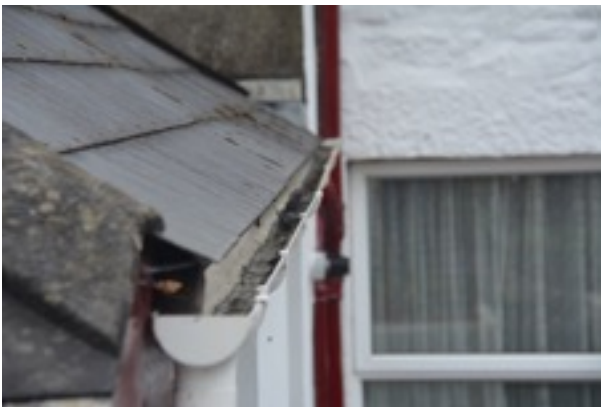
Guttering serving the side of the extension has been run in white half-round plastic sections. This too was seen to be in fair condition, there being a downpipe secured to the elevation wall by the store door, this ultimately jettisoning stormwater into the nearby gully, which also collects waste water from the bathroom. It was noted that the fixing bracket at the base of the downpipe has worked loose.

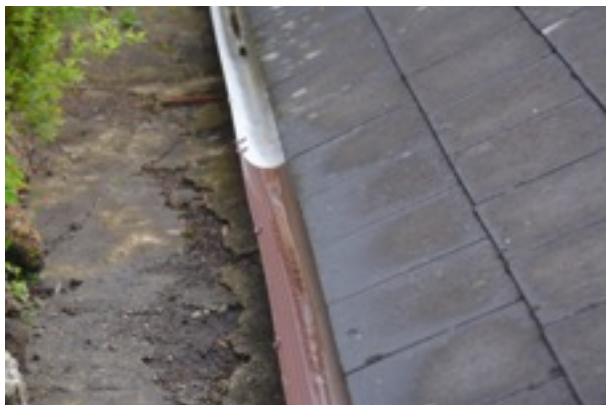
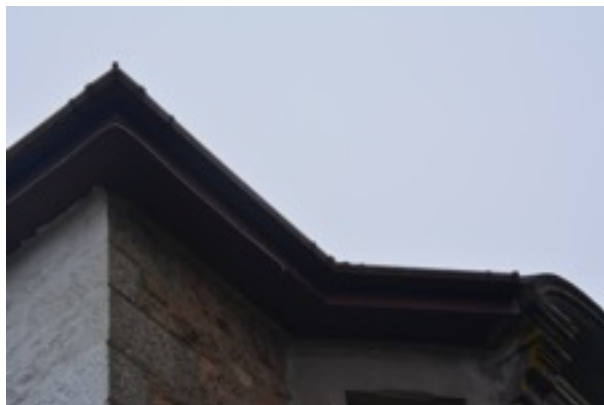
Guttering serving the rear roof slope has been run in a mixture of both brown and white plastic sections. This is shared with the adjoining dwelling and extends across and ultimately jettisons stormwater onto the side of the adjoining dwelling. The guttering extends down the side of the building where it is also run in brown box-shaped sections. Whilst we noted no obvious signs of any leaks, it is quite apparent that the guttering is dirt stained in this location and again requires to be cleaned and flushed through. The guttering wraps around the front of the building to where the bay is located.

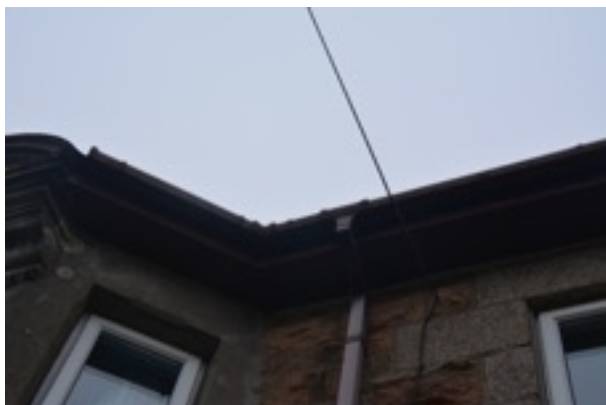
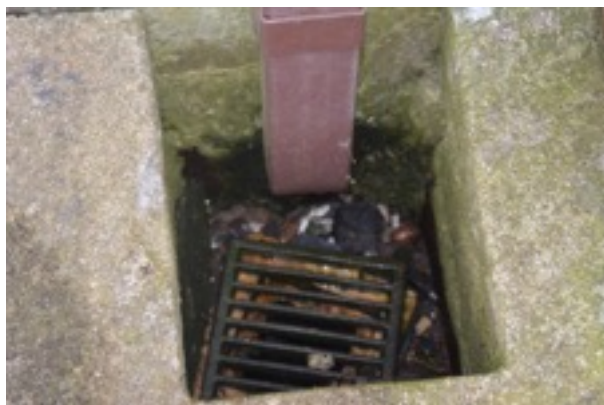
The final section of guttering is positioned to the right hand side of the bay where there is a further downpipe, this ultimately jettisoning stormwater into an open, although protected, gully at the base of the wall. It was noted that some of the cement benching surrounding the gully has now washed and weathered away, and this should be repaired to prevent water soaking down through into the foundation areas, which will ultimately cause damage and settlement problems.

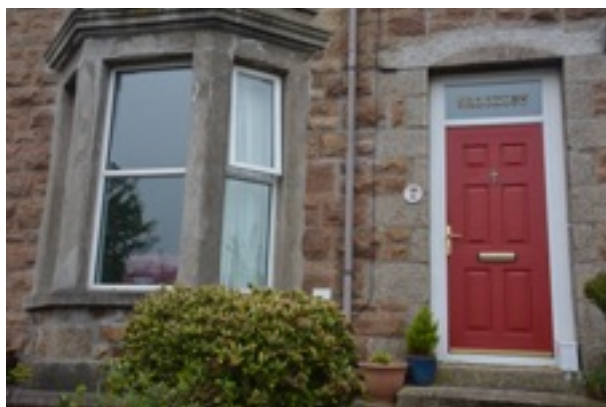
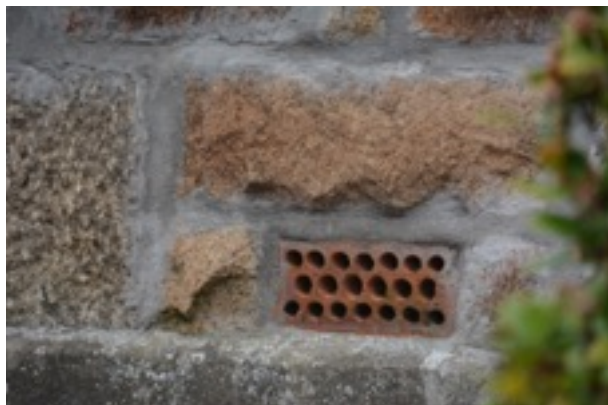
As viewed from the front of the dwelling the elevation wall was seen to be generally vertical, this largely comprising both stone and granite, with granite quoins and lintels around door and window openings. Where the bay is located, the bays have been rendered and the nature of the material below is not known, but we suspect stone or brickwork. This has obviously not been decorated and it would perhaps be greatly enhanced if the whole of the bay area was painted accordingly. Pointing to the stonework was seen to be in fair condition, there being one air brick present at low level below the bay providing for sub-floor ventilation.

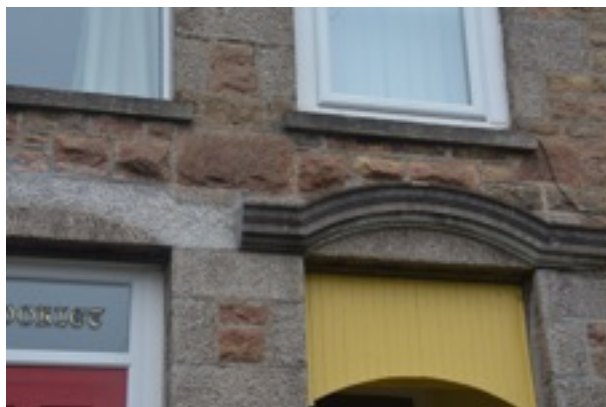
Some patch repairs have been undertaken to the pointing during the history of this dwelling. Where the entrance door is located originally there was some ornate cornicing immediately above the door, similar to that on No. 34, but this has obviously long since cracked and broken away, there now being a light scar on the granite where this was originally positioned.

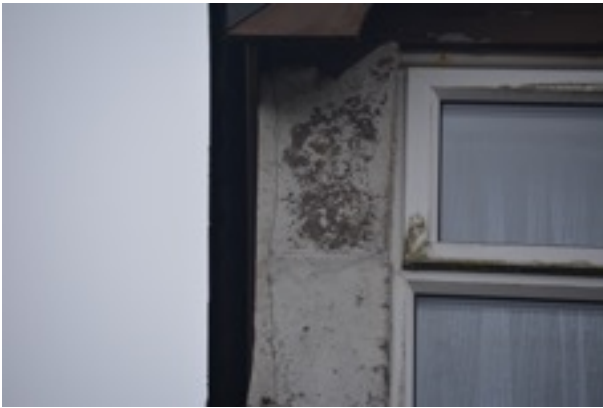
Where the dormer is located at the uppermost level we noted evidence of cracking to the rendered surface and suspect that the render may well be blown in this location. This obviously has not been decorated for very many years, to include for the wooden timberwork present in the uppermost part.

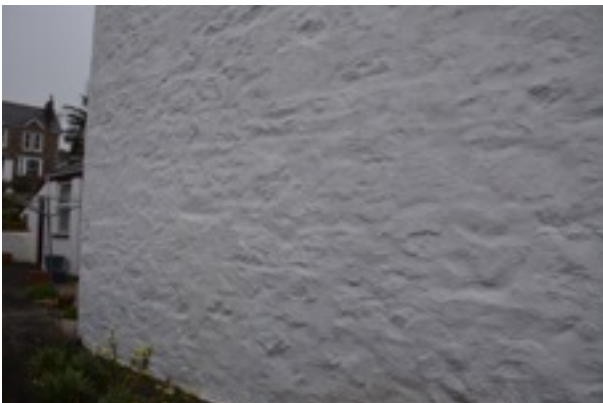
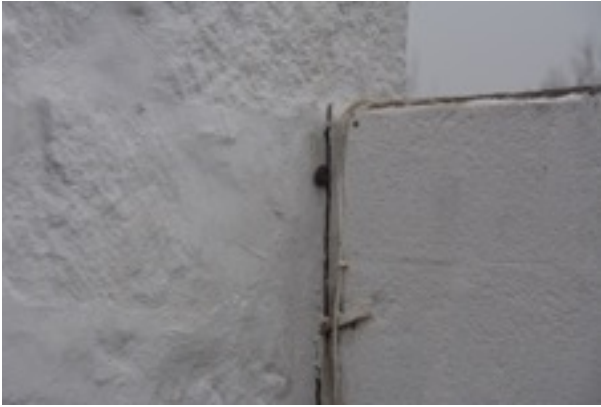
The side elevation wall of the main building is very obviously of stone that has been painted in the past, but a small area at high level has obviously not been decorated because the ladder wouldn't reach. We noted no evidence of any cracking, bowing or deflection, there being further air bricks present around the base to provide for sub-floor ventilation. Slight dirt staining was noted to the surface of the wall which will inevitably require to be redecorated in due course. Butting up to this wall where the side pedestrian gate is located there is a block built boundary. This has slightly pulled away from the wall due to, we suspect, differential movement and we noted no evidence of any physical or chemical damp proof course present in this location, which may result in damp bleeding through into the main structure.

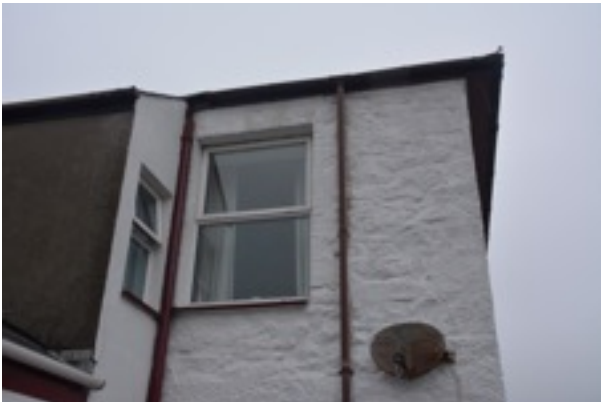
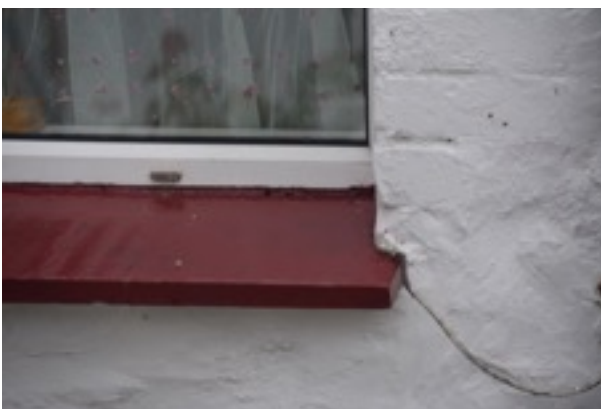
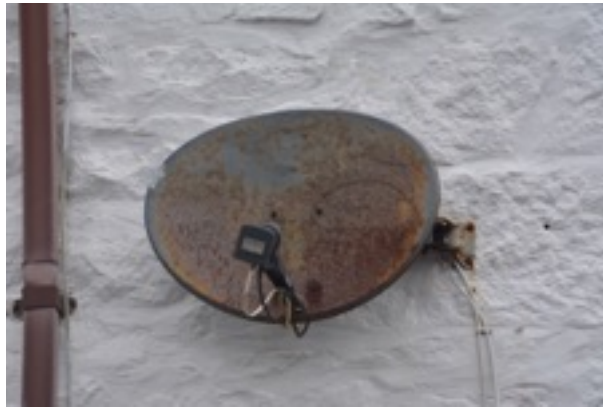
The rear elevation wall of the main body of the building is also quite clearly of stone and granite with some brickwork present surrounding the window openings, however that section to the left where the building protrudes where the separate WC is located has been rendered and partially painted. This is the section which is understood to be of brick. The elevation wall was seen to be vertical and again free from signs of cracking, bowing or deflection with window openings remaining square and cills being of solid slate that has been painted. Please note that to the rear of door and window openings on all parts of this building we are unable to comment as to the condition of any timber lintels that may be present. Against the rear elevation wall there is a satellite dish, but this was noted to be corroded and is probably now in need of replacement.

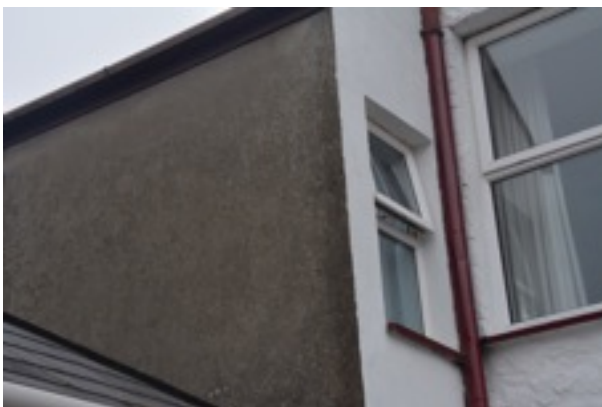
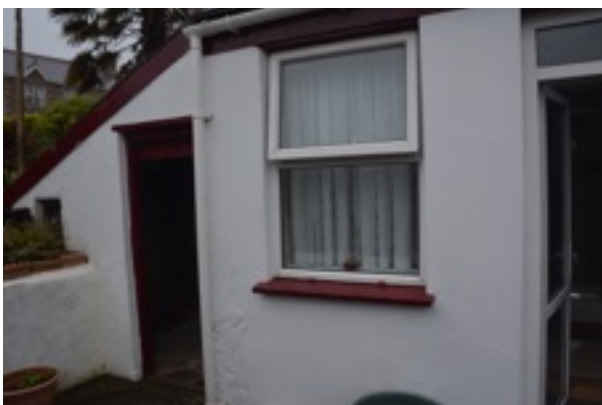
The side elevation wall of the back extension, which is also we understand of brick, was equally seen to be vertical and again free from signs of cracking, bowing or deflection, with the window openings remaining square and further slate cills present. In the corner, the soil vent pipe rises up between the small extension and the main building, but this stops short of the eaves and ideally this should be extended and goosenecked around the top with a suitable metal or plastic cage fitted. A balanced flue protrudes through the wall serving the internal boiler and at low level a gas meter box is positioned. To the left hand side of the back door position the wall was also seen to be generally vertical, but some patch repairs have obviously been undertaken at low level to the rear of the downpipe. Some brickwork is present to the right hand side of the back door where render is cracked and broken away (a foot scraper may possibly have been initially positioned in this location). Where the outside tap protrudes through the wall below the kitchen window this should ideally be fitted with insulation and a small lagging jacket to prevent the possible risk of frost damage.

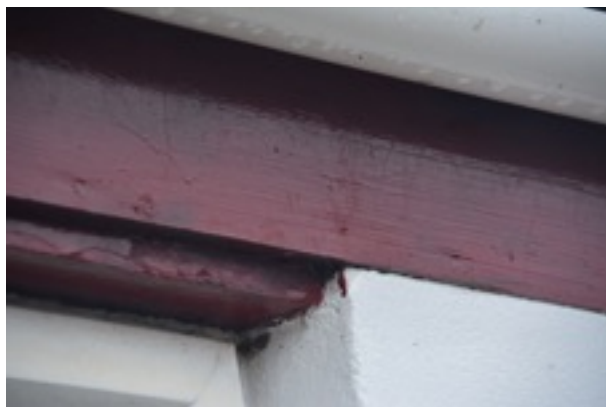
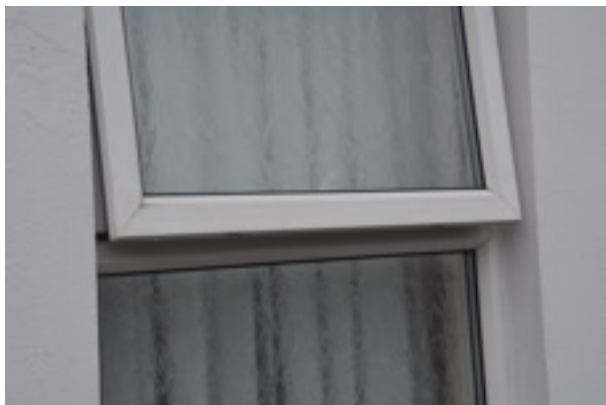
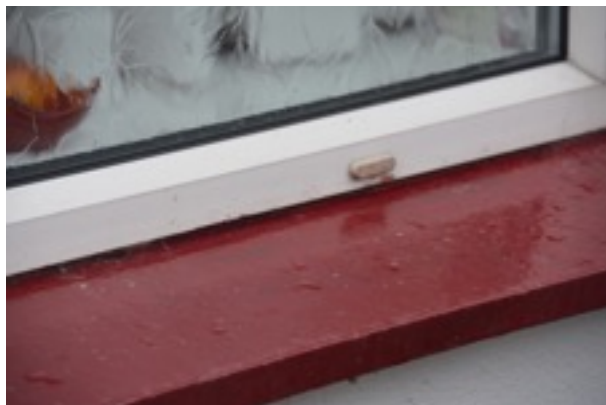
The various fascia boards, cills and wooden doors have been fairly well maintained during the history of this property, but they have suffered and gradually deteriorated over time, with small amounts of rot present around door frames. The fascia boards, which are painted, were seen to be in fair condition, but inevitably these too will require to be redecorated during the course of your occupation. The soffit boards have also been painted. Please note, we are unable to comment as to the nature of this material. The various other doors and windows are all of modern uPVC. These should remain relatively maintenance-free, but will inevitably require routine cleaning down in order to maintain their appearance. It was noted to the soffits where some electrical cabling is present this has dropped out of position and requires to be properly re-secured.

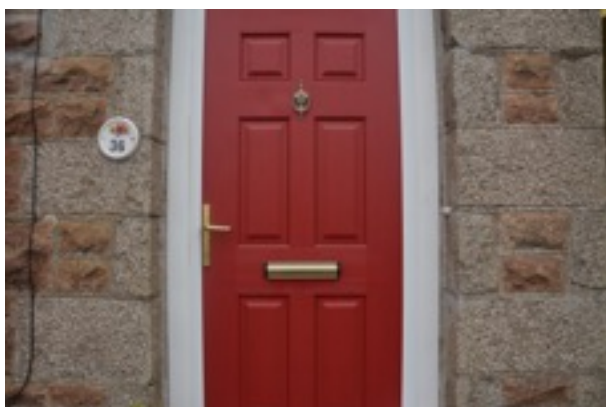
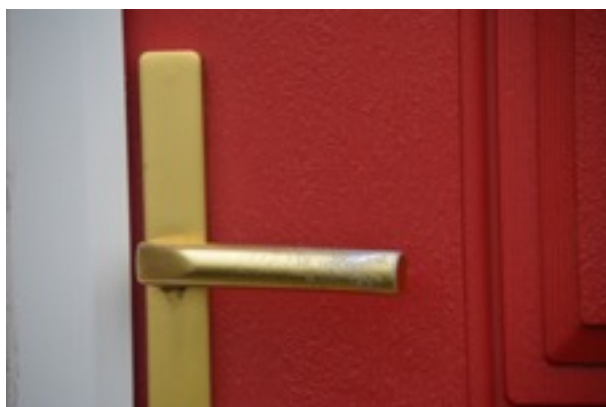
To the front of the building the same comments are largely applicable and, as already mentioned, it will probably be prudent to paint the bay area as this will considerably improve the overall appearance of the approach to the building. The main entrance door has more recently been replaced, but it was noted that the handle has become scratched and worn. Where the side pedestrian gate is present to the left hand side there is no proper gate stop and it would perhaps be beneficial to undertake some improvements in this location.

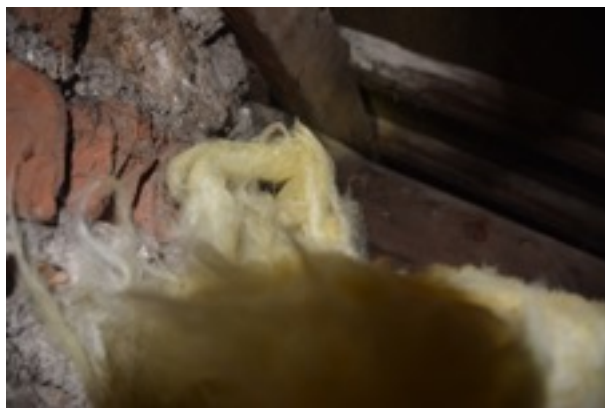
Access was available into the section of roof void immediately over the bathroom via a hatch positioned in the bathroom ceiling. We can confirm that immediately by the hatch rising up between the bathroom and the kitchen there is a further solid random stone wall, with a stone wall between the subject dwelling and adjoining property. These walls in the past have been covered over with a slurry cement wash and painted, but have obviously not received attention for many years as there is no point. The void was seen to be generally well insulated. Timbers within the void are the original timbers, which were seen to be in fair condition given their age, although there was evidence of past water staining due presumably to previous defective roofs. The undersides of the tiles have been protected with bitumen felt and the void has been generally well insulated. There is a very small opening to the right hand side leading through into the kitchen roof void where some lath and plaster was present. We can confirm that some further insulation has been stuffed into this area, but in all honesty no sensible inspection of the area beyond was possible. We can confirm that by pointing the camera into this area some brickwork was indeed present, but we suspect this to be associated with the chimney stack. Whilst the void has been generally well insulated, some pipework that is ducted through this part of the property has not been insulated and this should ideally be protected accordingly to prevent the possible risk of frost damage.

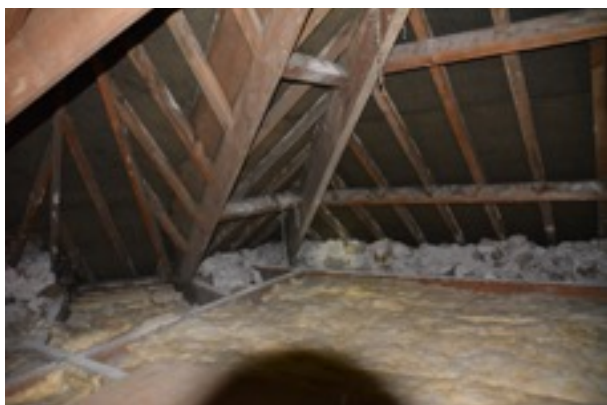
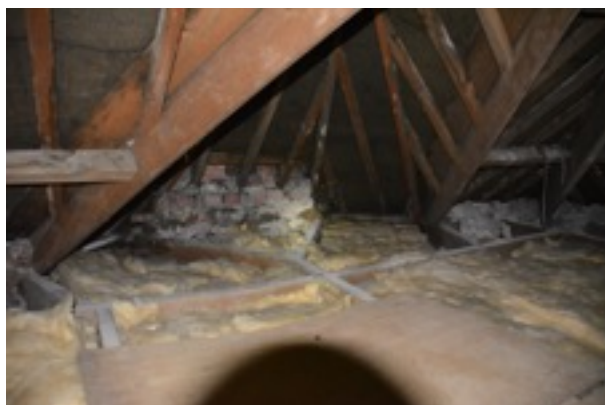
As you will recall, there is an attic room and therefore there is effectively no roof void; the attic room, which we suspect was always originally part of the structure of the building, effectively occupies this space. There is a hatch which gives access into the roof space beyond. A very small amount of boarding was present, but effectively inspection had to be undertaken from the hatch only. We can confirm that timbers were seen to be original and these were seen to be in fair condition with the undersides of the tiled roof surface being felted. We noted no evidence of any leaks through the valley areas surrounding the conical roof to the front where some rubble and brickwork was present to the uppermost part. Stonework was visible forming the upper parts of the walls surrounding this dwelling. The void has been generally well insulated, but ideally the depth of insulation should be further increased to a minimum depth of at least 12".

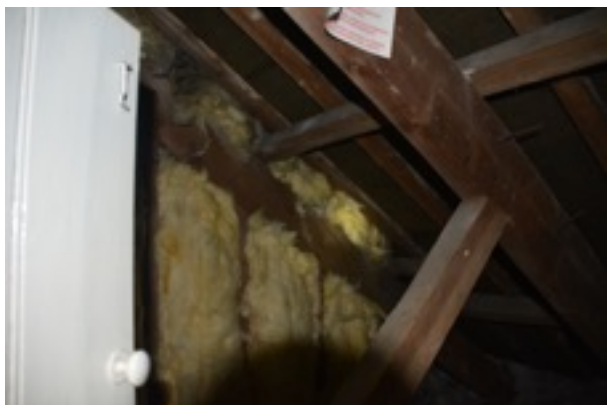
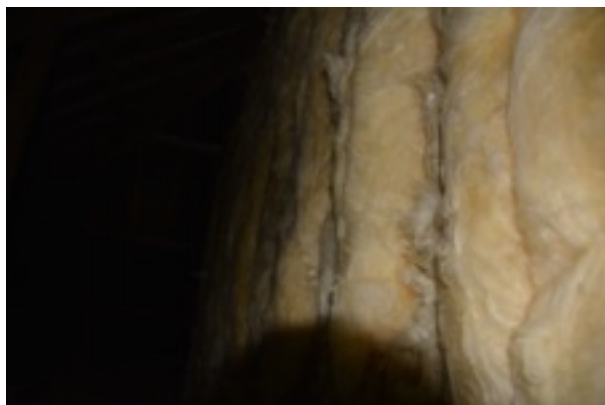
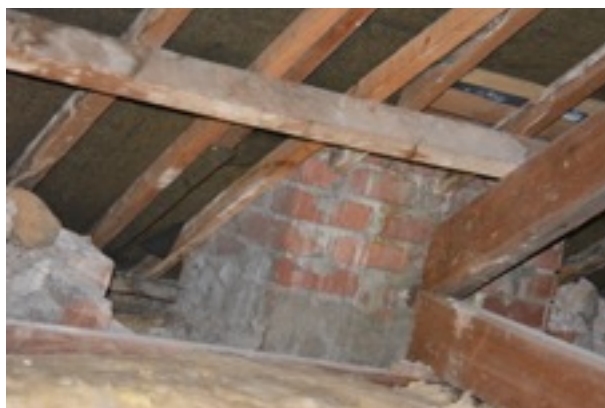
The very limited inspection of those parts of the void extending down the side revealed no obvious defects, with the roof again for the most part being clean, tidy and reasonably well insulated, to include for vertical insulation against the stud wall where the upper attic room has been formed. Where the chimney stack rises up on the gable end wall brickwork was visible, and this was seen to be in fair condition with no evidence of any rainwater penetration down through the uppermost parts.

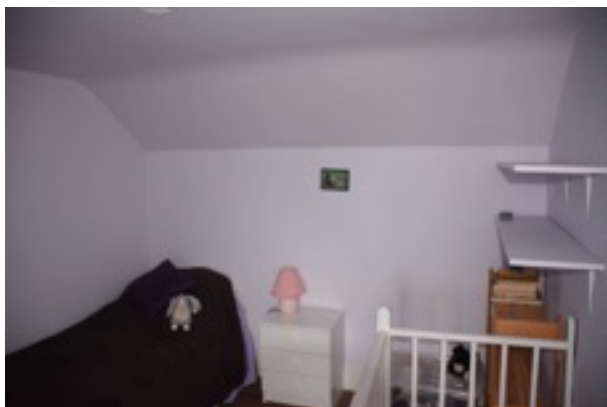
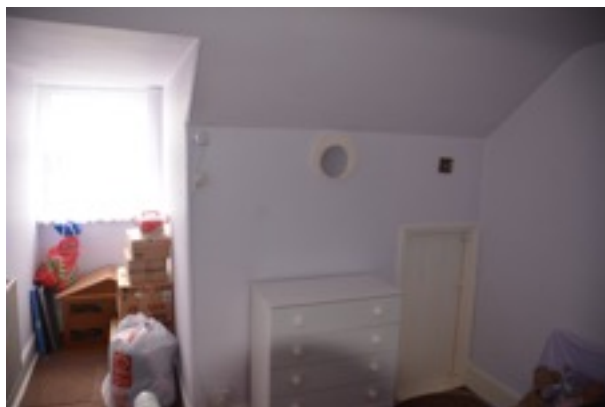
Within the attic room the ceiling is believed to be the original lath and plaster ceiling. We noted some evidence of cracking, but no evidence of imminent failure, however we would point out that where lath and plaster is present this does have a finite life expectancy, and the future longevity of this may therefore be limited. Where the dormer is located we noted slight disturbance to the surface, but again no obvious signs of imminent collapse, although some stains due to past leaks were present.

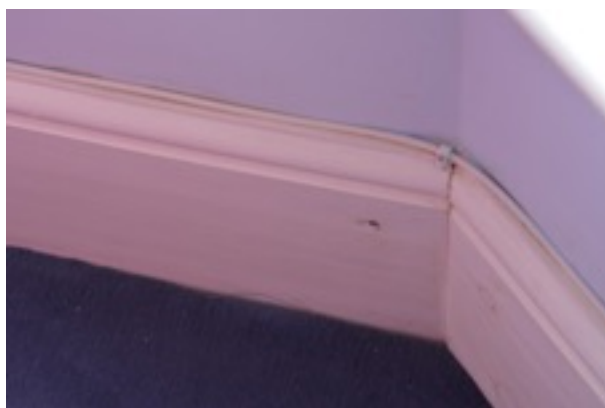
Where the attic room is located there is a small balustrade around the top of the attic stairwell, however this is loose and requires to be properly re-secured. The stairs have no adjoining grab rail, and as these have been painted they are potentially slippery and therefore also a potential hazard. We also noted that the balustrade to the stairway of the main part of the dwelling was loose, and this too should be additionally braced up. Elsewhere within the building woodwork was seen to be in fair condition, other than where it has naturally suffered from wear and tear. Where the door leads through into the kitchen from the hallway the upper part is glazed, but it is not known if glass is toughened or laminated. Skirtings and architraves to doors were seen to be in fair condition with a dado rail also present. Where the inner porch door is located further glass is present, to which the same comments apply. Inevitably doors will require easing and adjusting after redecoration, but subject to minor repairs and maintenance we see no reason as to why woodwork should not remain serviceable for its intended use. There was some evidence that skirtings in the front living room have been replaced with new skirting, indicating that there may have been a rot problem in this location in the past, and further decorative works are required.

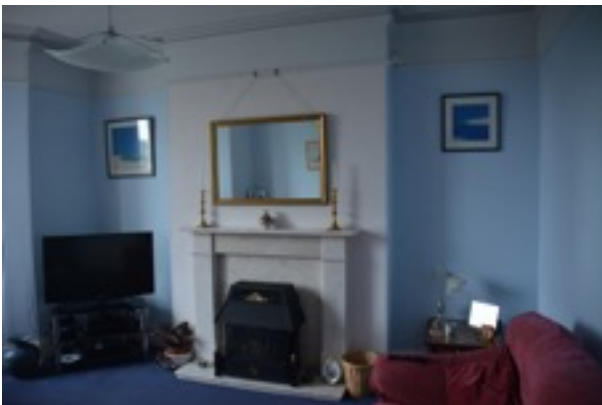
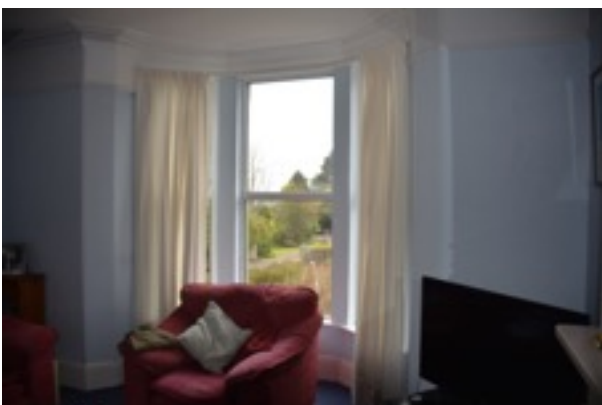
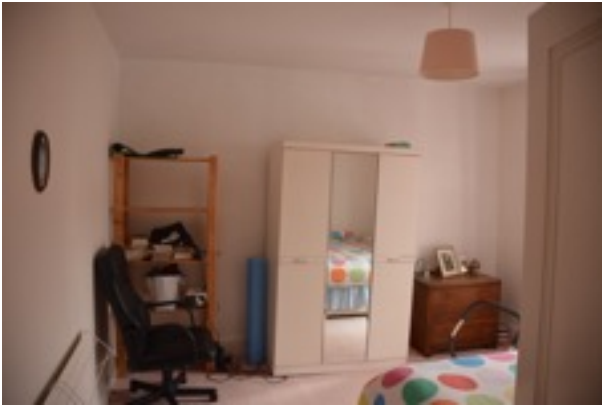
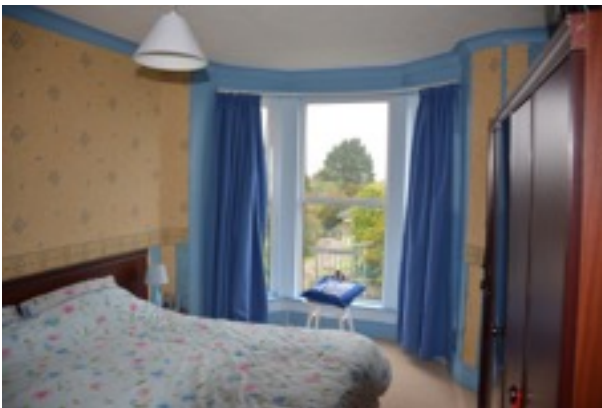
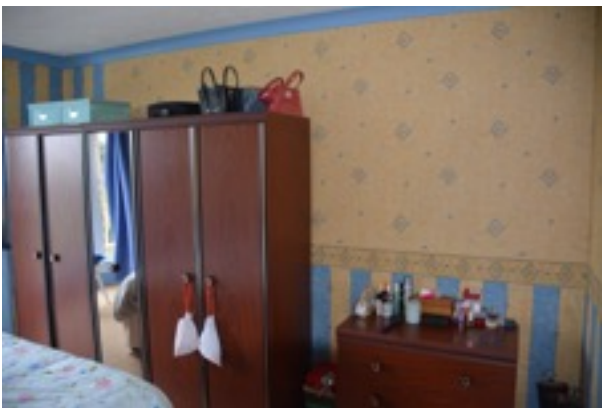
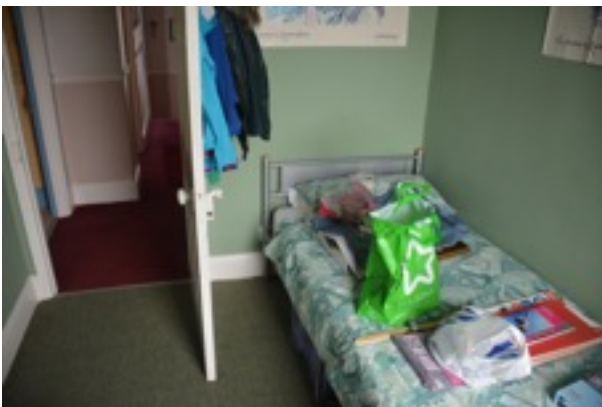
Throughout, this property has been relatively simply decorated, walls largely emulsioned and woodwork glossed or stained. The property is effectively ready for immediate occupation. We did note the use of some wood chip wallpaper, and in the event of this being removed it is quite feasible that the underlying plaster will pull away with it. Inevitably decorations will become lightly soiled and marked after the removal of furniture and fittings, and you will no doubt wish to redecorate in accordance with your own particular style and taste. Obviously some surface decorations are damaged where there have been high levels of damp and additional making good will be necessary in these locations.

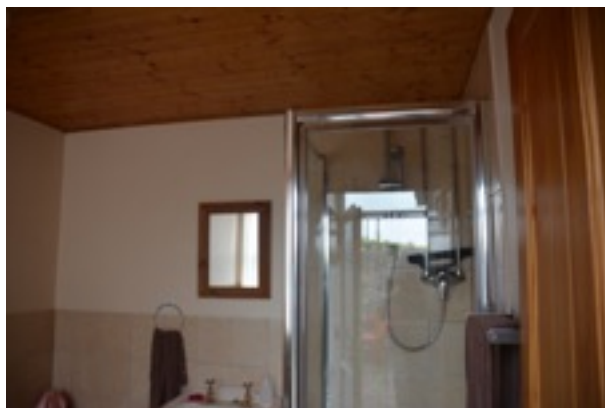
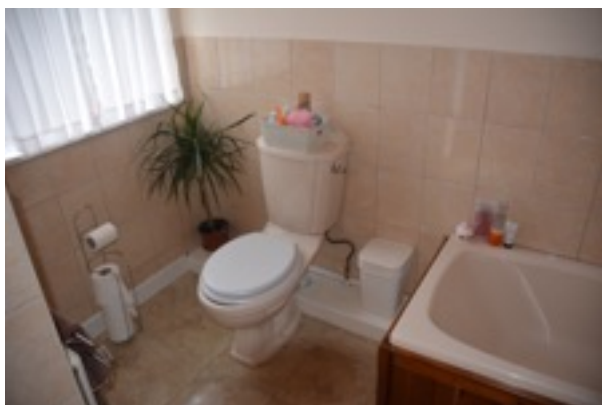
At ground floor level there is the principal bathroom, which we have to say is about as far away from all of the bedroom accommodation as you could possibly get. The bathroom comprises a bath, pedestal wash hand basin and WC together with a corner shower, these areas all being tiled. The facilities are perhaps dated in style and design, but should remain perfectly serviceable for their intended use, subject to normal routine cleaning down. None of the facilities were tested by ourselves.

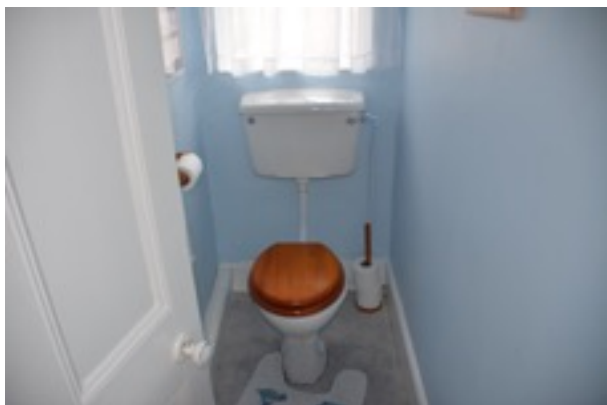
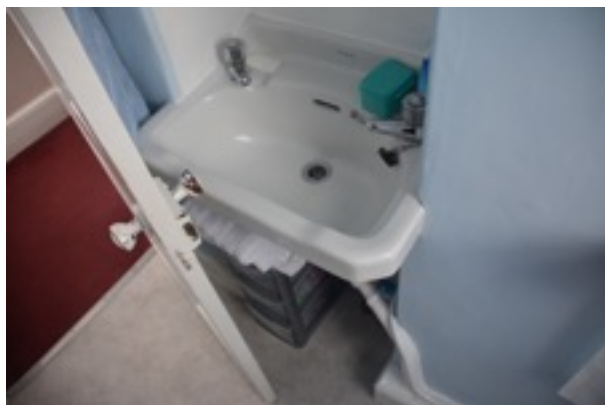
Where the separate WC is located there is a wash hand basin set into a small recess. Again, subject to cleaning down, these should remain serviceable for their intended use, but some of the pipework is surface mounted and relatively unsightly and there is an old lead waste serving the small wash hand basin. Please note that any lead service pipework present within this building should be stripped out and removed as it is obviously a potential health hazard.

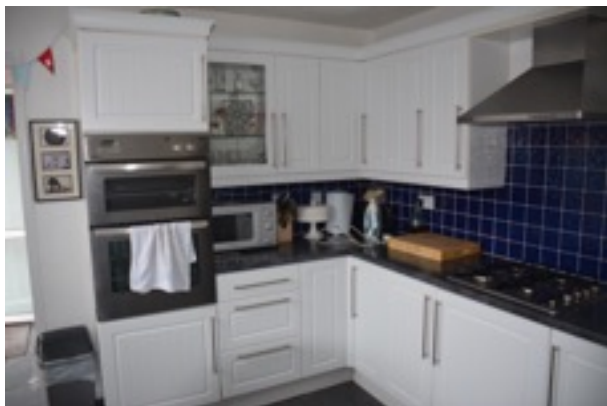
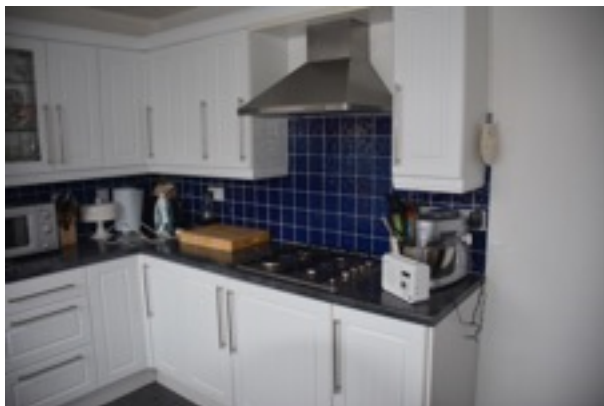
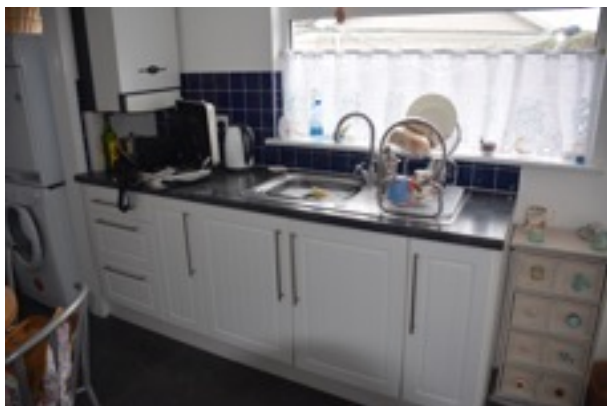
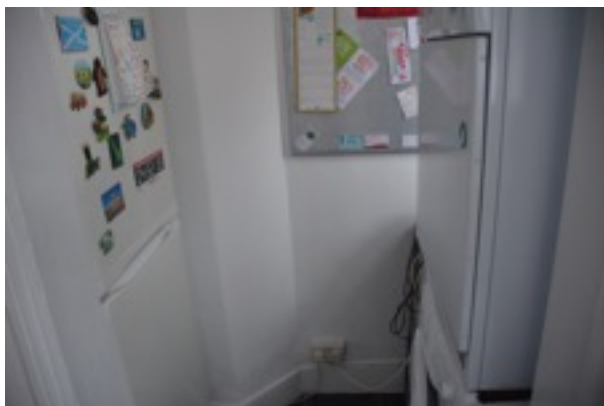
The kitchen comprises a range of base units with work surface above together with some eye-level cupboards, there being a built-in double oven and four burner gas hob. The work surface incorporates a single bowl, single drainer stainless steel sink unit with space in the recess which has been plumbed for a washing machine and tumble dryer for a freestanding fridge/freezer. There are a reasonable number of electrical points and sockets for modern day kitchen equipment, however none of the equipment present was tested by ourselves. Subject to normal cleaning down, we see no reason as to why the kitchen should not remain perfectly serviceable for its intended use.

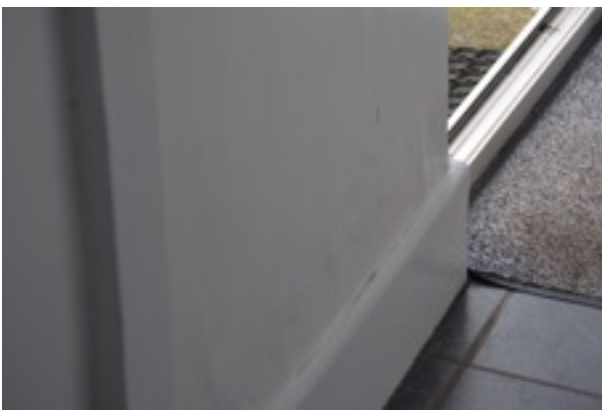
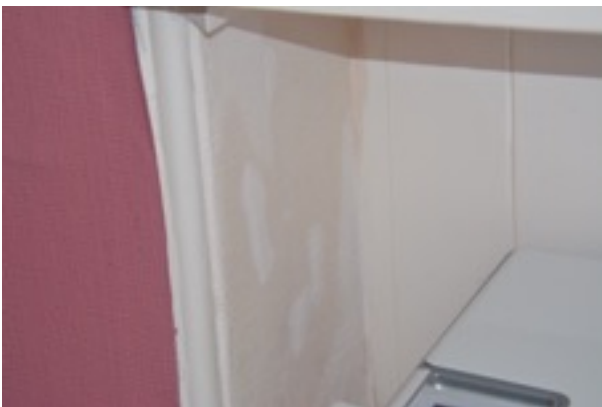
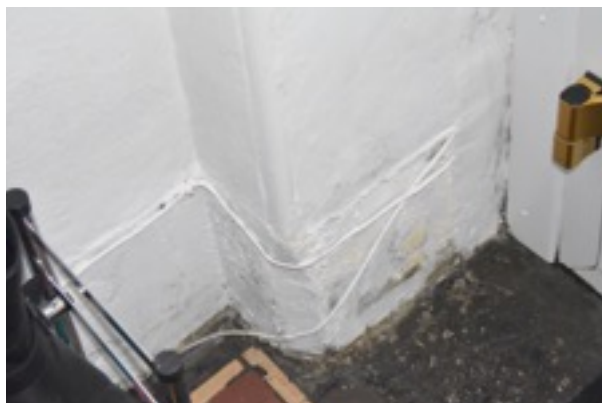
During the course of our inspection we noted some evidence of damp penetration, particularly through the front bay area where we suspect skirtings in the past have been affected. We also noted evidence of damp staining within the dining room where recesses are present on the external walls. Given the nature of the construction of this property we would inevitably anticipate it to be damp to a degree, this being very typical of this type of dwelling and probably impossible to eradicate on a comprehensive basis. There are further physical signs of damp within the entrance hall.

Moisture meter readings were taken throughout the dwelling at both high and low level. Needless to say, where staining was apparent these were unacceptably high and we have no choice but to now recommend that you please seek your own further specialist advice.

Please ensure that the external envelope of this building is adequately maintained in good order at all times, with particular attention to the main roof covering, rainwater goods and elevation walls as well as window reveals. Internally, it is important that the dwelling is adequately heated and ventilated at all times to prevent a build-up of condensation.
