BUILDING SURVEY REPORT (LEVEL 3)

Property Address: **Any House**
 Any Street
 Any Town
 Any County
 Any Postcode

Prepared By: **Richard C K Hocking FRICS, F LAND INST**

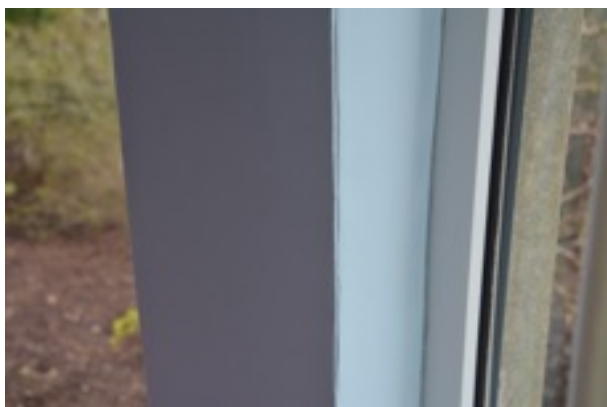
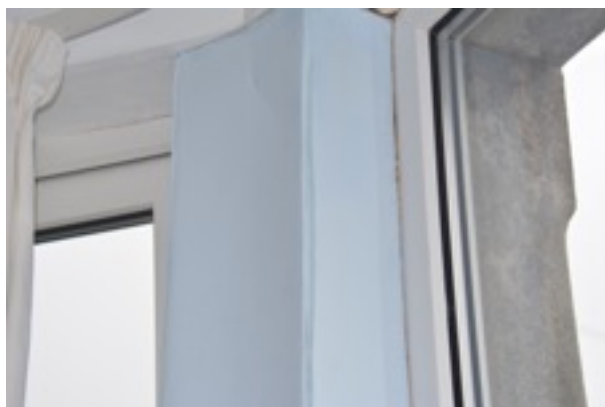
Where the bay area is located we noted Cotina to be present behind surface paintwork. Cotina is often used in an effort to repel damp and reduce levels of condensation. Where this has been applied to the two columns the standard of workmanship was noted to be poor.

We noted evidence of damp staining in the dining room, in the living room and in the entrance porch, with light staining where the chimney comes down on the gable end wall where readings were also found to be unacceptably high. In the hallway from the base of the stairs towards the front door the wall has in part been dry lined.

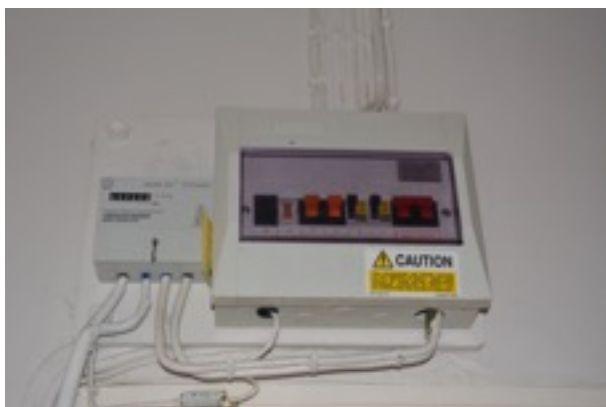
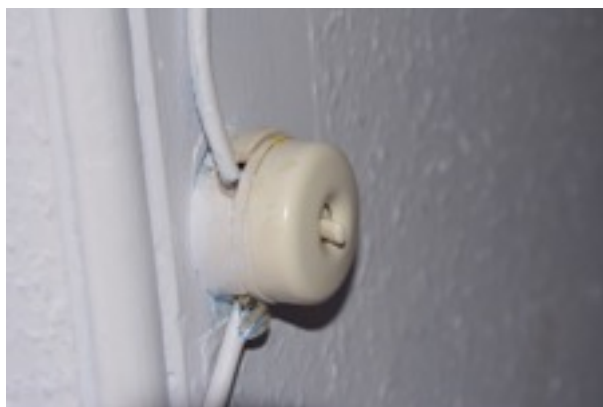
9.1 Electricity:

Mains electricity is connected, the mains electrical riser entering the property beside the dining room door, the meter and consumer board being located at high level immediately above, the meter reading at the time of inspection being 40069.2. The consumer board is a relatively modern consumer board incorporating independent circuit breakers.

In our experience, domestic wiring normally has a life expectancy of approximately 25 years and should ideally be tested at least every 10 and on change of ownership. It is now recommended that a suitable test is put in hand by a qualified electrician who can advise as to the overall condition of wiring circuits within this dwelling and the extent of any upgrading/rewiring now necessary. Almost certainly, you will wish to improve upon the number of electrical points and sockets within principal locations in order to accommodate for modern day living requirements. We did note some old switchgear which should also ideally be upgraded. Please ensure that smoke alarms are incorporated within this dwelling at both ground and upper levels. No tests were undertaken by ourselves.

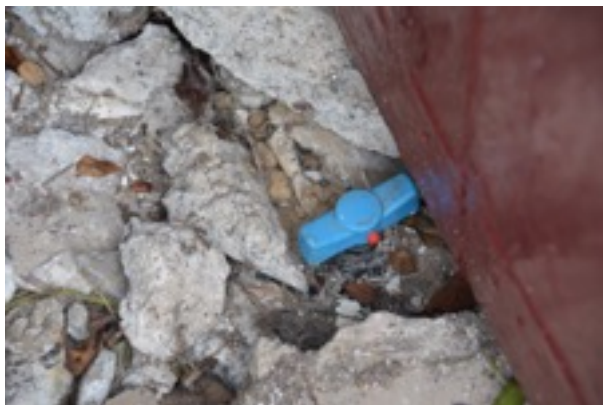
9.3 Water:

Believed to be connected to the mains water supply, there being evidence of a fairly new stop cock being located within the store at the back of the property, but the floor surrounding this requires to be properly made good. Pipework internally was run in a mixture of copper and plastic, and we noted no obvious signs of any leaks at the time of inspection, but no tests were undertaken by ourselves. We noted no evidence of any cold or hot water storage tanks present within this dwelling. Obviously should you wish to improve either kitchen or bathroom facilities then inevitably there will be a need to upgrade associated plumbing, which is likely to include for additional electrical work in terms of earth bonding.

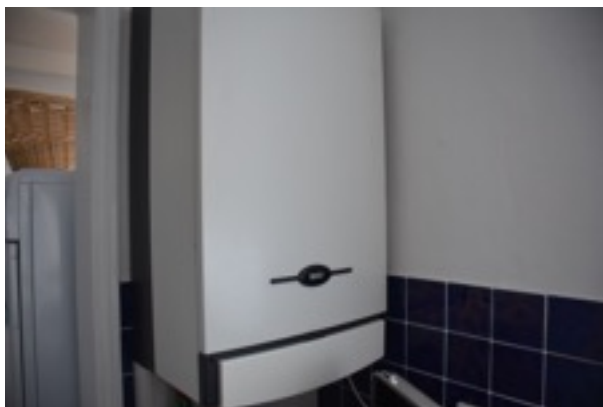
9.4 Central Heating and Fireplaces:

Gas fired central heating is installed, this being operated via the wall mounted combination Baxi boiler located in the kitchen. This was seen to be on and was working at the time of inspection, but the equipment was not operated by ourselves. Please raise enquiries to ascertain the service history of the boiler together with its age and as to whether or not there are any maintenance or service contracts associated with this. Radiators are present within principal locations, these benefiting from additional thermostatic valves, and we would envisage that these adequately heat the dwelling during the colder months of the year, but obviously cannot confirm, and we are equally unable to comment as to the future longevity of the boiler itself. The gas fire in the living room was not operated by ourselves and, as mentioned above, this should also be checked by a Gas Safe engineer.

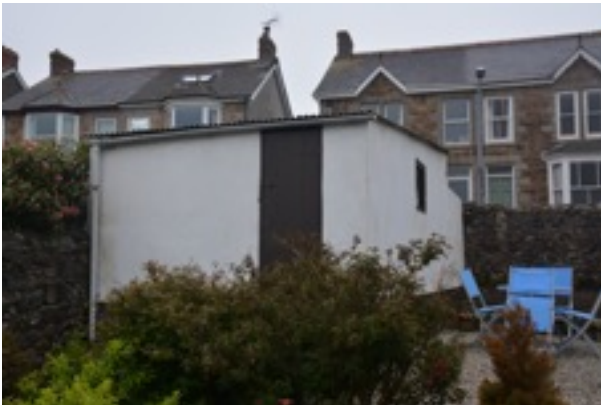
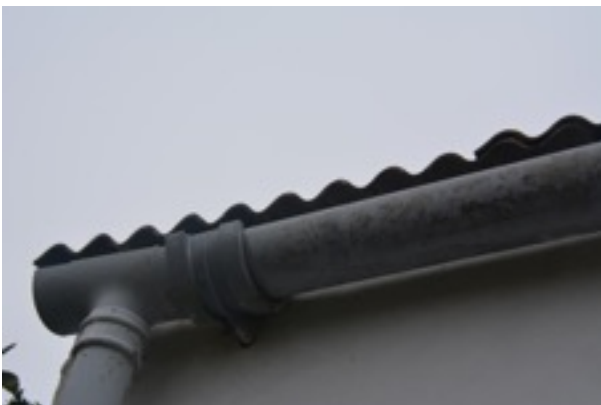
As you are aware, at the top end of the garden there is a single block-built garage below a corrugated asbestos sheeted roof which drains to the rear where there is a half-round plastic gutter, but this is perhaps not best positioned below the asbestos roof, and the downpipe in the corner is simply propped up by a piece of breeze block and ultimately drains into the adjoining flower bed. It was noted that the corrugated roof is a relatively new roof, but we are unable to comment as to whether or not the material is of a hazardous nature. To the front, the garage is accessed via side hung opening wooden doors (locked and not operated by ourselves).

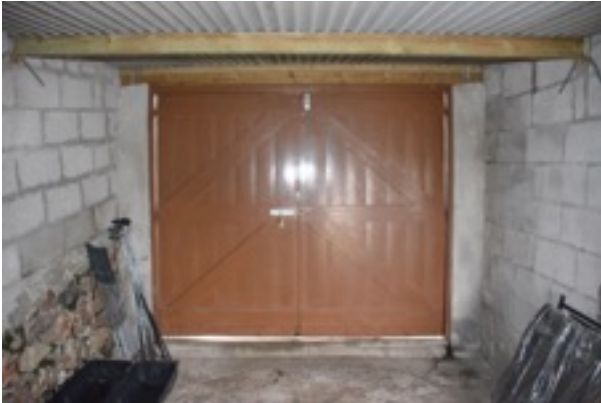
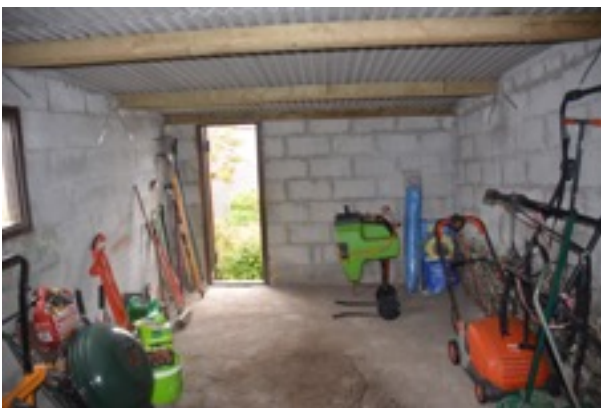
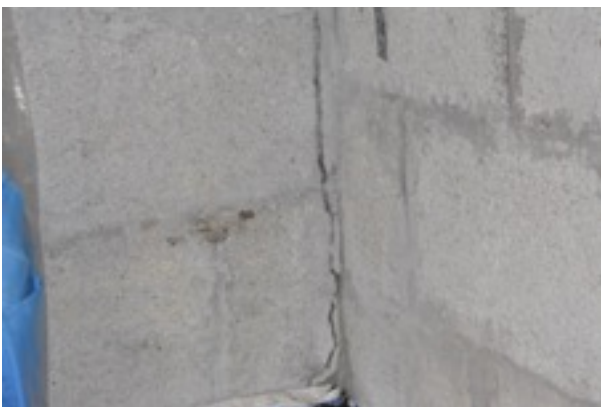
The internal walls of the garage were seen to be in fair condition, there being some stonework present roughly on the party wall line, with the garage having a solid concrete floor, although the floor was noted to be cracked and occasionally pitted, albeit that it remained generally clean and well presented. The roof is supported on new timber beams and, subject to normal routine maintenance works, we see no reason as to why the garage should not remain perfectly serviceable for its intended use, albeit that the structure is relatively basic. Please be aware that this area is always likely to remain cold, damp and prone to high levels of condensation. In the corner where the back wall adjoins the side wall on the party wall line there is obvious evidence of past movement, there being cracking present as a result of the blockwork not being properly stitched in in this location. We noted further evidence of slight cracking towards the front on the outer wall, due we suspect to minor settlement problems.

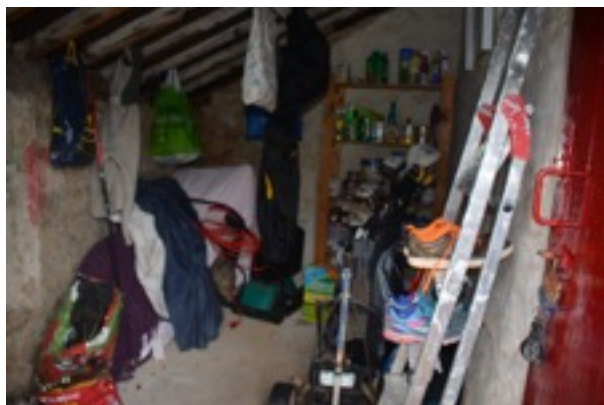
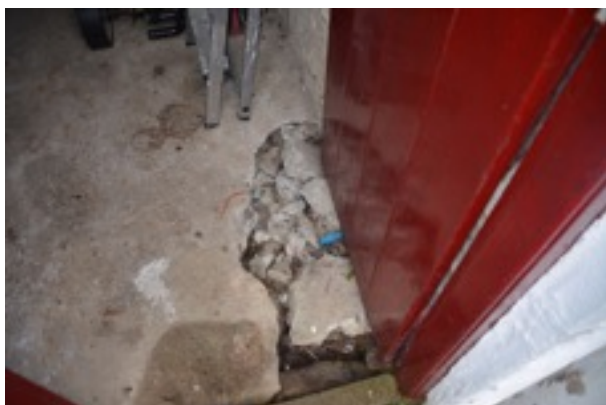
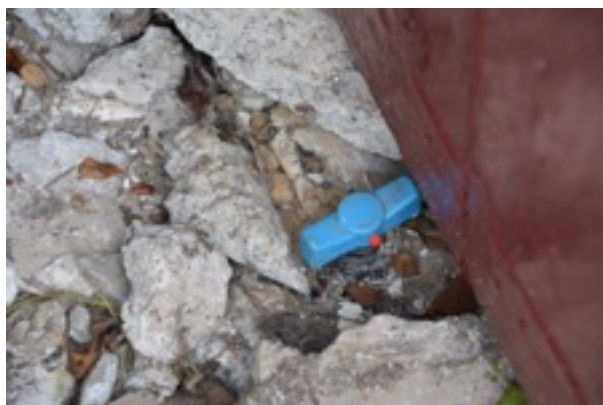
As you are aware, there is a small rear store present at the back of the bathroom, upon which we have commented above. This provides for some useful additional storage, but inevitably is likely to remain cold, damp and prone to high levels of condensation, the roof over this structure forming part of the roof to the rear addition itself. Within the store it was noted that the concrete flooring has cracked and broken open where the mains water enters the building, there being evidence of a relatively new stop tap being installed in this location, but the concrete flooring still requires to be made good.
